**Report of investigation into the
grounding of the Togo registered
general cargo ship “*Yu Hai 1*” in
Discovery Bay, Hong Kong
on 23 August 2017**

The Hong Kong Special Administrative Region
Marine Department
Marine Accident Investigation Section

25 February 2020

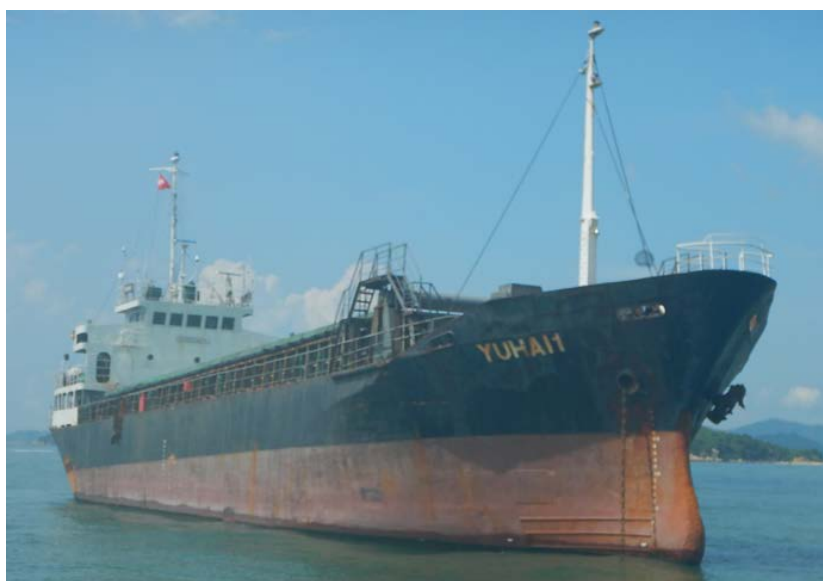
Figure 1: *The vessel.*

- 4.14 During the period at WA1, *the vessel* carried only about 15 tonnes of fresh water and 30 tonnes of fuel oil without any cargo or ballast water. *The vessel* was in a very lightly loaded condition with mean draft of about 1.6 m. As shown in Figure 1 and Figure 4, this loading condition had resulted in producing a large exposed hull area making *the vessel's* movement particularly more susceptible to wind force. As indicated in Table 1, the vessel was rolling and pitching moderately at about 0800 hrs. on 23 August 2017 when typhoon signal No. 8 was hoisted. In any event of a vessel under pitching and rolling condition, irrespective of the typhoon signal, the master and senior officers still failed to take any action to ballast *the vessel* in order to reduce the large exposed hull area for the sake of making *the vessel* less susceptible to wind.

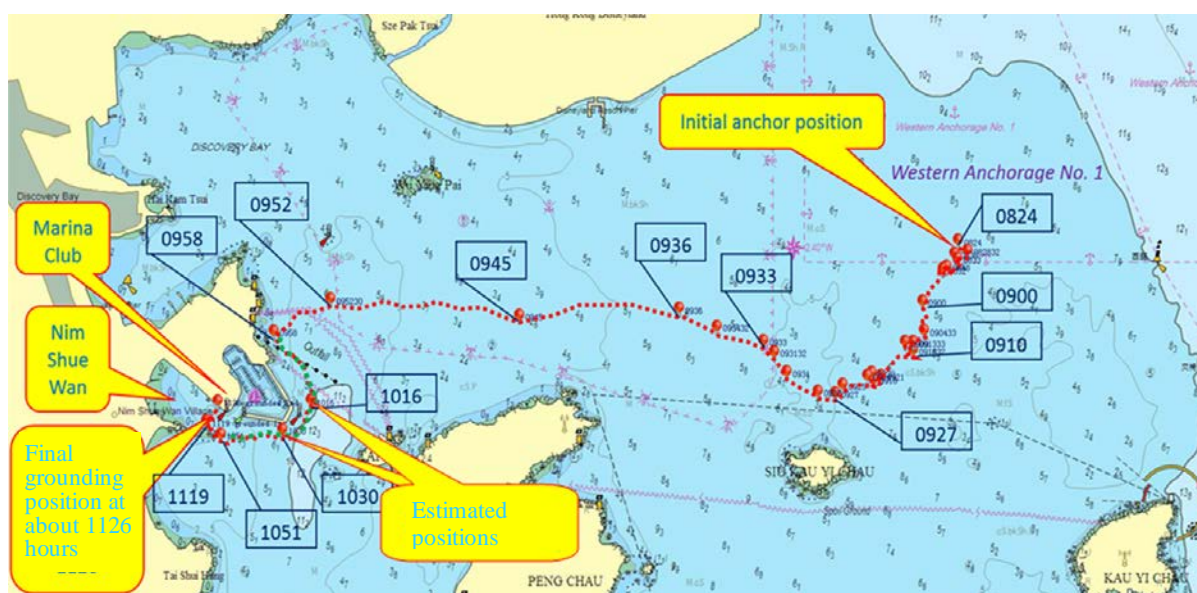
- 3.17 Figure 2 shows *the vessel’s* movement track and her final grounding position. Figure 3 shows the photographic image indicating the final grounding position of *the vessel*.

Figure 2: Sketch showing *the vessel’s* movement track and her final grounding position on 23 August 2017.

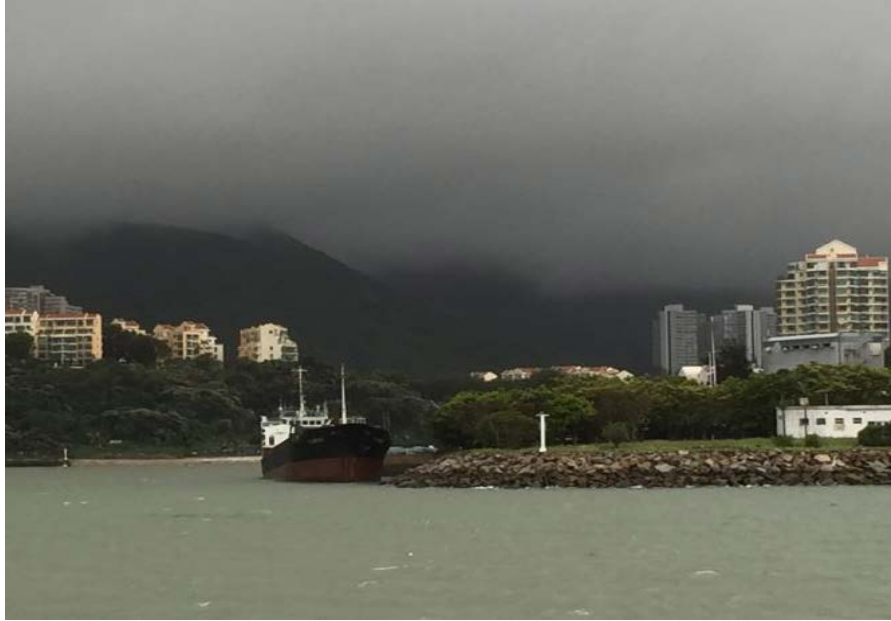
Figure 4: Photo taken at about 1900 hours on 23 August 2017

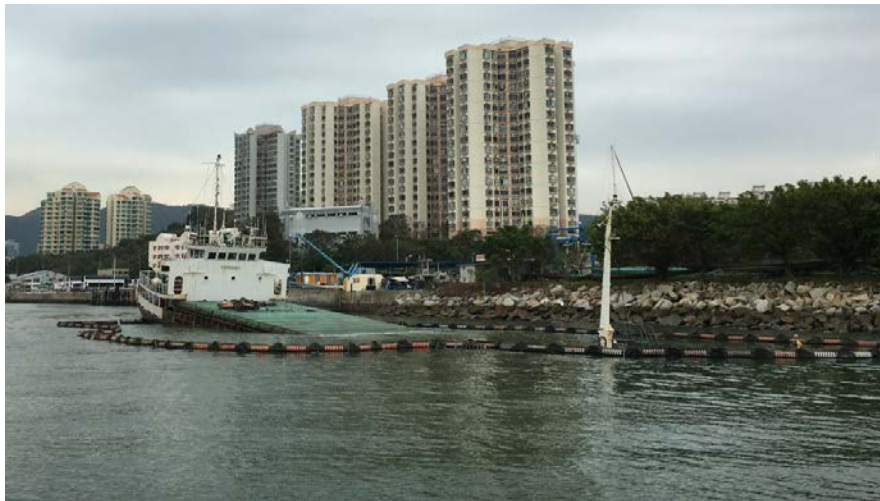
- 3.21 The salvage operation commenced in the morning on 26 August 2017. However, *the vessel's* bottom was further damaged by another severe typhoon “Pakhar” on 26 and 27 August 2017. Her bow was eventually submerged in water (Figure 5).

Figure 5: The bow of *the vessel* submerged in water
