**Report of investigation  
into the fatal accident of the bosun  
on board Hong Kong registered  
bulk carrier “*BBG Bright*”  
at Praia Mole anchorage, Brazil  
on 1 October 2017**

**The Hong Kong Special Administrative Region  
Marine Department  
Marine Accident Investigation Section**

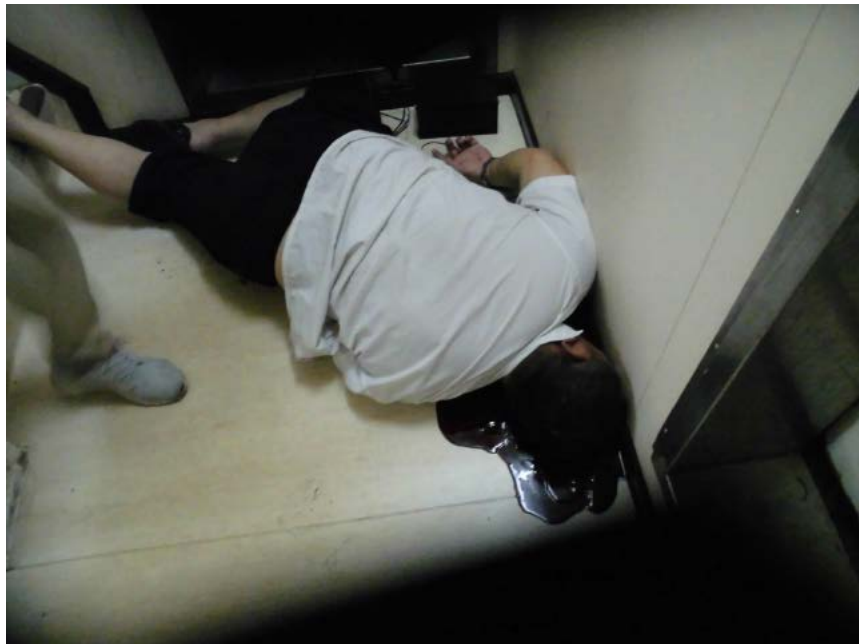
- 3.5 At 2000 hours, another able bodied seaman (AB2) left his cabin on C Deck to go down to the mess room on A Deck. On B Deck, AB2 saw the bosun lying with his head in a pool of blood on A Deck (Figure 2). He went down the stairway and patted on the bosun's shoulder but the bosun did not show any response.

Figure 2 The bosun lying on A deck with his head in a pool of blood

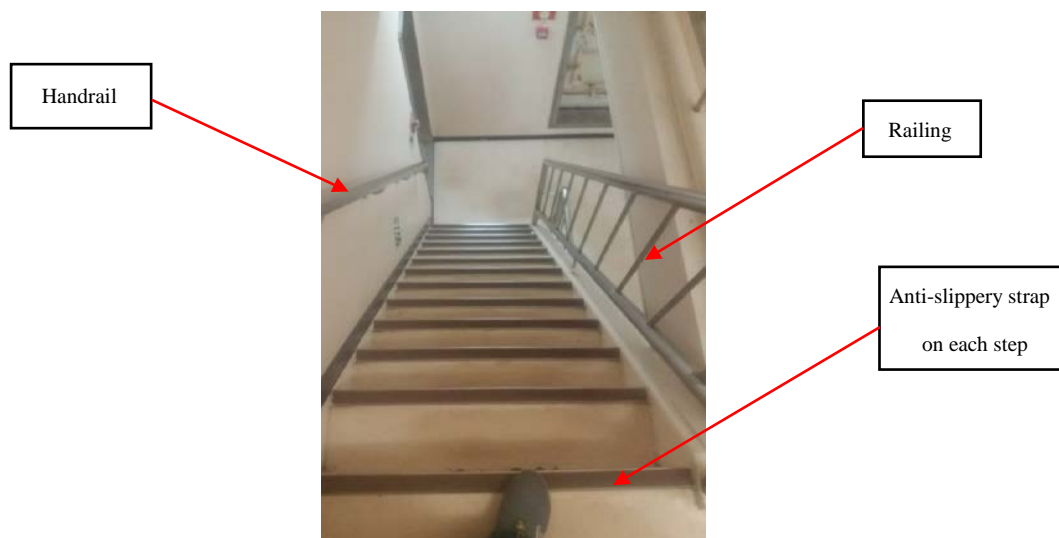
- 4.9 The configuration of the stairways connecting each deck was the same and met the requirements of the *Fire Safety Systems Code* (FSS Code) under the *International Convention for the Safety of Life at Sea*. The inclination angle of the stairway was approximately 47° which is permitted by the FSS Code of not greater than 50°. The dimensions of each step of the stairway was 23 cm (height) and 23 cm (depth). Anti-slippery straps were adhered on each step of the stairway. Railing and handrail were installed on both sides of the stairway (Figure 3).

Figure 3 The stairway

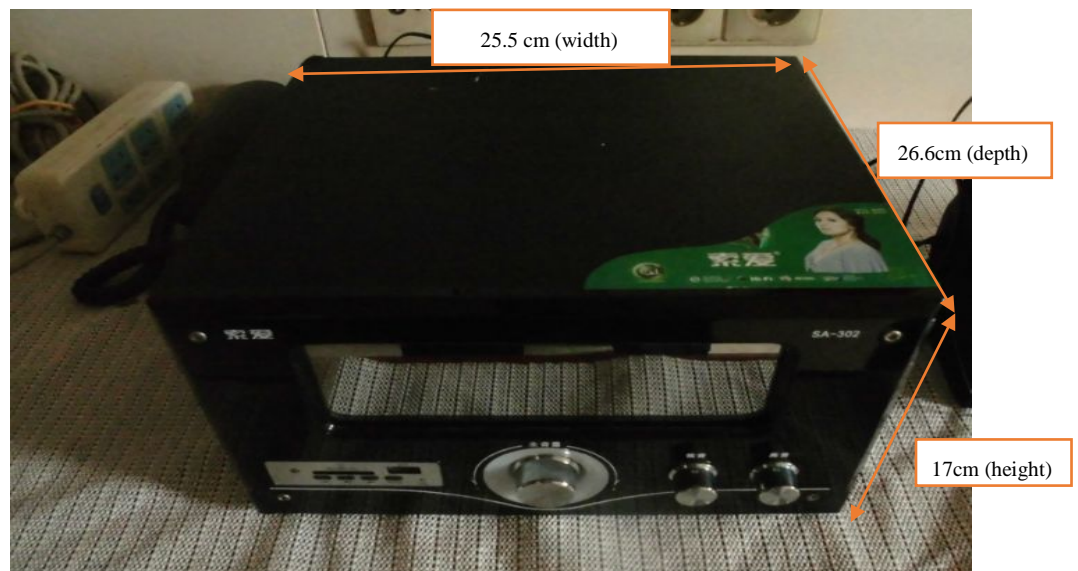
- 4.10 The bosun's music audio system consisted of one tuner (Figure 4) and two speakers (Figure 5). Each speaker and the tuner weighted 1.3 kg and 3.7 kg respectively. The dimensions of the tuner were 25.5 cm (width) x 17 cm (height) x 26.6 cm (depth) and that of the speaker were 21 cm (width) x 11 cm (height) x 11 cm (depth).
- 4.11 It is apparent that the bosun needed both hands to carry the three-piece audio system with a total weight of 6.3 kg. He put himself in difficulty and at risk when walking up the stairway with the bulky music audio system when *the vessel* was subject to sudden and heavy rolling intermittently at any time.

Figure 4 Tuner of the music audio system

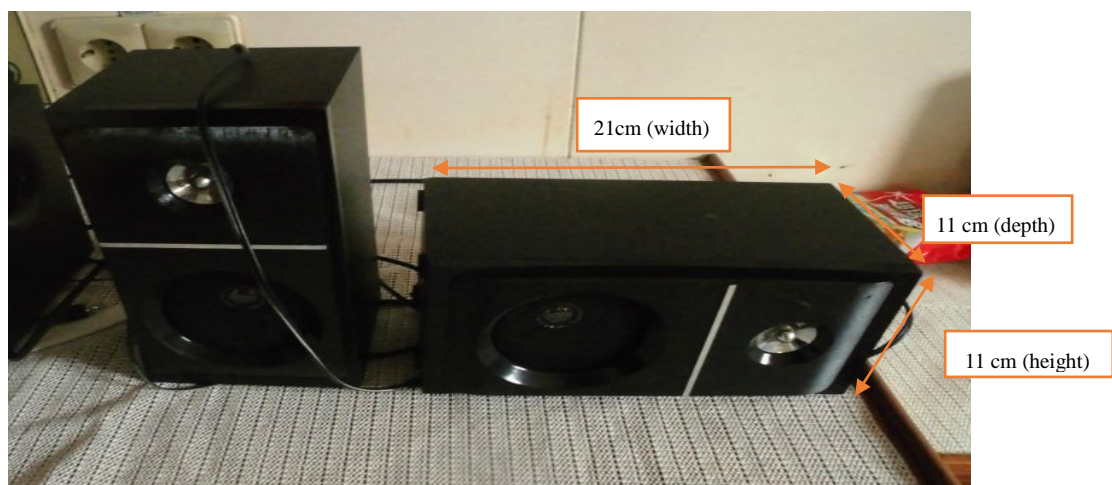
Figure 5 Two speakers of the music audio system

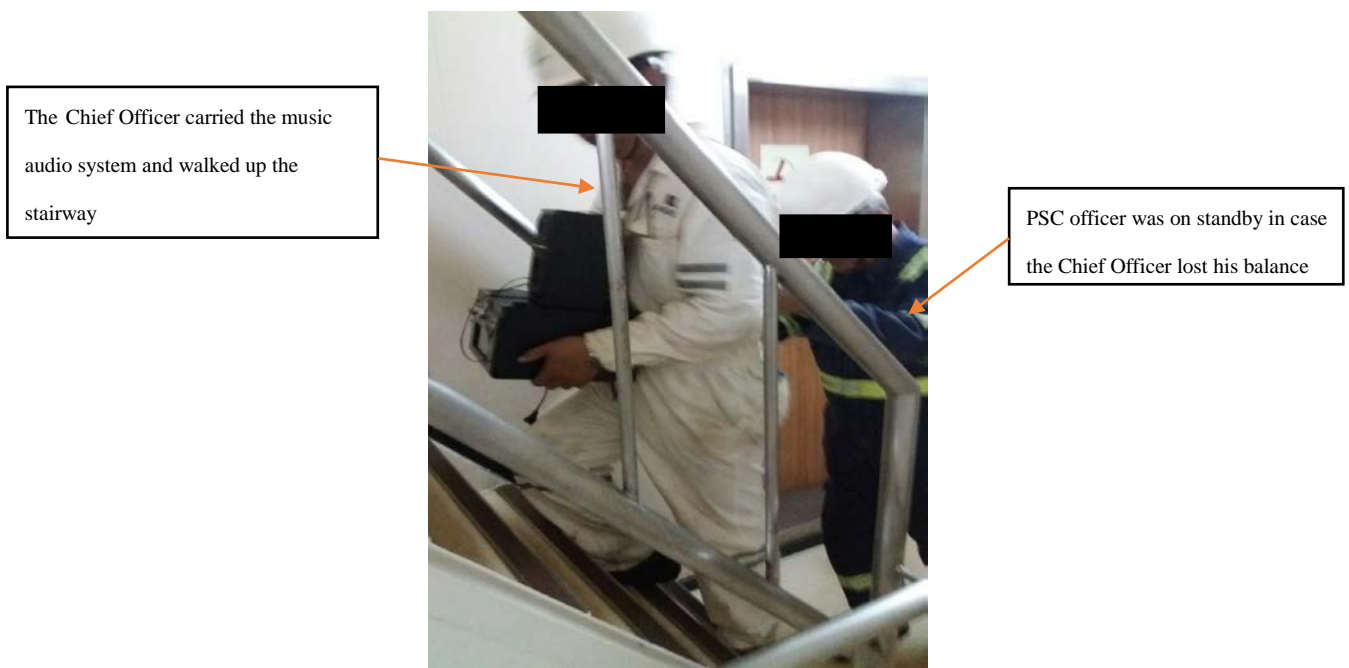
- 4.12 A simulation was requested by the port State control (PSC) officers of Brazil after the accident (Figure 6). During the simulation, the chief officer carried the three-piece music audio system and walked up the stairway. While walking up the stairway, the Chief Officer was asked to come back. When he turned his body, he lost his balance. This test proved that always holding the handrails while walking up or down the stairway was crucial from safety point of view.

Figure 6 Simulation carried out during the PSC inspection

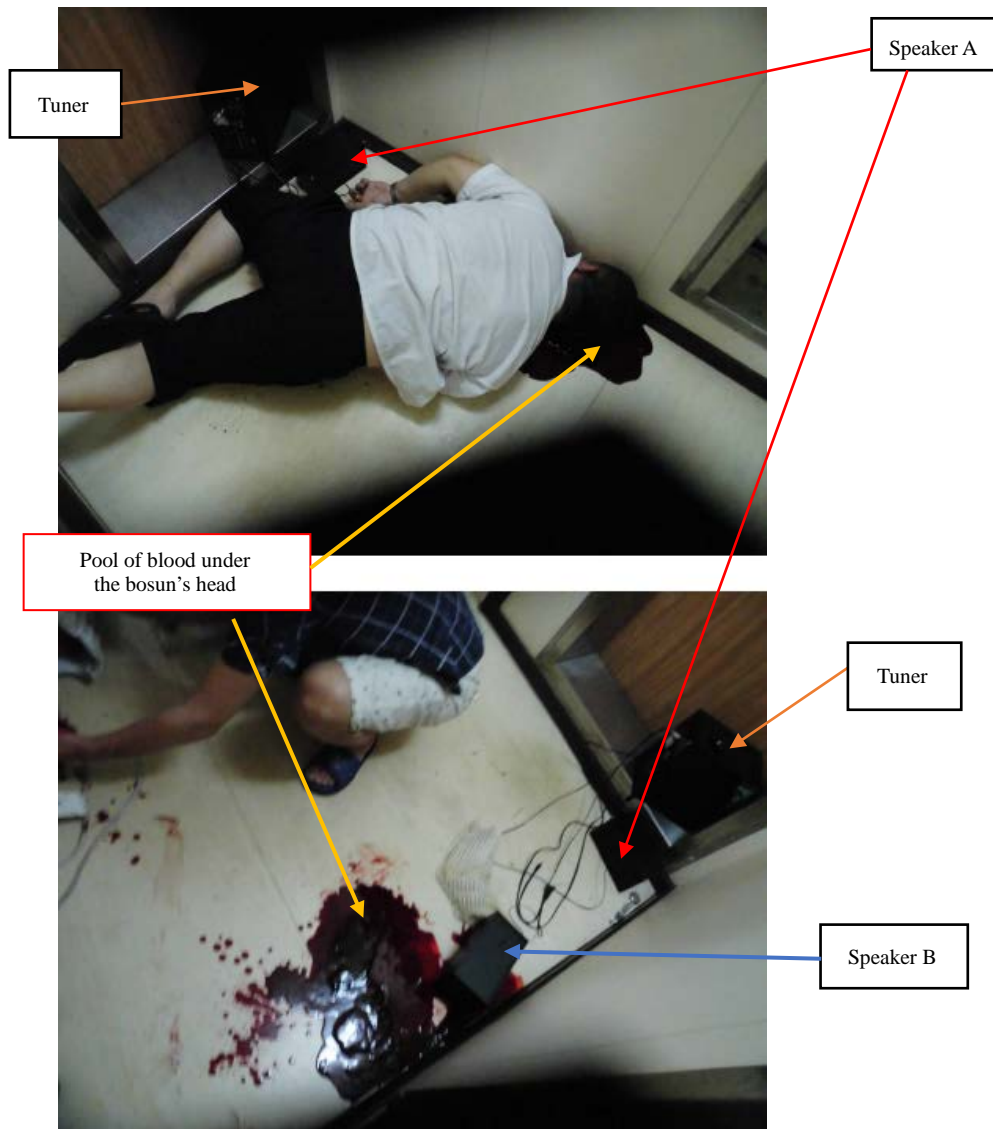
- 4.15 As shown in Figure 7, the tuner was at the galley door and a speaker (Speaker A) was in front of the bosun's body. Another speaker (Speaker B) was in front of bosun's face with a pool of blood around his head and the speaker. It could be deduced that when the bosun fell down, his head hit violently on the edge of Speaker B resulting in a head trauma with copious bleeding.

Figure 7 Accident scene

- 6.1 The management company of *the vessel* is recommended to issue notice/circular to draw the attention of their masters, officers and crew to the findings of the investigation and to remind them that:
- (a) they must take care of themselves when moving around the ship at all times;
  - (b) care should always be taken when walking up and down of stairways by holding handrail throughout the walk; and
  - (c) the company's alcohol policy should be strictly followed.
- 6.2 A Hong Kong Merchant Shipping Information Note should be issued to promulgate the lessons learnt from the accident.
