Report of investigation into the
collision between the Hong Kong
registered oil tanker

“Brightoil Lucky” and

in position 39°47.4’N 132°07.9’E
on 5 October 2017

Marine Department

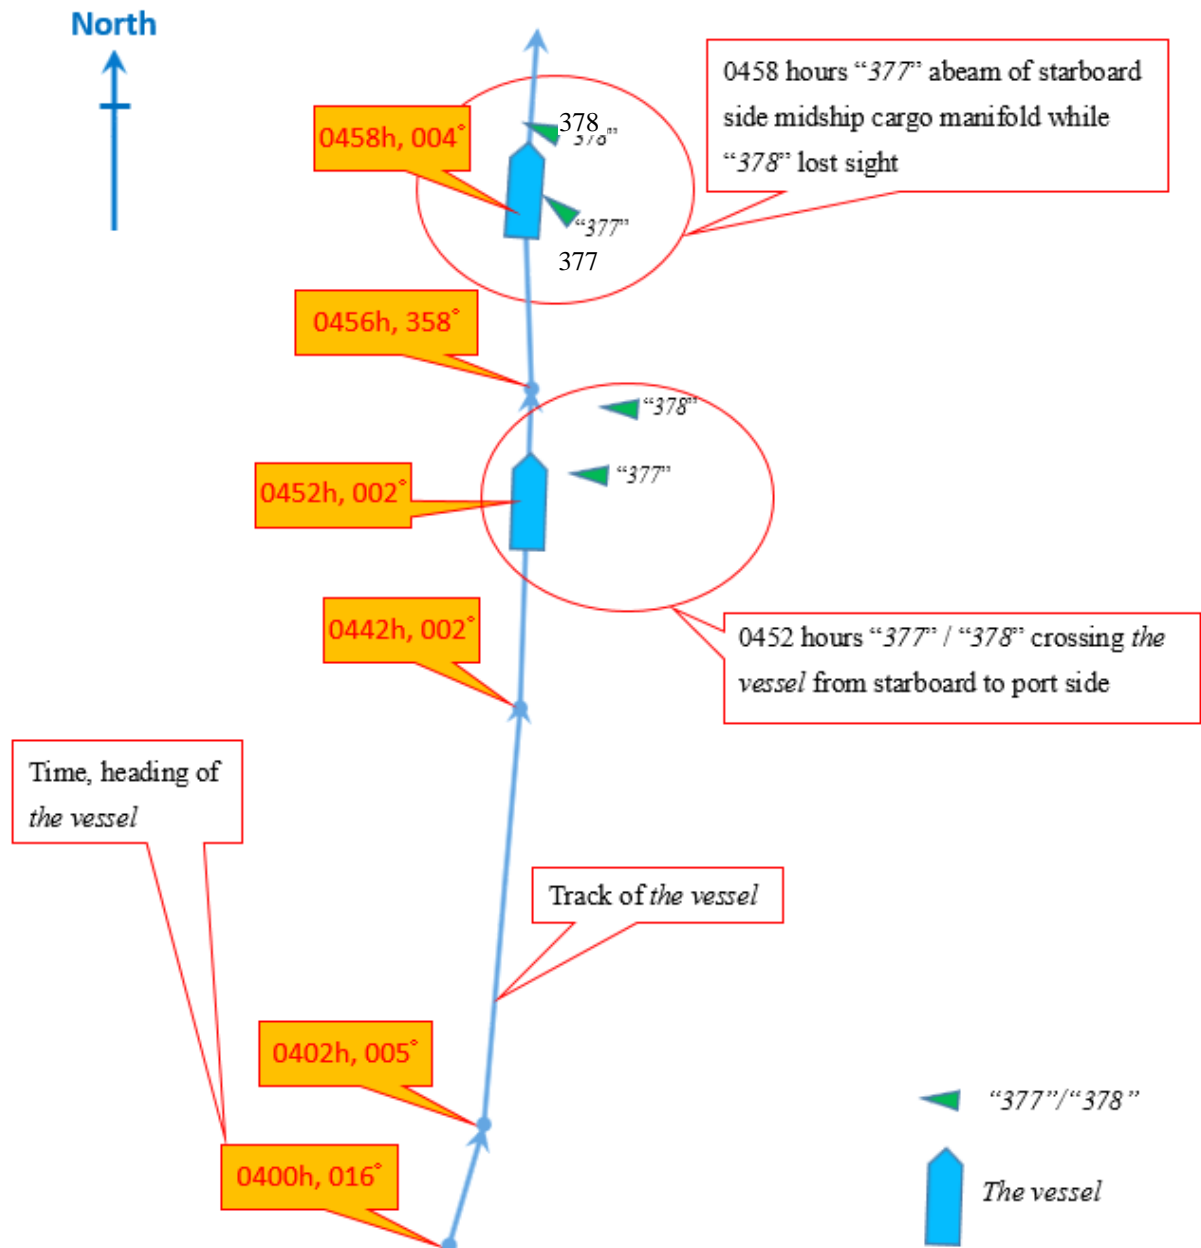
Figure 3 Sketch showing the movement of *the vessel* before collision with “378”

- 3.9 At 0458 hours, “378” was at *the vessel's* starboard forward position at close range and kept crossing ahead of *the vessel*. When “377” was passing along the starboard midship of *the vessel*, the chief officer adjusted *the vessel's* heading to starboard from 358° to 004° in an attempt to pass the stern of “378” and to keep *the vessel's* stern clear of “377”. At about 0500 hours when *the vessel* was turning to starboard, the chief officer lost sight of “378” which had

entered into the forward blind sector of *the vessel*. Figure 3 is a sketch showing the movement of *the vessel* before the collision with “378” up to 0458 hours.

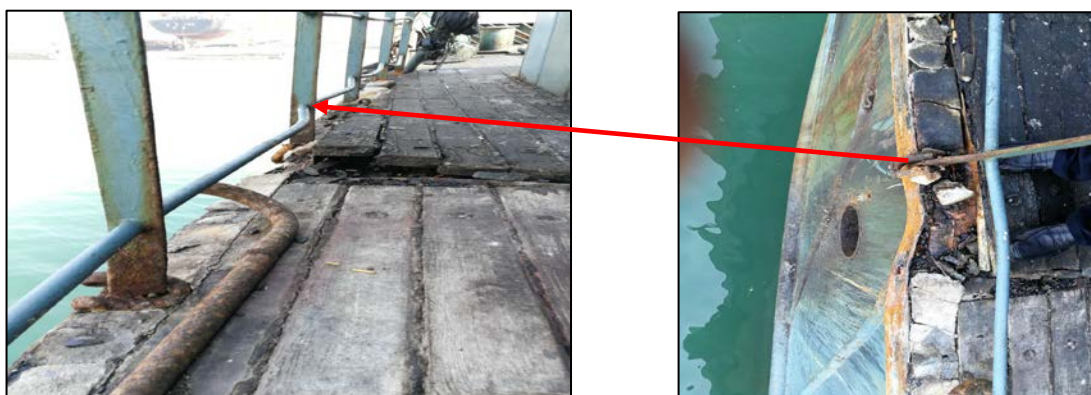
Figure 4 Damage to port deck and handrails of “377”

- 4.12 A damage survey of *the vessel* was carried out by LR surveyor after she arrived in Singapore on 16 October 2017. Some deformation was found on the shell plating in way of the starboard side of No. 1 WBT and the fore peak tank (FPT). An internal inspection of FPT was carried out. The inspection, however, could not conclude that the deformation at FPT was caused by the collision with “378” as the damage was not newly formed.
- 4.13 The port side of “377” collided with the starboard side of *the vessel* and sustained minor damages to her port deck and handrails (Figure 4). No personal injury and oil pollution were reported by “377”.

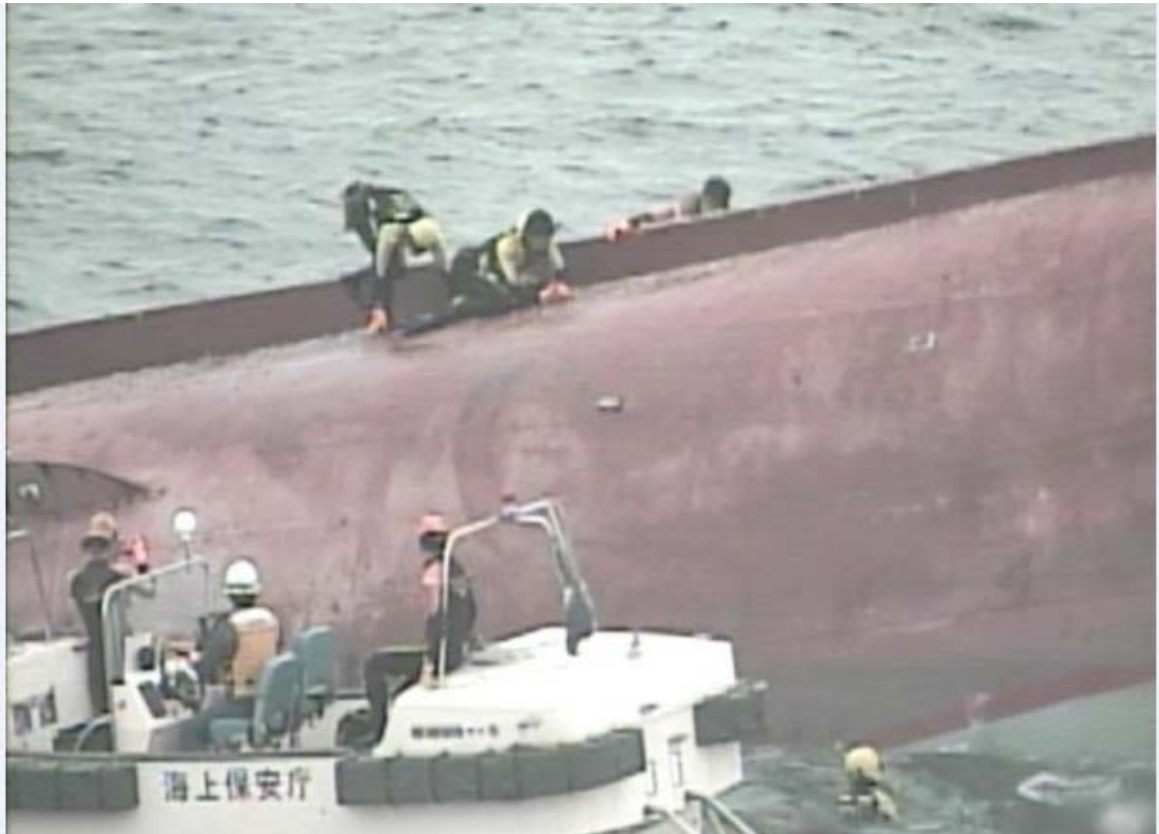
Figure 5 “378” floating upside down in the sea

- 4.14 After the collision, “378” capsized and floated upside down in the sea (Figure 5). It was deduced that *the vessel’s* bow had hit the port side of “378” causing the latter to capsize abruptly. 12 out of the 16 fishermen on board “378” could not escape in time. *The vessel’s* crew did not notice the impact of the collision with “378”.
