**Report of investigation into the  
sinking of Hong Kong registered  
bulk carrier “*Emerald Star*”  
at position 19°03’N, 124°52’E,  
east of the Luzon Island,  
the Philippines on 13 October  
2017**

**The Hong Kong Special Administrative Region  
Marine Department  
Marine Accident Investigation Section**

**11 May 2021**

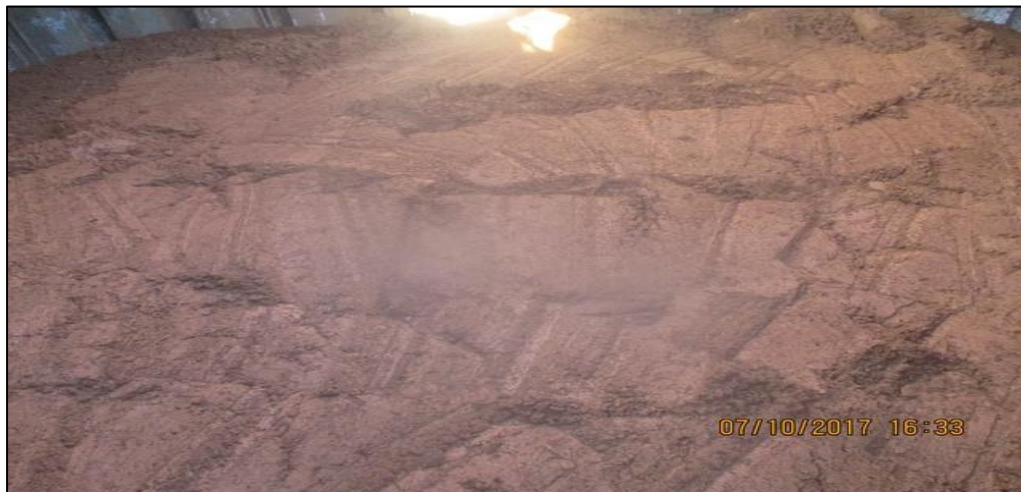
- 3.9 Each cargo hold was about half-full after the completion of loading. The cargo top was about six to seven metres below the hatch coaming. The cargo inside the cargo holds was trimmed and pressed by cargo grabs to prevent sliding movement (Figure 2).

Figure 2 The cargo surface of one of the cargo holds after trimming

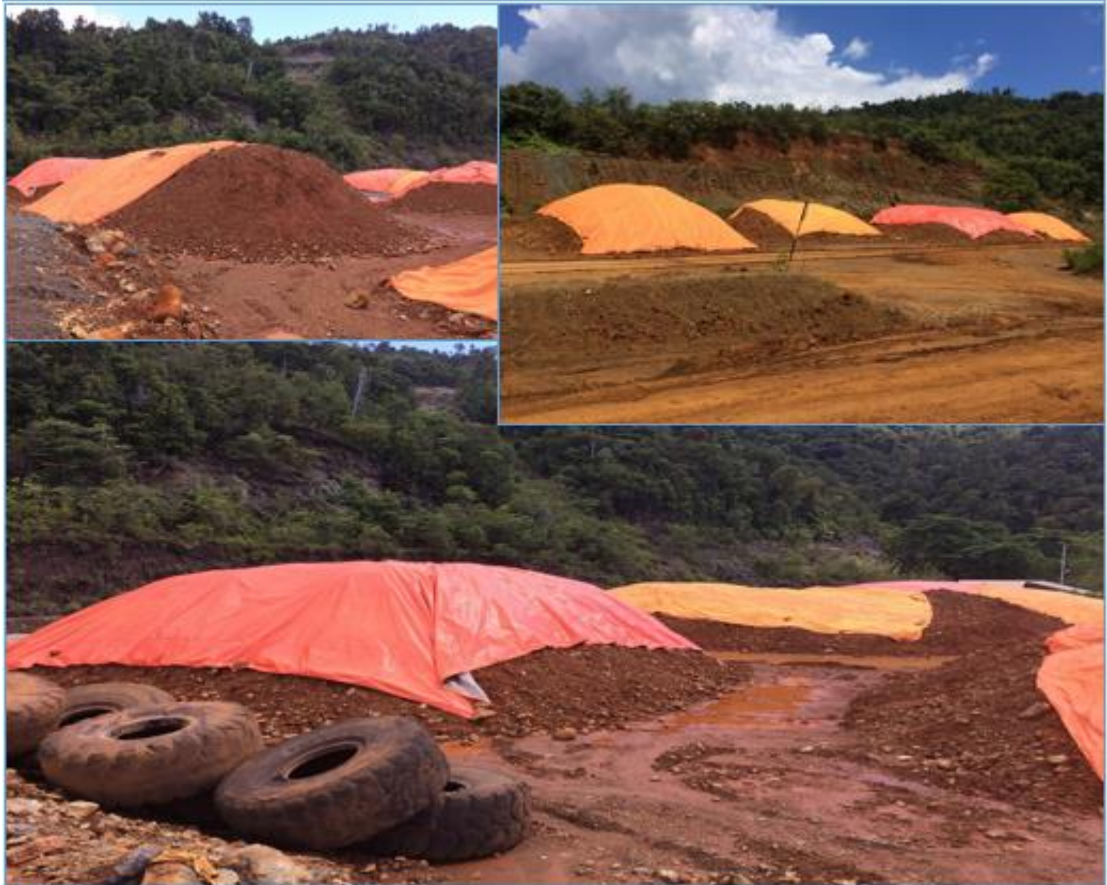
- 4.8 The investigation found that the exposed stockpiles of the cargo in the mining area for *the vessel* were partially covered by under-sized canvas. Some cargo piles were stacking with water accumulated on the floor and some parts were exposed to the rain directly (Figure 3). Under such stock condition, it was reasonable to expect that cargo contained high moisture content.

Figure 3 Photographs showing cargo stockpiles (taken after the accident)

- (i) the requirements of IMSBC Code;
  - (ii) the requirement of re-certifying the moisture content of the cargo by shipper if there has been significant rain or snow during loading of bulk cargo;

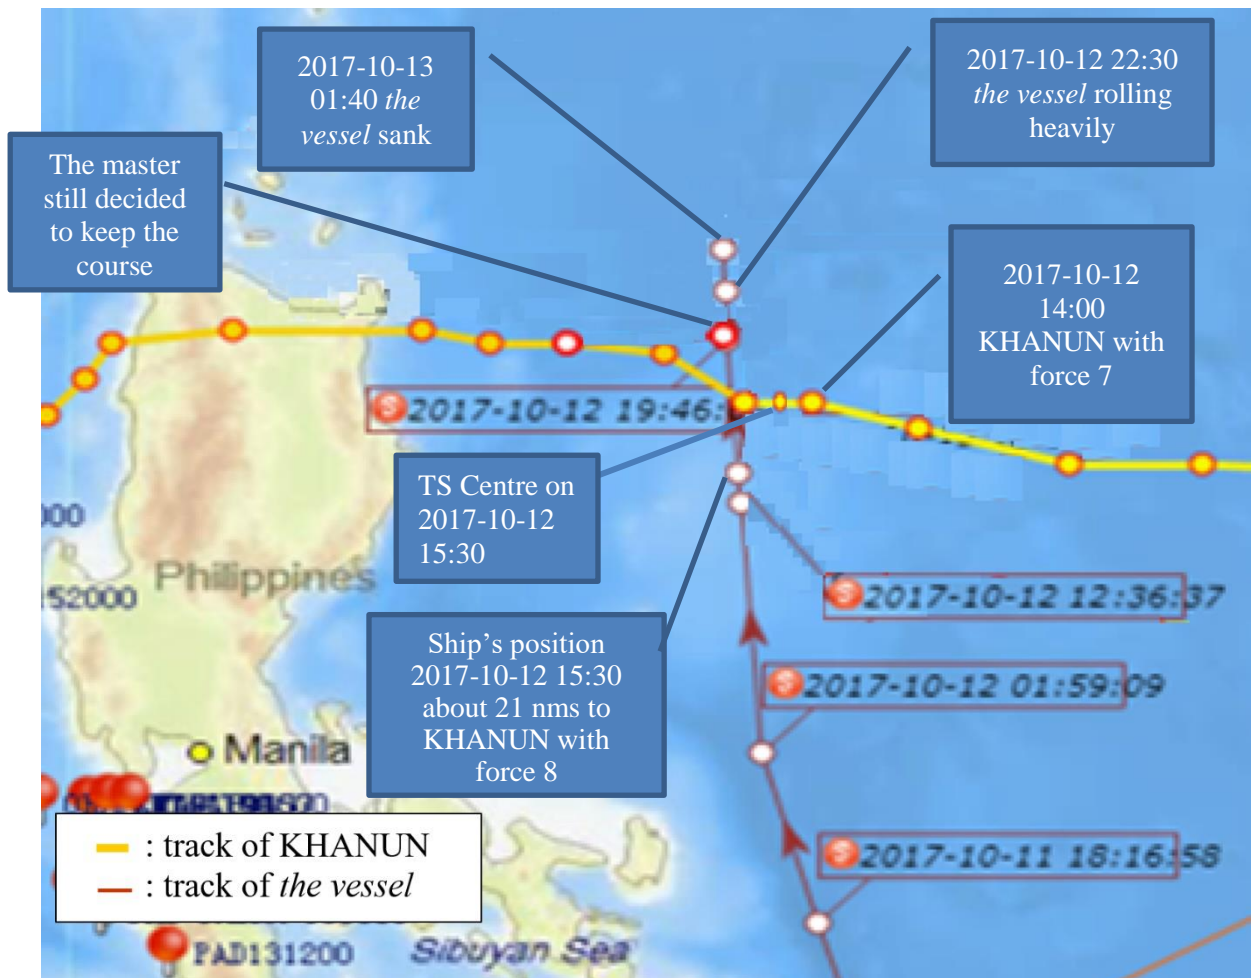
- 4.21 Pursuant to paragraph 5.33 of the Mariner’s Handbook<sup>7</sup> as referred to in the navigation and bridge procedures of *the vessel’s* Safety Management System, a ship should keep away roughly from within 80 nms of the storm center under all circumstances. At about 1530 hours on 12 October 2017, *the vessel* was only about 21 nms from the TS storm centre (Figure 4).

- 4.22 There was no evidence that the master had altered course to avoid approaching the TD/TS of “KHANUN”. The master also had not prudently assessed the risk and consequence to *the vessel* and the cargo on board to suitably plan her voyage when approaching the center of the TS.

Figure 4 The tracks of *the vessel* and the TD /TS “KHANUN”

- (iii) all relevant shipboard procedures for voyage planning avoiding adverse weather; and
  - (iv) the emergency plan for immediate action, such as abandon ship etc., when ships encounter serious list.
