**Report of investigation  
into the fatal accident of the Bosun  
on board the Hong Kong registered  
bulk carrier “*Grand Amanda*” at sea  
on 18 October 2017**

**The Hong Kong Special Administrative Region  
Marine Department  
Marine Accident Investigation Section**

13 May 2021

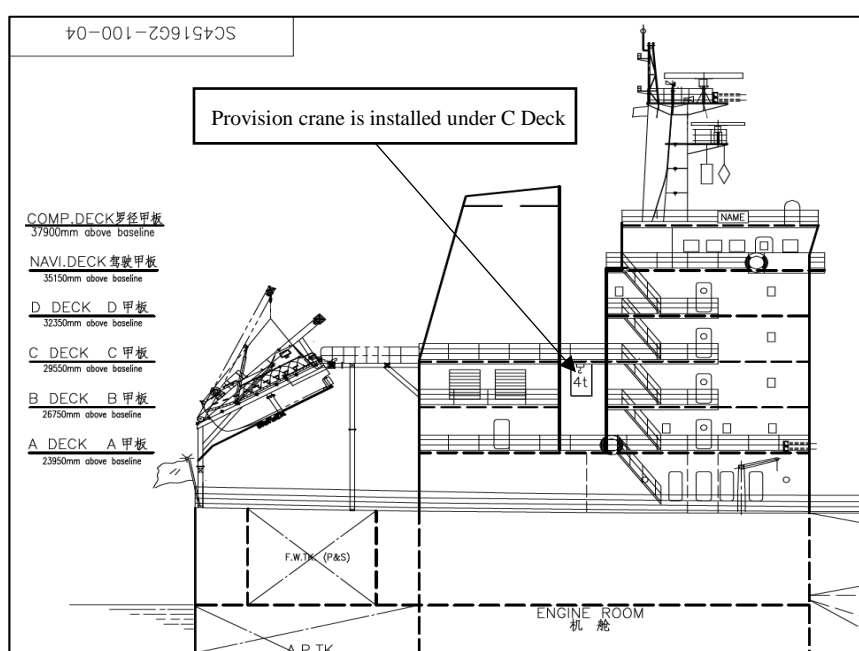
Figure 2 Location of the provision crane

- 4.8 The provision crane was an electric monorail crane installed under C Deck (Figure 2). Its main structure consisted of a runway beam and a gangway beam (Figure 3). The general specifications of the provision crane are as follows:

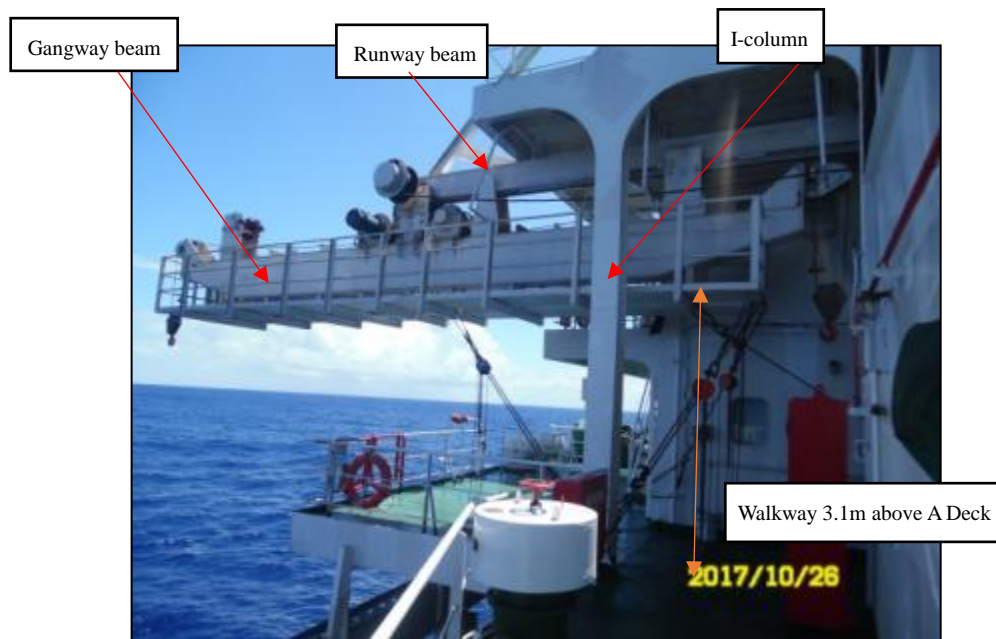
Figure 3 Construction of the provision crane

*the vessel* rolling heavily, the braking system might not be able to hold the gangway beam resulting in its rapid movement along the runway beam. Apparently, the loss of control of the provision crane was caused by the working environment which was beyond the designed working condition.

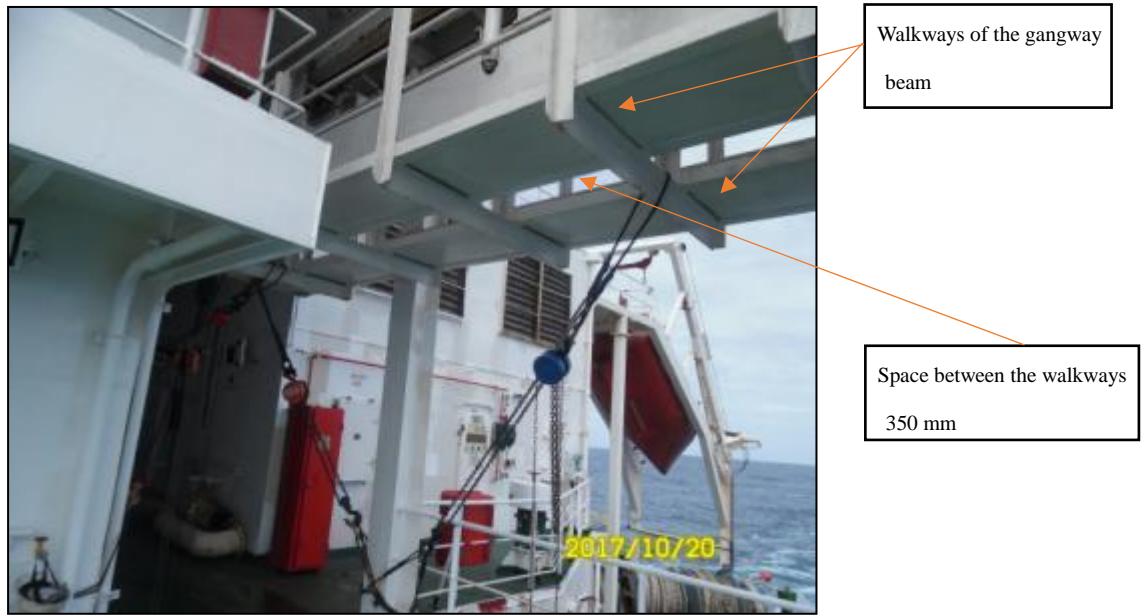
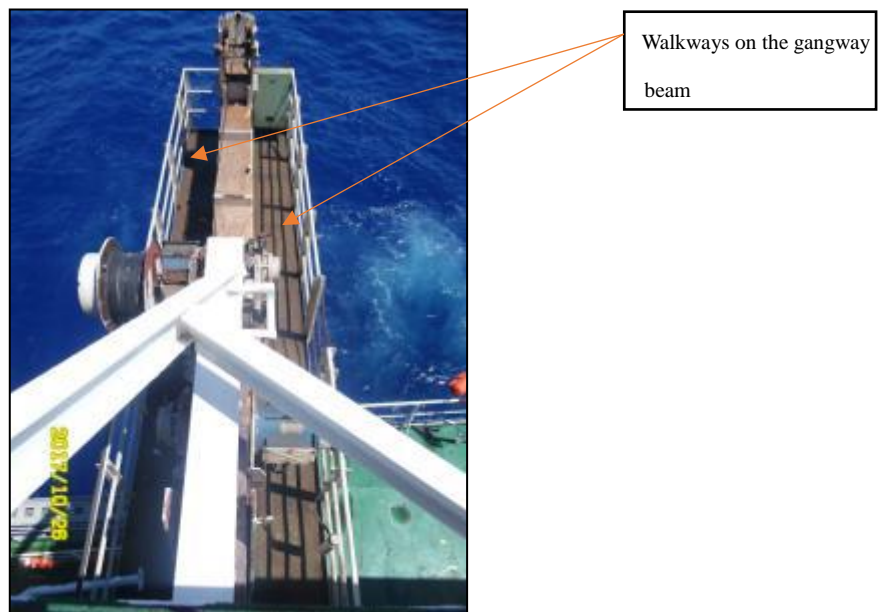
- 4.11 The gangway beam of the provision crane was a box structure with two walkways on sides leaving a space of about 350 mm between them (Figures 4 and 5). There were two I-columns at port and starboard sides of A Deck to support the C Deck structure (Figure 6). There was a gap of about 100 mm between the gangway beam and the I-column (Figure 7). Under normal working condition, the provision crane was held in position by the crane's braking system. The travel distance of the provision crane to the ends (port and starboard) is limited by limit switches. For fail-safe arrangement in case that the limit switches fail to stop the provision crane, the crane will be stopped by a stopper plate fitted at the end of the runway beam (Figure 8).

Figure 4 Walkways of the gangway beam of the provision crane

Figure 5 Top view of the walkways of the gangway beam of the provision crane

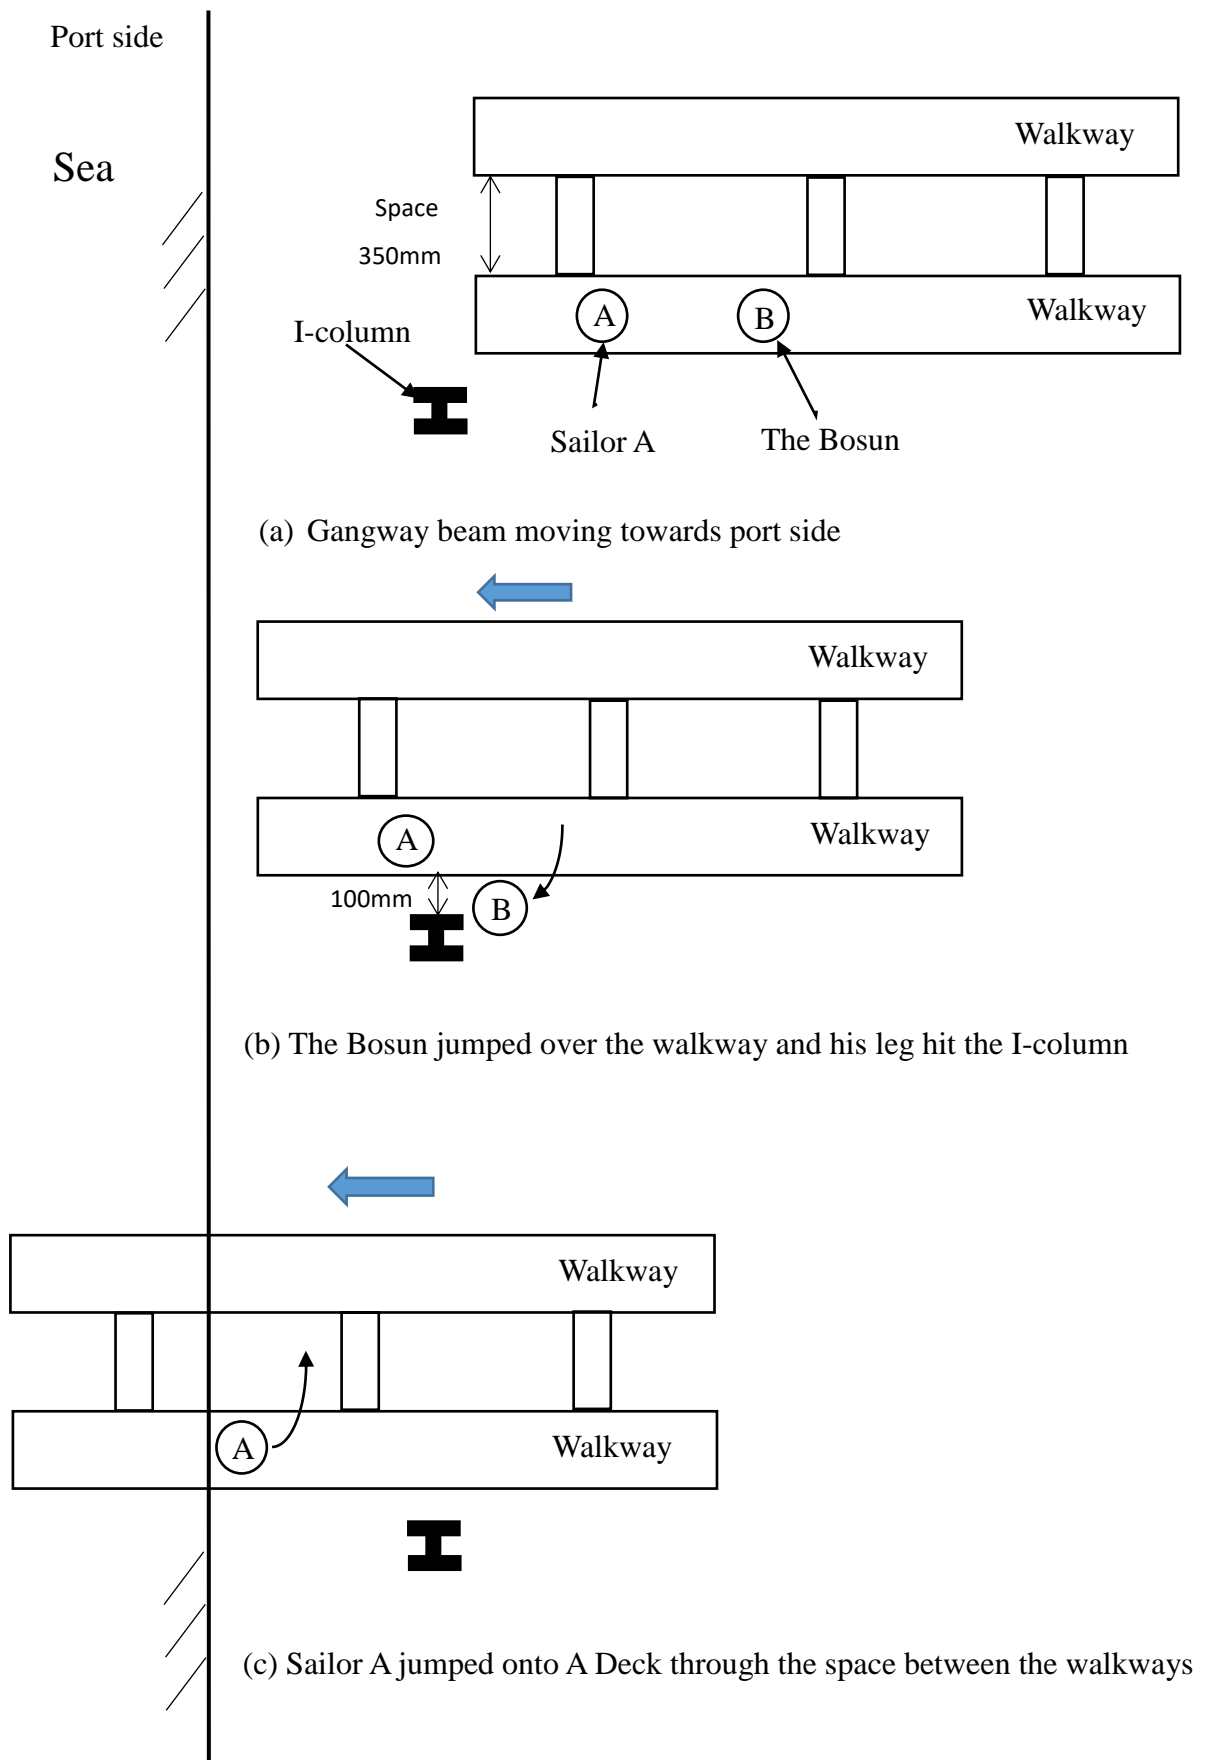
Figure 9 Sketch showing the probable responses of the Bosun and Sailor A when the provision crane moved towards port side

- 4.12 Based on the evidence, the probable cause of the accident was deduced as below. On the afternoon of 18 October 2017, the Bosun and Sailor A used the provision crane as the working platform to paint the underdeck area of C Deck. *The vessel* was rolling in adverse weather condition. The rolling motion overcame the designed braking force of the provision crane causing the crane moved unexpectedly towards the port side (Figure 9(a)). Both the Bosun and Sailor A were responded intuitively and jumped over the walkway. The Bosun's legs were trapped and crushed in the space between the I-column and the gangway beam (Figure 9(b)). He then fell onto A Deck with his legs fractured and bleeding (Figures 10 and 11). The Sailor A jumped onto A Deck through the space between the walkways (Figure 9(c)). The provision crane was then stopped by the stopper plate. When Sailor A was on A Deck, he saw the Bosun lying on the deck near the I-column.

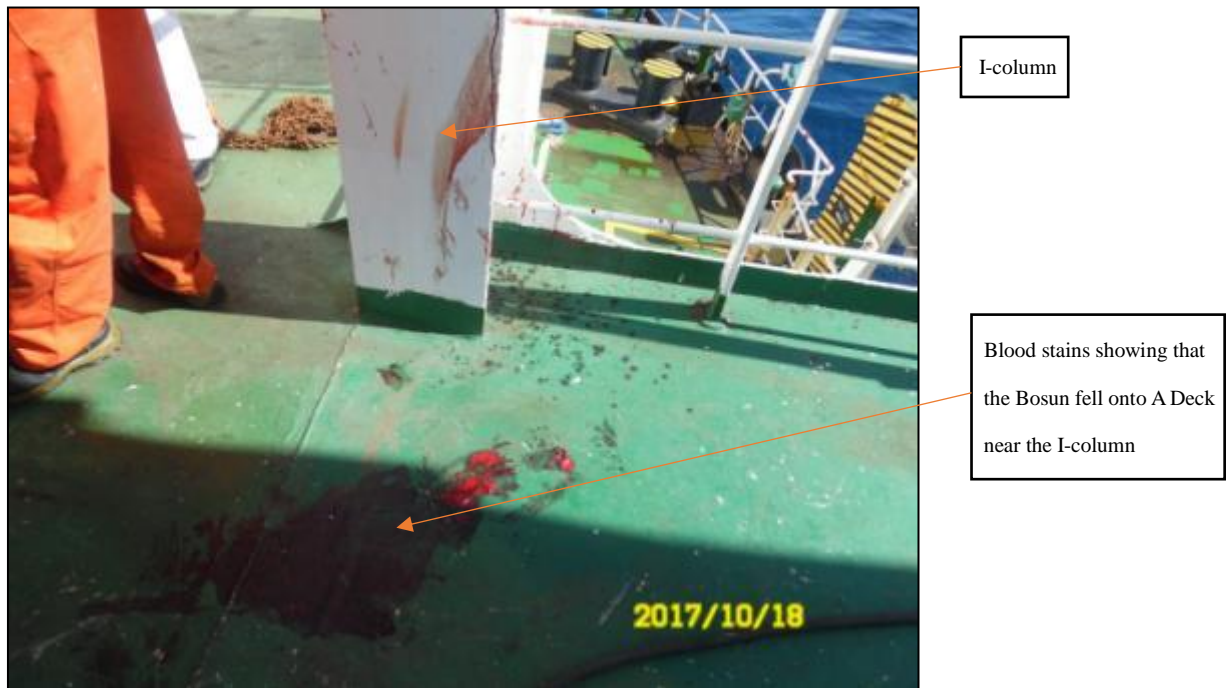
Figure 10 The blood stains near the I-column

Blood stains showing that the Bosun fell onto A Deck near the I-column

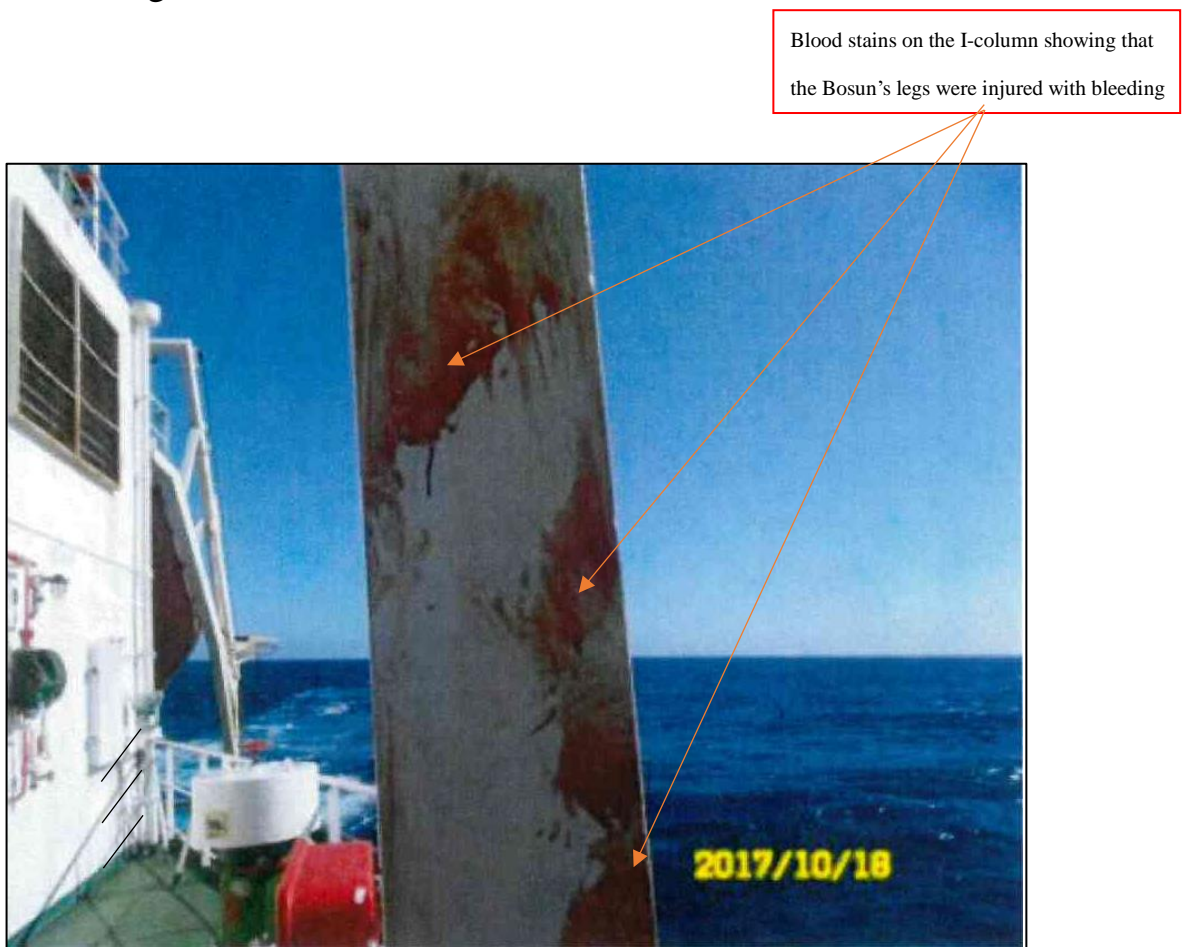
Figure 11 Blood stains on the I-column

Blood stains on the I-column showing that the Bosun's legs were injured with bleeding
