**Electrical blackout and
subsequent grounding of
the Iranian registered container ship
“*Touska*” at the Magazine Island,
Hong Kong on 5 November 2017**

**The Hong Kong Special Administrative Region
Marine Department
Marine Accident Investigation Section**

19 August 2019

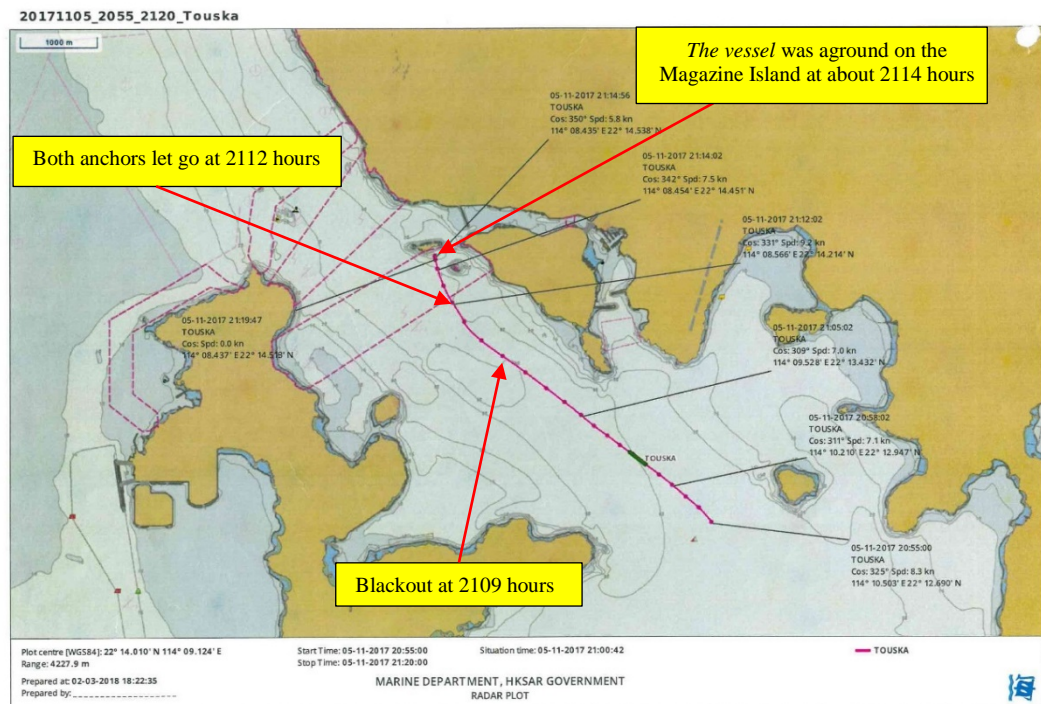
Figure 2 Radar plot of *the vessel*

- 3.7 After the blackout, *the vessel* lost its propulsion power and control of the steering gears and was slowing down. About one minute later, with the sea current about 3.5 knots from the port side, *the vessel* started turning to the starboard side and heading to the Magazine Island (Figure 2).

- 3.9 Both anchors were let go at about 2112 hours. However, the action could not stop *the vessel* to run aground at about 2114 hours (Figure 2).
- 3.10 With the emergency generator running, the emergency lights were on. The second engineer first started the generator engine diesel oil flushing pump using compressed air (Figure 3). He was then able to start the No. 1 and No. 2 generator engines. The main electrical power supply resumed at about 2115 hours after *the vessel* was already aground.

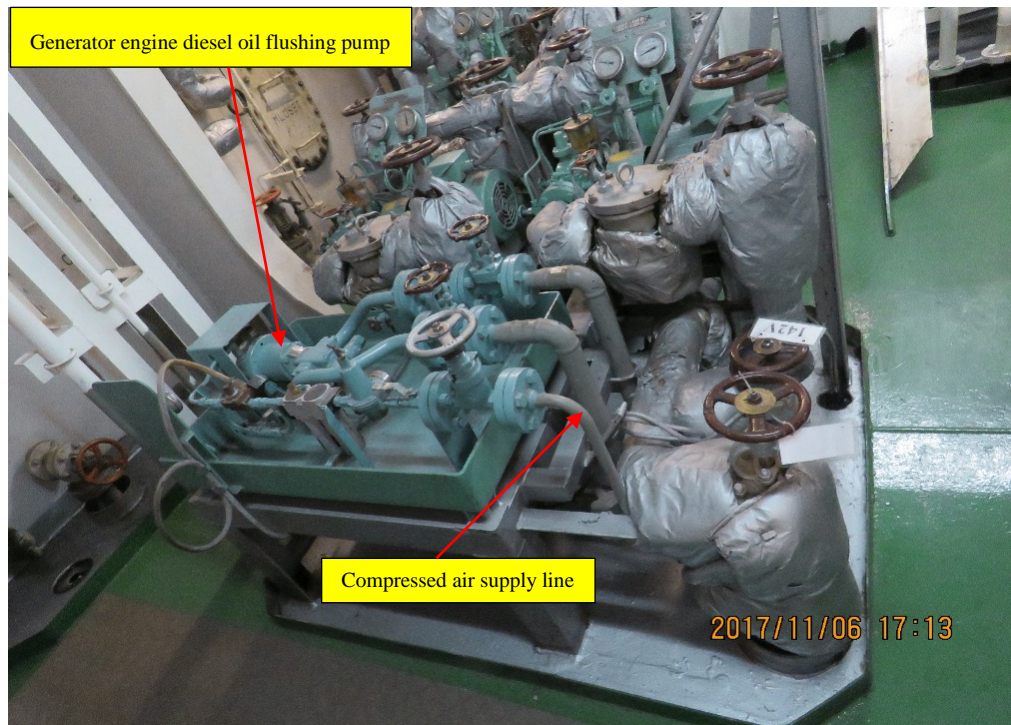
Figure 3 Generator engine diesel oil flushing pump

- 4.15 In this accident, the second engineer opened the inlet and outlet valves of the flushing pump and used compressed air to drive the flushing pump so that diesel oil could be supplied to No. 1 and No.2 generators and the main electrical power supply was resumed at about 2115 hours.

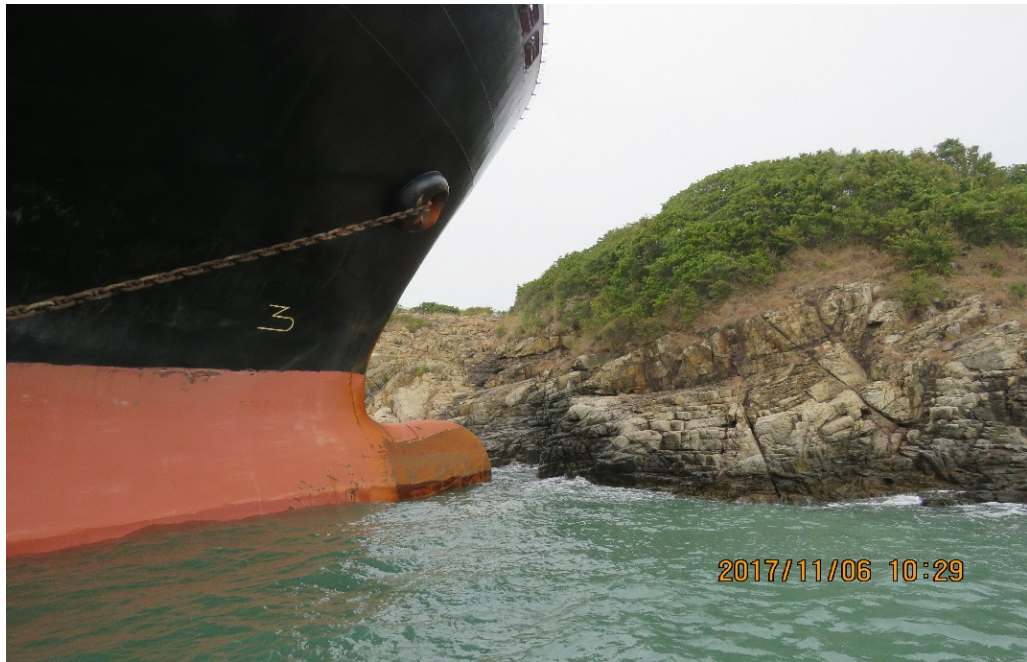
Figure 4 *The vessel aground in front of the rocks*

- 4.9 When *the vessel* proceeded to Shenzhen, the master had prepared a standby anchor team according to the procedure of SMS. After the master had given the order to drop both anchors, the anchor team took actions swiftly. It is apparent that dropping of the anchors had slowed down *the vessel* and reduced extensive damage to the hull.

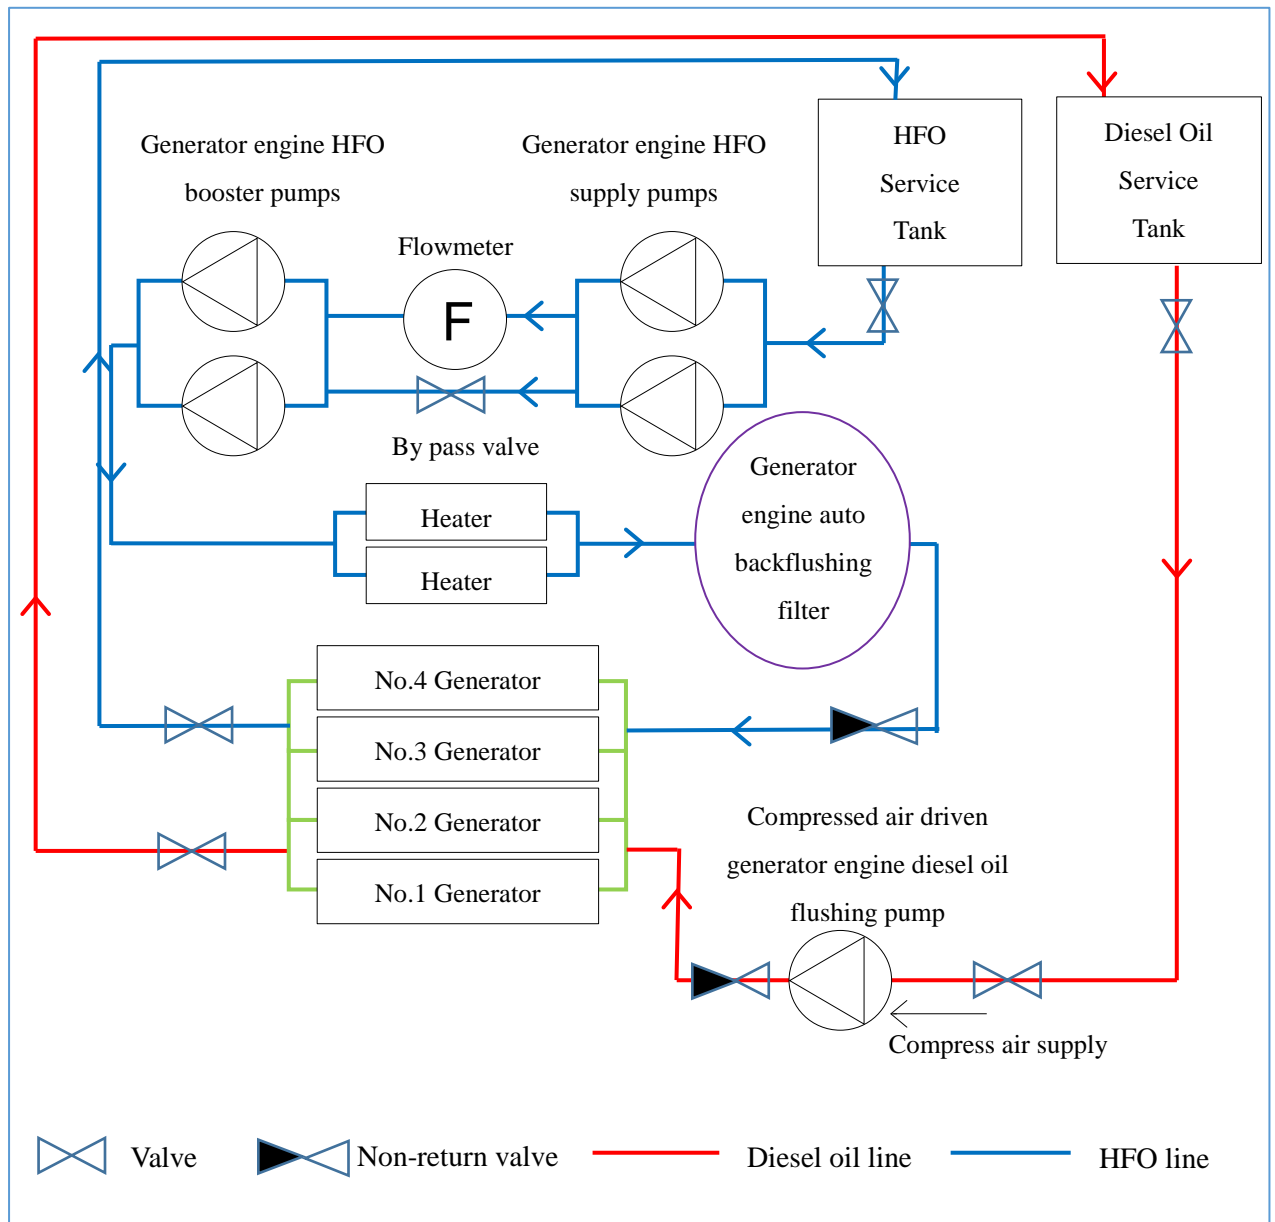
Figure 5 Schematic diagram of the HFO and diesel oil piping systems for generator engines

- 4.12 In Figure 5, the pipe lines of the heavy fuel oil (HFO) piping system, the diesel oil piping system and the common pipe lines for both systems were marked in blue, red and green respectively.
- 4.13 The HFO piping system consists of a feeding line from the HFO service tank to the generator engines via the HFO supply pumps, the HFO booster pumps, the auto backflushing filter (ABFF) and the heaters. In this system, pumps and heaters are of duplex type, but the ABFF is of simplex design. In case the ABFF fails to operate, HFO cannot be fed into the generator engines.
- 4.14 The diesel oil piping system consists of a feeding line from the diesel oil service tank to the generator engines via the generator engine diesel oil flushing pump

(flushing pump). If there is no electrical power supply, compressed air can be used to drive this pump and supply diesel oil to the generator engines.

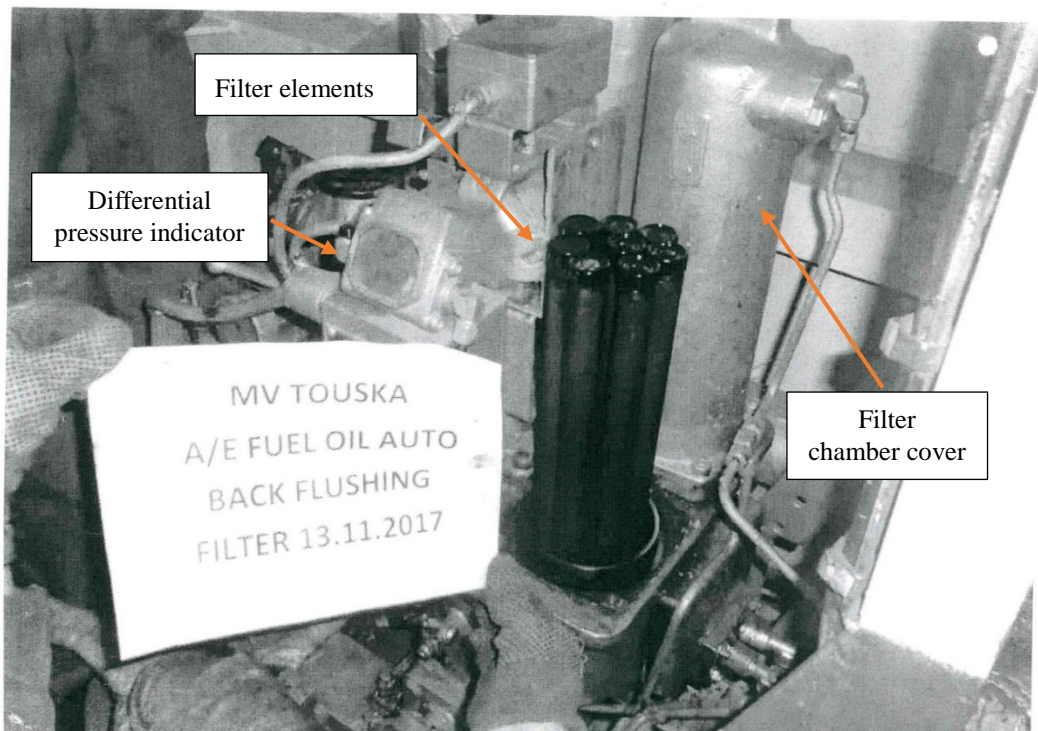
Figure 6 ABFF with one of the two filter chamber covers removed

- 4.19 After the accident, the filter chamber covers of the ABFF were removed for inspection on 13 November 2017. The condition of the filter elements in one of the two filter chambers is shown in Figure 6 below.

- 4.20 The management company carried out an investigation into the accident. Based on the information collected from the concerned crew and the company investigator's observation, the management company concluded that the blackout was caused by *"Sudden failure of auxiliary engines automatic backflush fuel filter mechanism which caused abrupt discontinuation of fuel flow to running generators and consequently led to power failure and blackout"*.

- 4.21 Failure of the ABFF might be caused by the malfunctioning of the DPS and/or the ECS. If the DPS fails to provide a signal or there is an interruption of this signal to the ECS to start the regeneration operation when the filter elements are contaminated, this will block the fuel supply to the generator engines. Furthermore, if the ECS fails to control the regeneration operation, even the DPS can send out a signal, the result will be the same.

- 4.22 Preventive maintenance and close monitoring of the ABFF is essential as the failure of the ABFF will stop the fuel supply to the generator engines. Proper maintenance of other equipment of the HFO system, such as HFO purifiers, filters and heaters etc., is also important since this will help to maintain the quality of HFO fed to the ABFF and reduce the chance of failure of the ABFF.

- a) monitor closely the performance and function of the ABFF especially during sailing in the harbour and congested waters etc.; and
- b) carry out proper preventive maintenance of the ABFF and other equipment of the HFO system of the generators in order to avoid any sudden failure of the equipment.
