Report of investigation  
into the collision between  
the Hong Kong registered container ship  
***“CSCL Manzanillo”*** and  
the Chinese fishing vessel  
***“Lu Wei Yu 60012”***  
in Qinhuangdao, China  
on 28 December 2017

The Hong Kong Special Administrative Region  
Marine Department  
Marine Accident Investigation Section

3 November 2020

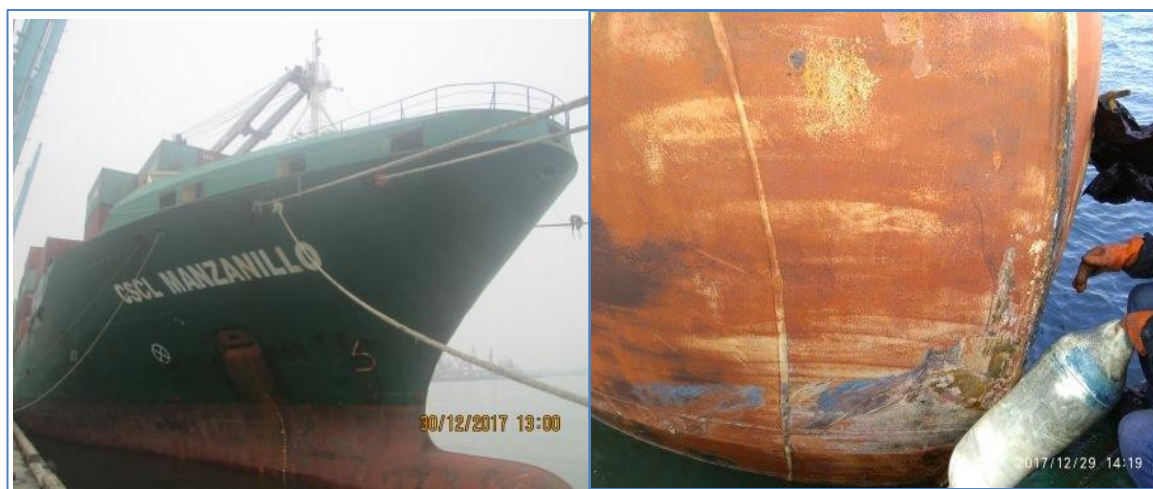
Figure 3 Damage to *the vessel*

- 4.11 *The vessel* sustained minor indentation on the bulbous bow (Figure 3).

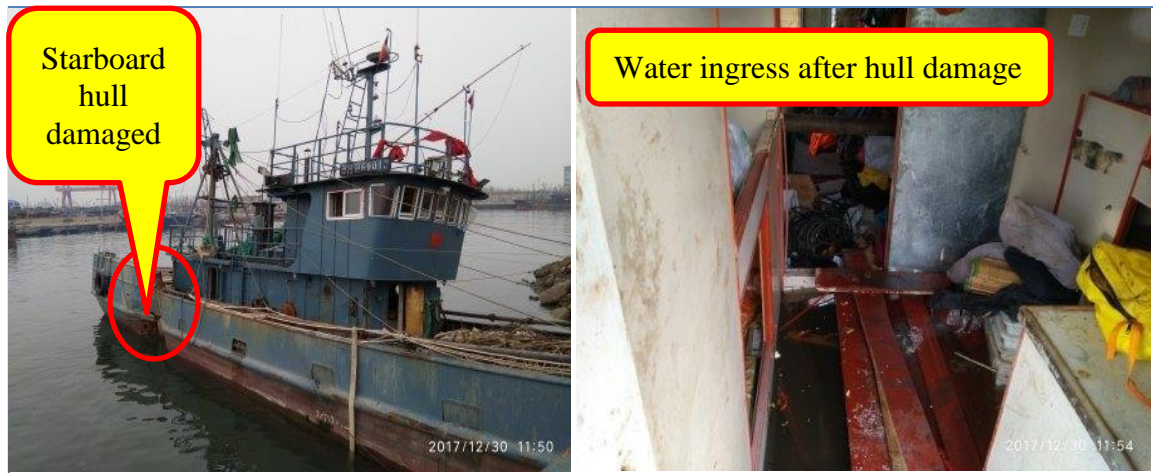
Figure 4 Damage to “60012”

- 4.12 “60012” sustained damage on her starboard hull and bridge. She was listed due to the water ingress into the engine room and living quarters (Figure 4).

- 5.1 A collision occurred between *the vessel* and “60012” at position 39°47.32’N/119°41.83’E near the entrance channel of Qinhuangdao, China at about 2059 hours on 28 December 2017. As a result of the collision, “60012” sustained hull damage and listed due to water ingress. One fisherman was missing and five fishermen suffered minor injuries.

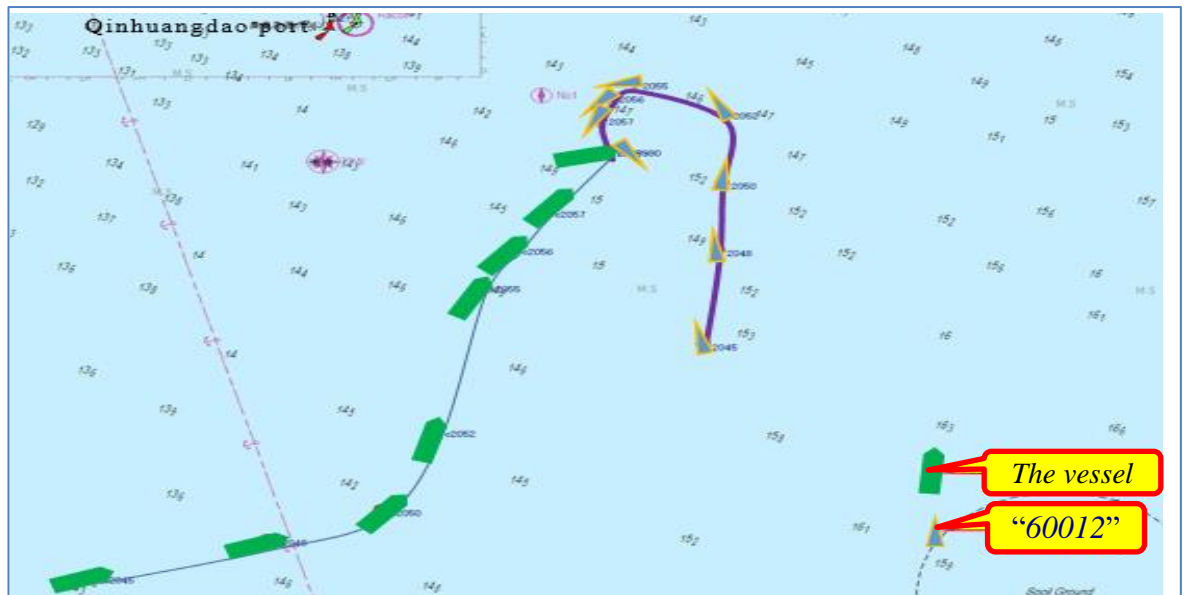
Figure 5 The tracks of both vessels about 14 minutes before the collision

- 4.13 The movement records of “60012” and *the vessel* were retrieved from Fishery BeiDou Navigation Satellite System<sup>1</sup> (BDS) and *the vessel*’s ECDIS<sup>2</sup> records respectively. *The vessel*’s Voyage Date Recorder (VDR) was failed and the master had reported such failure to the Company for arranging repair when *the vessel* arrived at Qinhuangdao.
- 4.14 The data of corresponding movements of both vessels were retrieved and plotted as shown in Figure 5.

- 4.15 Based on the movement records of both vessels, at about 2041 hours on 28 December 2017, “60012” crossed *the vessel* at a distance of 3.3 nms from the starboard side to the port side and there was no collision risk.

- 4.16 At about 2048 hours after observing “60012” on her port bow at a distance of 2.3 nms, the master altered course to port side converging with “60012” at a speed of more than 13 knots and the converging speed of both vessels was faster than before. The master failed to keep a safe distance to pass “60012” by navigating with extreme caution and with due regard to the observance of good seamanship and extreme caution.

4.20 With the rudder stuck at 18° to port, “60012” continued turning to port side from 002° with a speed of 9.9 knots, thus creating an imminent collision risk with *the vessel*. Since the master was in the engine room, he was not aware of the risk of collision and took no action of avoiding collision in accordance with Rule 8 of COLREGS (Action to avoid collision).
