**Report of investigation
into the fatal accident on board
the Hong Kong registered cargo ship
“*Thorco Africa*”
at Ploce, Croatia
on 24 January 2018**

**The Hong Kong Special Administrative Region
Marine Department
Marine Accident Investigation Section**

10 November 2020

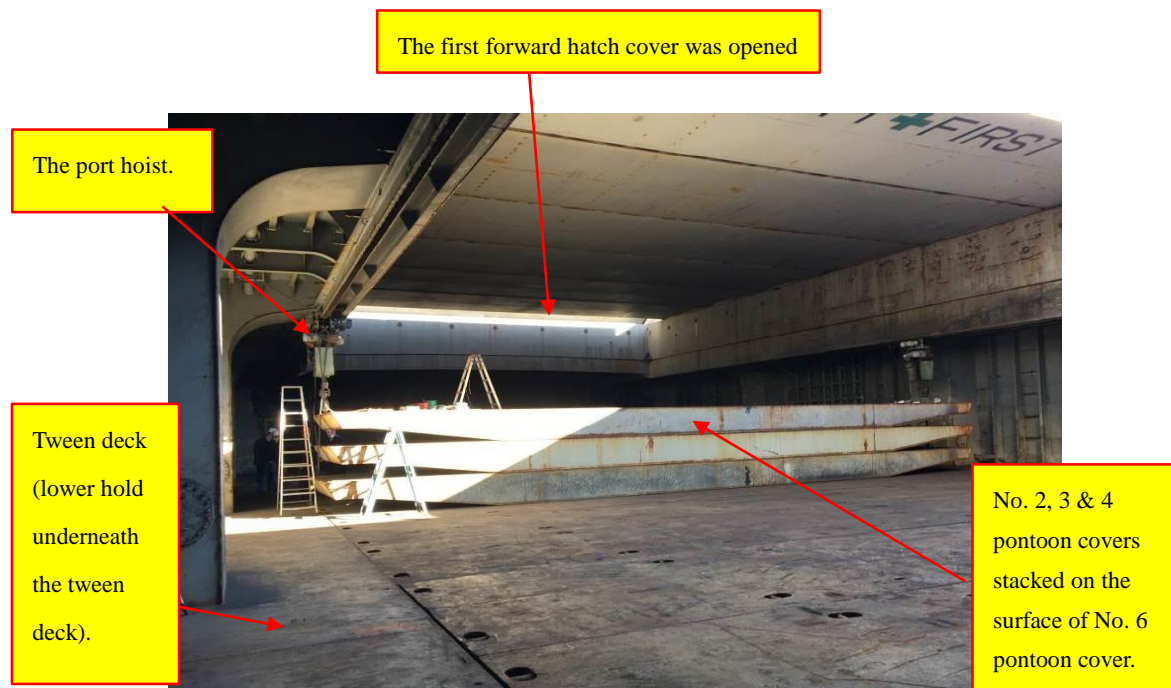
Figure 2 No. 1 cargo hold tween deck

- 4.9 The cargo hold was fitted with an eight-panel folding type hatch cover, and the tween deck was covered by 11 pieces of pontoon covers. At the time of the accident, No. 2 to No. 4 (counting from the ship's front) tween deck pontoon covers were removed and stacked on the surface of No. 6 pontoon cover (Figure 2). As such, the forward part of the tween deck was left open. Meanwhile, the first forward panel of the cargo hold hatch cover was also folded upward, making partial opening through which direct natural daylight illuminated the forward-most part of the cargo hold (Figure 2). In other words, the forward part of the tween deck was under the daylight and this would exclude the possibility that the falling of the chief engineer through the opening on the tween deck on to the bottom plating of the lower hold was due to total darkness.

- 4.10 Two monorail electric hoists with each installed at port and starboard sides respectively inside the cargo hold under the longitudinal hatch coaming. On the day of the accident, the chief engineer organized a work team to replace the electrical motor of the port hoist with a new one (Figure 2). There was no electrical lighting installed in the cargo hold. The natural daylight beamed from the opening at the forward-most of the cargo hold hatch was insufficient to illuminate the aft part of the tween deck. As such, the aft area of the tween deck was relatively dim but this was not considered as a contributory factor in connection with the accident (Figure 2).

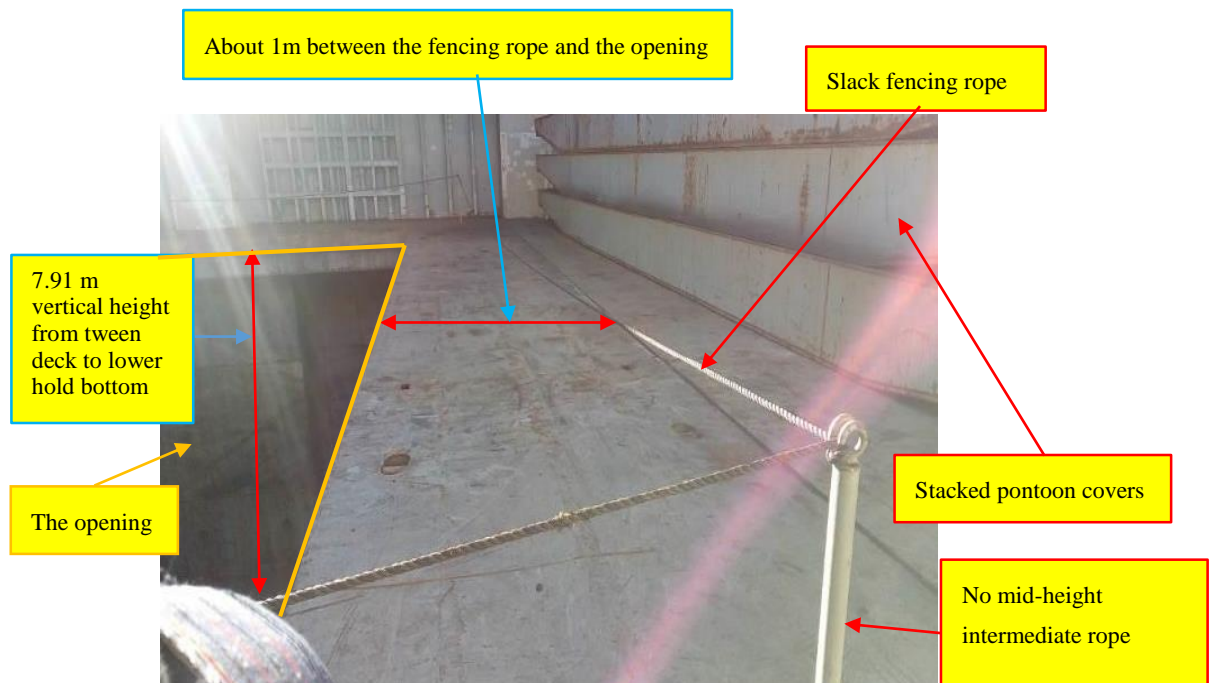
Figure 3 The fencing arrangement of the opening

4.11 The opening at the forward end of the tween deck was fenced by ship's crew to prevent any person from falling. The investigation, however, revealed that the fencing was only done by using a slack sagging fencing rope running through widely separated stanchions which were less than 1 metre in height. As a result, the rope went slack in almost touching the tween deck floor. In addition, there was no mid-height intermediate rope across the stanchions (Figure 3). The fencing arrangement did not meet the requirements of paragraphs 11.6.3 and 16.2.9 of the "Code of Safe Working Practices for Merchant Seafarers"¹ (the Code) which state that:

- (a) Paragraph 11.6.3: *Guardrails or fencing should consist of an upper rail at a height of 1 metre and an intermediate rail at a height of 0.5 metres. The rails may consist of taut wire or chain; and*
- (b) Paragraph 16.2.9: *when hatches are open, the area around the opening and in the hatchways should be appropriately illuminated and guardrails erected where necessary. Guardrails should be tight, with stanchions secured in position, and properly maintained.*

- (b) restrict entry into tween deck space when some of the pontoon covers have been removed. If necessary, safety measures must be in place to prevent persons from falling; and

- (c) arrange relevant safety training to enhance the crew's personal safety awareness including the use of personal protective equipment; familiarization with the permit-to-work system; and the capability to arrange an effective safe guardrail/fencing system.

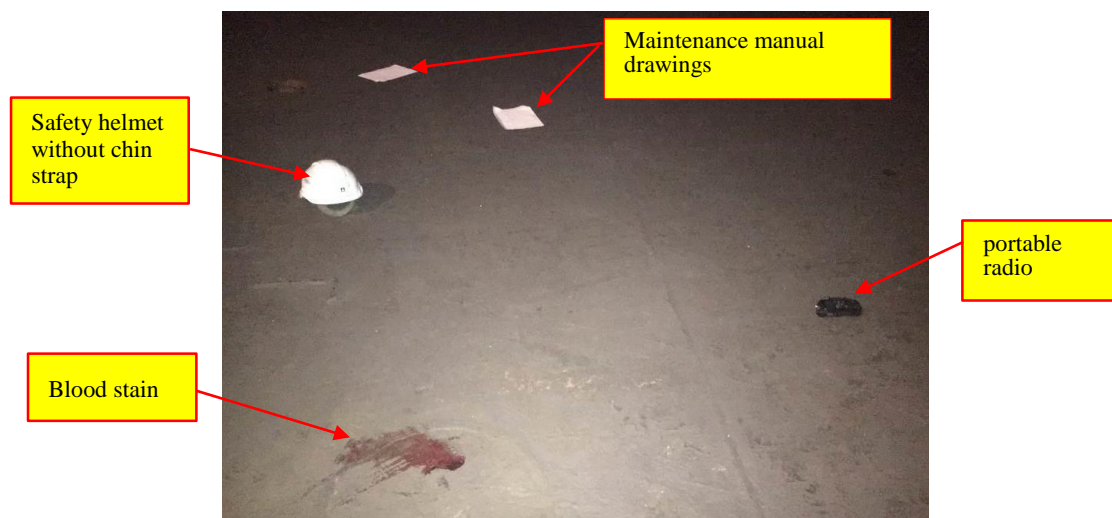
Figure 4 The accident scene

- 4.12 The photograph taken at the bottom of the cargo hold showed that there were a few pages of maintenance manual drawings, a safety helmet, a portable radio and blood stain (Figure 4). The helmet, seemingly without chin strap, was away from the blood stain. It was likely that the safety helmet might have fallen off from the chief engineer's head before he hit the bottom of the hold. Although the Coroner's report did not mention that the chief engineer had sustained head injury, it should be a safety issue that safety helmet should always be provided with chin strap.

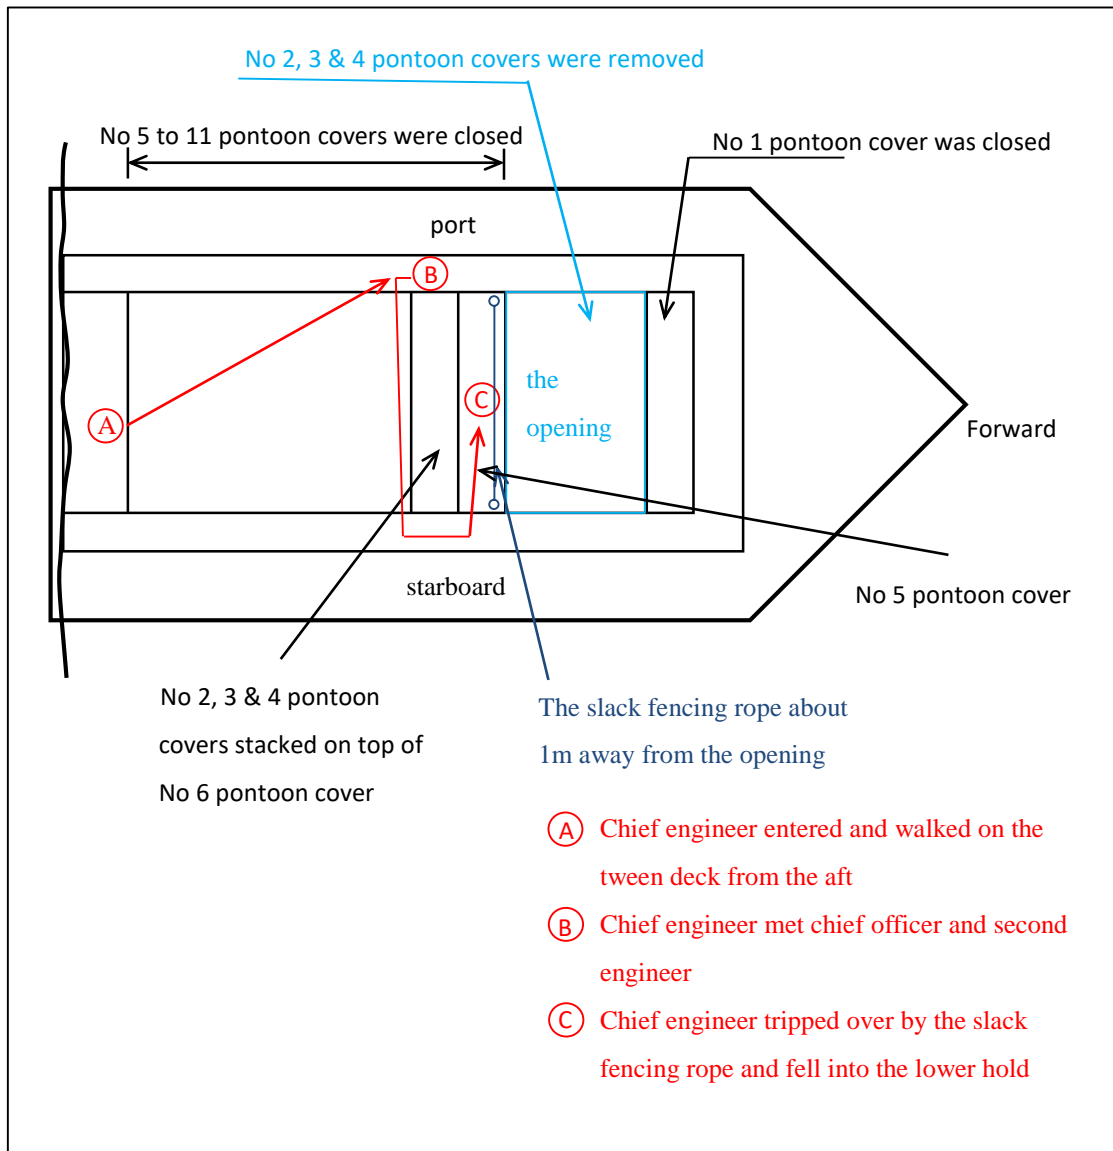
Figure 5 The deduced walking path of the chief engineer

- 4.13 There was no eyewitness for the accident. From the evidence and statements collected, the cause of the accident could be deduced as shown in Figure 5. The chief engineer entered the cargo hold from the aft entrance and walked on the tween deck. He went to the port side forward to meet the chief officer and the second engineer to enquire about the motor replacement plan of the port hoist. He then walked across the tween deck to the starboard side and continued walking towards the middle of No. 5 pontoon cover. For unknown reason, he might be tripped over by the slack sagging fencing rope and fell into the lower hold from the edge of the opening.
