**Report of investigation into
the fatal man overboard accident
happened on board
the Marshall Islands registered
bulk carrier “Win Win”
at the South West Lamma Anchorage,
Hong Kong on 24 February 2018**

The Hong Kong Special Administrative Region
Marine Department
Marine Accident Investigation Section

30 October 2019

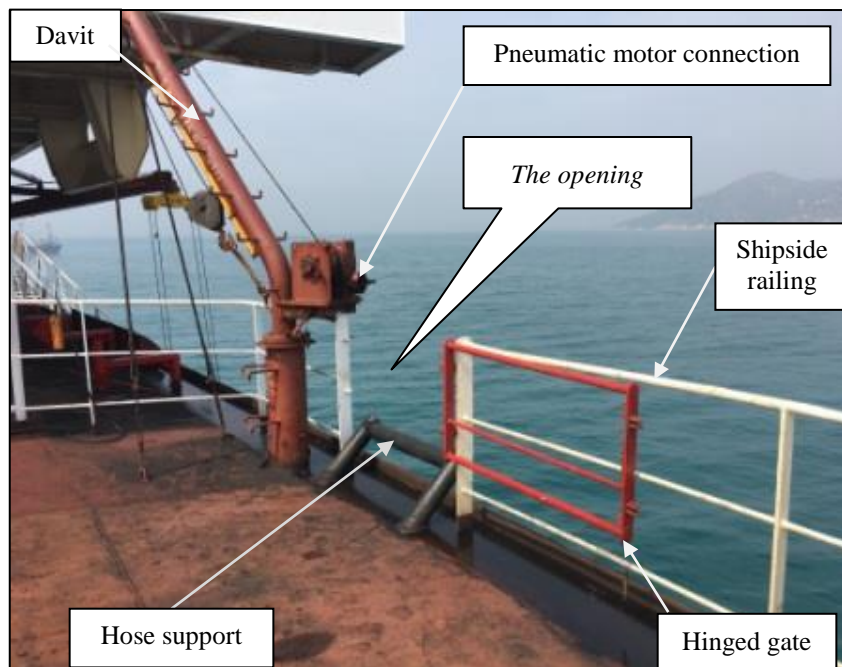
Figure 3: The davit and shipside fittings for bunker operation

- 3.1 At about 1945 hours on 24 February 2018, *the vessel* anchored at the South West Lamma Anchorage in Hong Kong for receiving 2100 metric tons heavy fuel oil bunker.
- 3.2 After *Feoso* was tied alongside the port side of *the vessel* at 2000 hours, the bosun, AB1 and another able-bodied seaman (AB2) gathered together at the port side of the main deck near the bunker manifold for connecting the bunker hose of *Feoso* to *the vessel*.
- 3.3 Near the bunker manifold at the port side of *the vessel*, there was a pneumatic motor driven davit used for lifting bunker hose from bunker barge. A hinged gate and a hose support were fitted on the shipside railing to facilitate bunker operation (Figure 3). At the material time, the hinged gate was opened to allow the passing of the bunker hose.

- 4.11 At the material time of the accident, the hinged gate on the shipside railing was opened without temporary chain or rope to safeguard the crew from falling overboard. It was possible that AB1's safety alertness had dropped under the effect of alcohol, hence failed to notice the danger and fall overboard through *the opening*.

- 5.4 The investigation identified the following contributing factors to this accident -
- (a) there was no proper safeguard at *the opening* of the shipside railing when the hinged gate was opened; and

- 4.12 Two days after the accident, the management company took immediate action to conduct a safety meeting on board *the vessel* to brief all crew to apply safety precautionary measures, such as using ropes to guard *the opening* when the hinged gate is opened. The management company also conducted an investigation into the accident and decided to adopt corrective measures, such as (i) to inform its fleet about the findings and lessons learnt from the accident; (ii) to train all ship staff through case study of this accident during superintendents' ship visit; and (iii) to modify the design of the hose support of *the vessel* in the forthcoming dockings so as to block *the opening* permanently, etc.

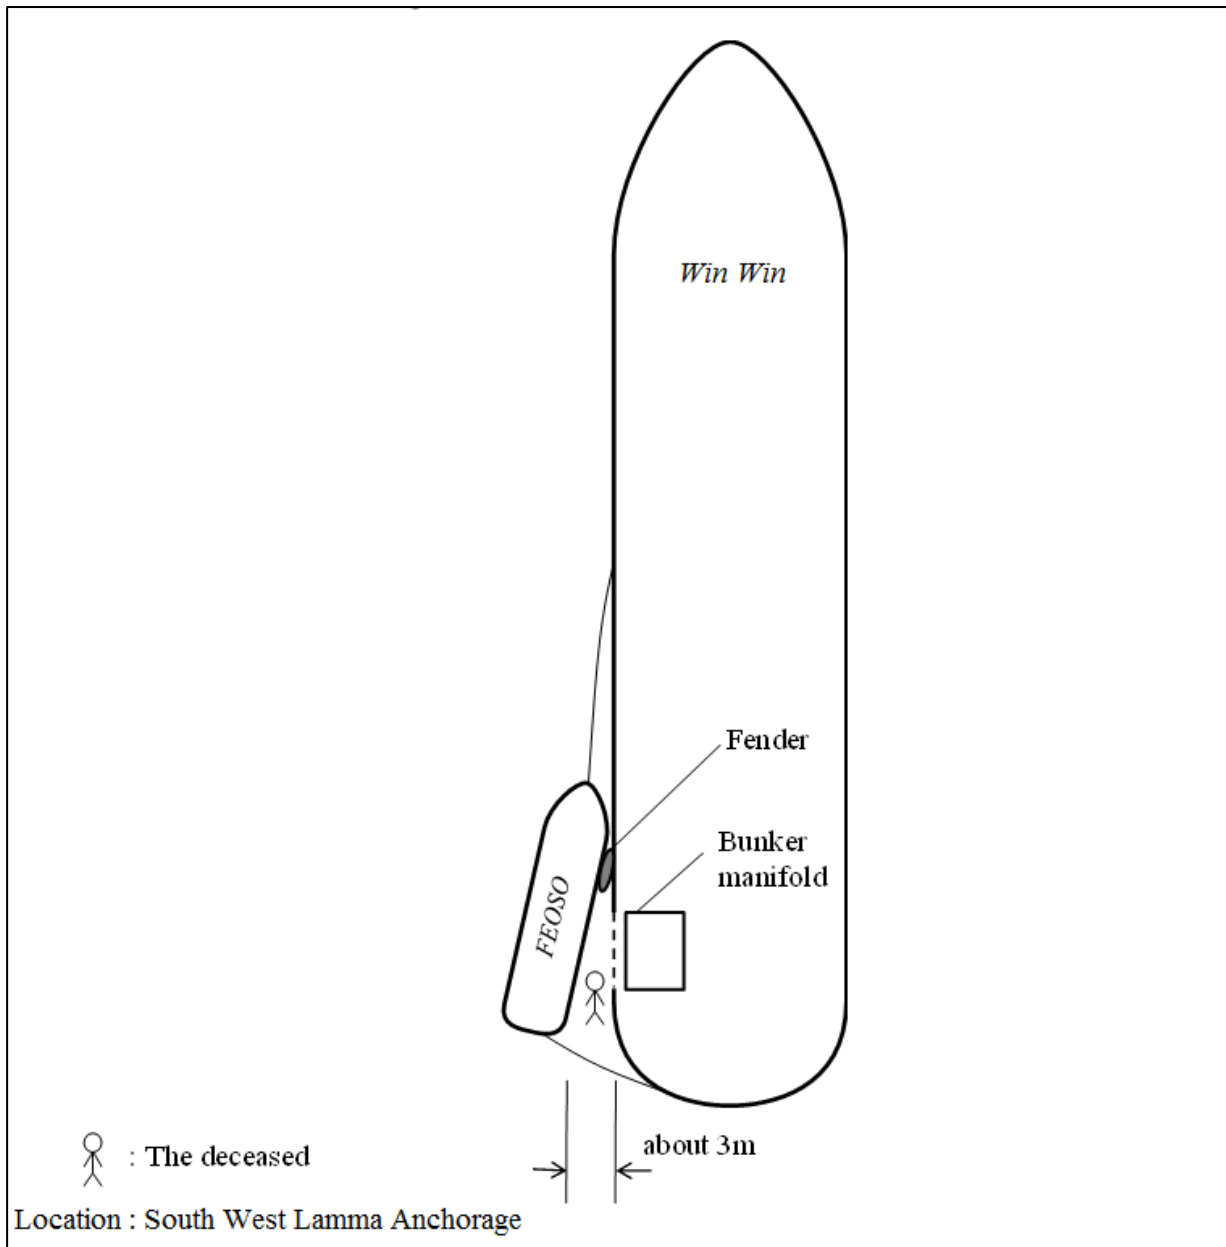
Figure 4: Scene of the accident

- 3.4 The bosun and AB2 stated that whilst connecting the bunker hose, they saw AB1 walking close to the shipside and fell overboard through *the opening* accidentally. The bosun raised the emergency alarm and broadcasted the accident through the public address system of *the vessel*.

- 3.7 The accident scene is depicted in Figure 4 below.

- 5.3 When AB1 walked close to the shipside, he fell overboard through *the opening* of the shipside railing where a hinged gate was opened. The crew of *Feoso* rescued him out of the water. AB1 was airlifted to the hospital subsequently and was pronounced dead on the same day.
