**Report of investigation
into the man overboard accident
on board Hong Kong registered
bulk carrier “*Lara Venture*”
on 13 March 2018**

**The Hong Kong Special Administrative Region
Marine Department
Marine Accident Investigation Section**

16 April 2021

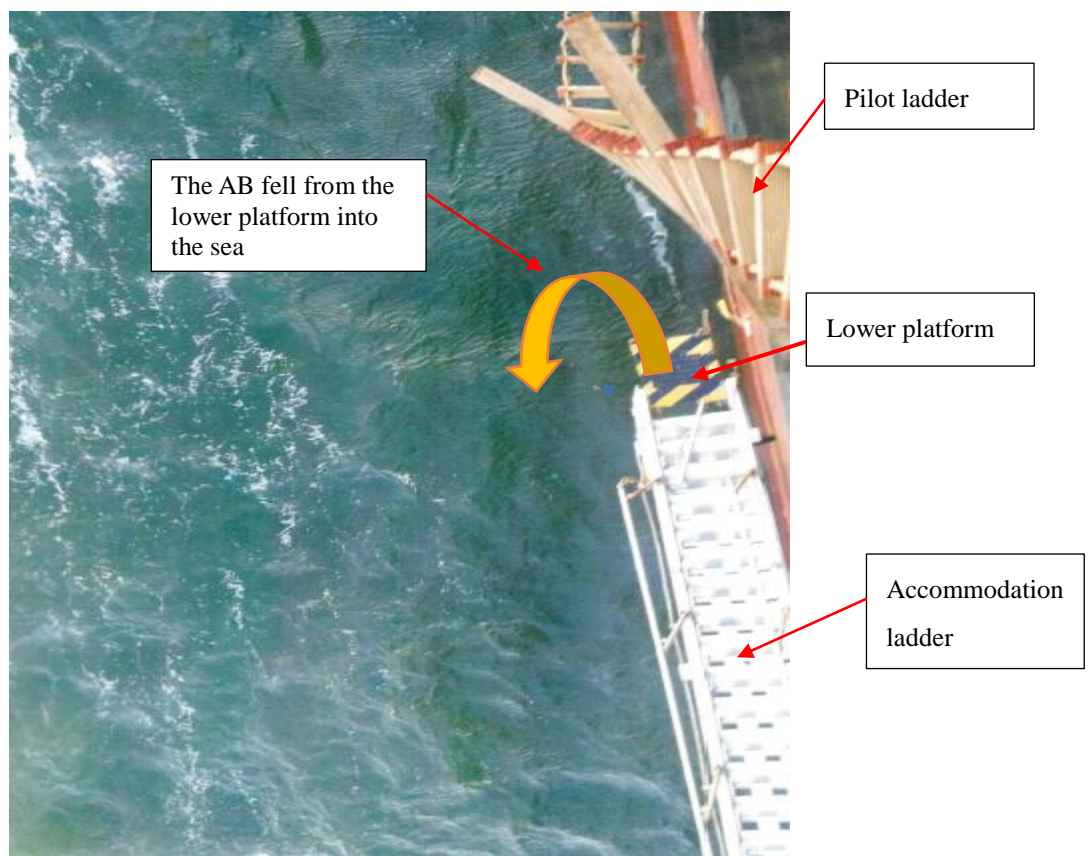
Figure 2 The SCL

- 3.2 After the pilot disembarked from the SCL at 0201 hours (Figures 2 and 3), the chief officer instructed the bosun and the AB to recover the accommodation ladder of the SCL. He then went to the bow to check the anchor chain condition.

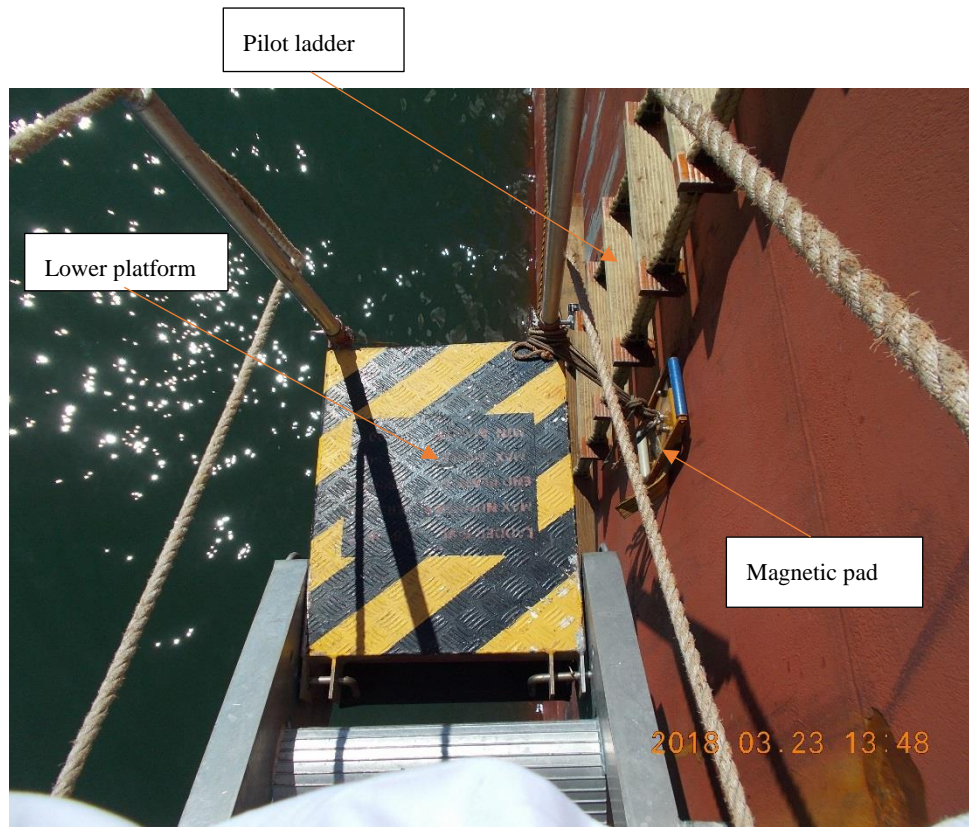
- 3.3 The bosun instructed the AB to release the lashing of a magnetic pad at the end of the accommodation ladder. When the AB reached the lower platform of the accommodation ladder, a high wave suddenly struck at the platform causing him to fall overboard. The bosun on the main deck threw the nearest lifebuoy to the AB and reported man overboard to the bridge using his portable radio. The bosun saw the AB floating in the water with face downwards.

Figure 3 The SCL with a magnetic pad to secure the accommodation ladder to shipside

- 4.6 The weather was overcast with northwesterly strong gale and long swell. There was snowfall a few hours before the accident which made the accommodation ladder steps and the platform slippery. At the time of the accident, the lower platform of the accommodation ladder was suddenly struck by a high wave. Poor weather and sea conditions were contributory factors of the accident.

4.13 According to the chief officer's statement, he instructed the bosun and the AB to recover the accommodation ladder of the SCL. The bosun then asked the AB to go to the lower platform to release the lashing of the magnetic pad at the end of the accommodation ladder. The AB went down the accommodation ladder to the lower platform without wearing a lifejacket. While the AB was releasing the magnetic pad, a high wave suddenly struck the lower platform causing the AB to fall overboard.

- a) follow the company's procedure of wearing lifejacket when working over the shipside; and
 - b) arrange relevant safety training to enhance the crew's safety awareness on effect of the poor weather and sea conditions and familiarize themselves with the company's safety procedures. The crew should also be strengthened on the use of proper personal protective equipment.
