**Report of investigation  
into the fatal accident on board the  
Hong Kong registered bulk carrier  
“*Feng Hui Hai*” at Navlakhi, India on  
22 April 2018**

The Hong Kong Special Administrative Region  
Marine Department  
Marine Accident Investigation Section

03 January 2022

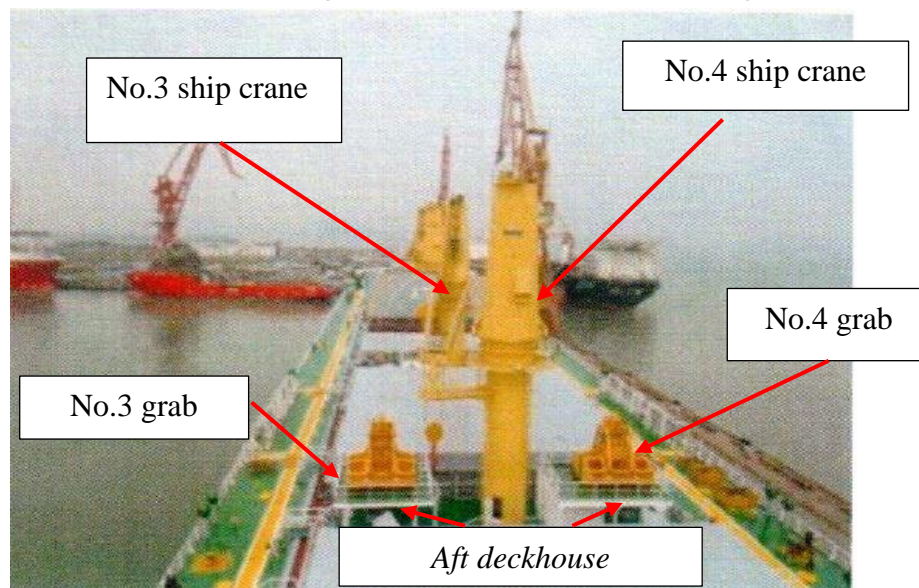
- 3.4 At about 0830 hours, all cargo hold hatch covers were opened, the bosun, AB1 and AB2 then prepared to link the grabs to the ship cranes.
- 3.5 *The vessel* was fitted with 4 pieces of grabs. Nos.1 and 2 grabs were stowed on top of the deckhouse between Nos. 1 and 2 cargo holds. Nos.3 and 4 grabs were stowed on top of the deckhouse between Nos.4 and 5 cargo holds (*aft deckhouse*) (Figure 2).

Figure 2 The overview of the Nos. 3 and 4 ship cranes as well as Nos.3 and 4 grabs.

4.26 The operation of transferring the No.3 grab to the No.3 ship crane had been carried out a few times previously. The No.3 grab would normally be placed on the passageway or hatch covers without the crew members to enter into the cargo hold to process the operation. The hatch covers and passageways were recently painted and the crew members did not want to damage them. As such, the crew

members decided to place the No.3 grab on the cargo pile in the No.4 cargo hold but failed to consider the fatal hazards of entering the enclosed space. There was no evidence to show that any safety issues had been discussed with the C/O relating to transferring the grabs by lowering onto the cargo pile inside cargo holds.

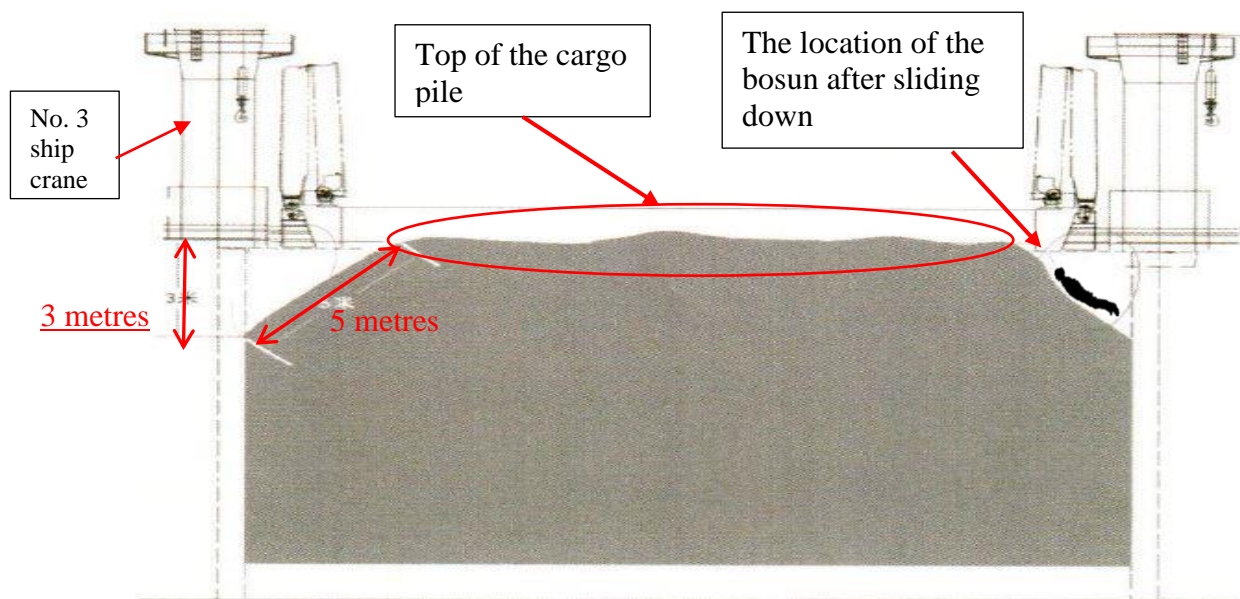
- 3.8 At about 0915 hours, the bosun arrived at the edge of the cargo pile in No.4 cargo hold intending to climb to the top of the cargo pile to disconnect No.3 grab from the hook of No.4 ship crane. Unfortunately, the bosun collapsed upon walking a few steps on the cargo pile and slipped down to the edge (Figure 3).

Figure 3 The diagram showing the condition of No.4 cargo hold from the view of the port side

- 4.13 The atmospheric testing in the No.4 cargo hold was carried out daily during the voyage and the oxygen level was recorded between 4% to 15.6% which was lower than the normal oxygen level of 20.9% in the atmosphere. The oxygen level at or below 16% will not sustain life.

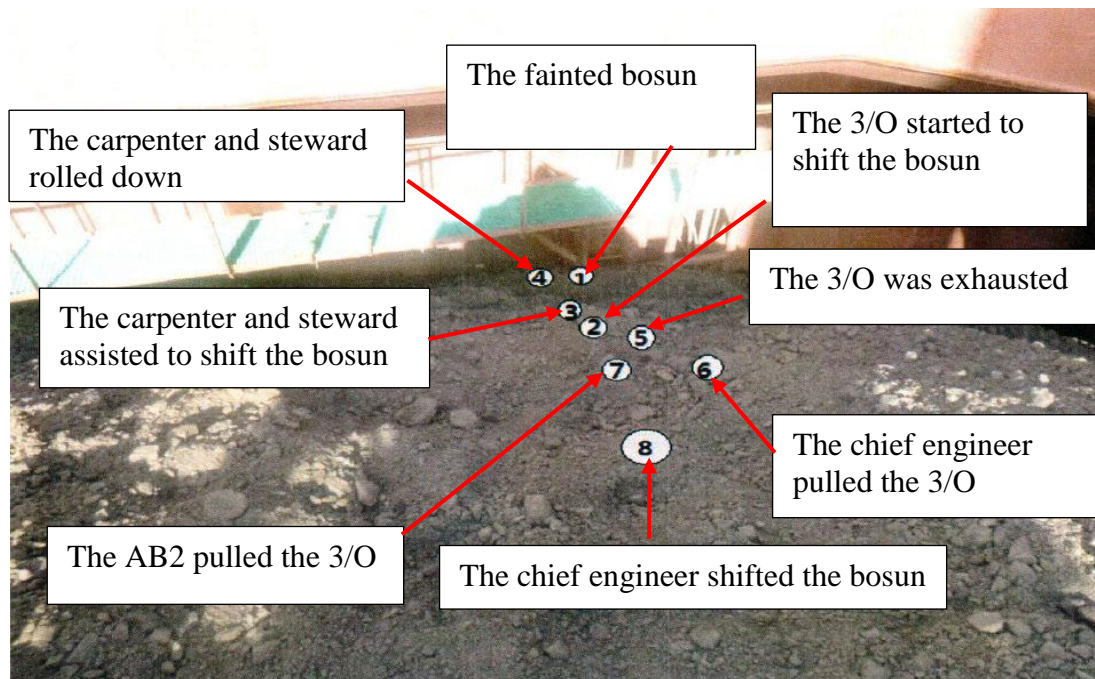
- 3.12 While the 3/O was halfway in pulling the bosun to the top of the cargo pile in No.4 cargo hold, the carpenter and steward without donning SCBA came to assist him. The carpenter and steward lifted the bosun's legs and the 3/O pulled the bosun's shoulder. Soon after, the carpenter and steward fell and rolled to the edge of the cargo pile about 2 metres away from the top of the cargo pile. Meanwhile, the 3/O also exhausted and failed to shift the bosun to the top of the cargo pile by himself (Figure 4).

Figure 4 The location of the crew members on the cargo pile in the No.4 cargo hold during the rescue operation

- (a) The carpenter and steward did not assess the condition of the cargo hold before entering it. The proper way to ensure safe entry into the cargo hold for rescue operation was either measuring the atmosphere inside the cargo hold or donning the SCBA.
- (b) The AB1 and AB2 arrived at *the aft access trunk* and considered that the cargo hold was unsafe to enter without SCBA. However, none of them stayed at the *aft access trunk* to remind other crew members of the hazards of the cargo hold at that moment.

- 6.1 The management company should issue circulars informing all masters, officers, and crew members of its fleet of the findings of the investigation and lessons learnt from this accident and instruct them to:
  - (a) enhance safety awareness and safety culture onboard to ensure the risk assessment and permit to work system to be followed before entering into enclosed space; and
  - (b) enhance the training plan on enclosed space entry and the potential fatal hazards of the carriage of coal cargo.
- 6.2 The management company should conduct an internal audit on *the vessel* to ensure that the crew members strictly follow the safety requirements when entering the enclosed space as well as familiarize and understand their duties under SMS in emergencies.
- 6.3 A Hong Kong Merchant Shipping Information Note is to be issued to promulgate the lessons learnt from this accident.
