**Report of investigation
into the fatal accident of the bosun
onboard the Hong Kong registered
bulk carrier “*Great Reward*”
at sea on 17 May 2018**

The Hong Kong Special Administrative Region
Marine Department
Marine Accident Investigation Section

2 December 2020

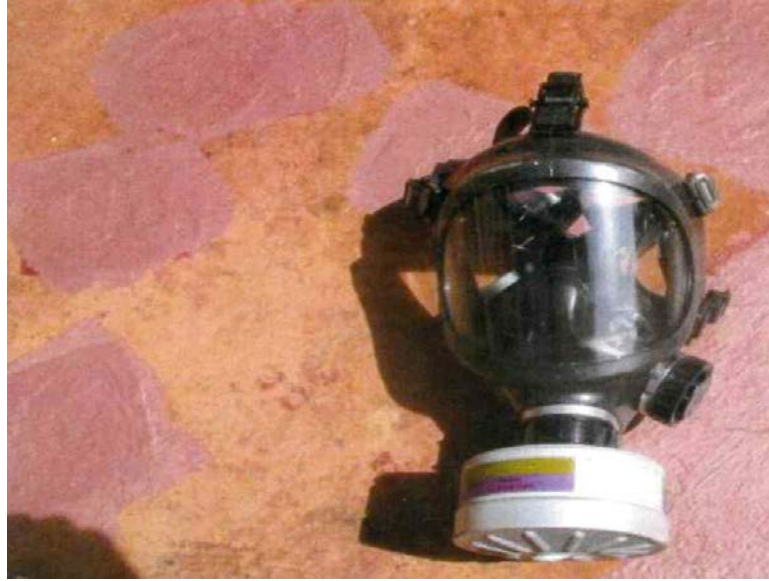
Figure 2 Mask respirator

- 4.15 As shown in Figure 2, the mask respirator worn by the bosun belonged to the air-purifying type rather than the air-supplied type which could supply breathable air to the wearer. In accordance with the Material Safety Data Sheet of Aluminum Phosphide (Southphos), “*if engineering controls don’t maintain airborne concentration to an acceptable level, a niosh- approved self contained breathing apparatus must be worn.*”. With reference to *Circ. 1264*, the bosun did not wear adequate protective equipment appropriate for the fumigant used and was not accompanied by the fumigator-in-charge for entry into *the C/H*.

- 4.16 The chief officer stated that both the fumigator-in-charge and the ship’s crew wore the same type of mask respirator used by the bosun when applying fumigant tablets. Furthermore, the chief officer considered that it would be safe to wear the mask respirator for entry into the fumigated *C/H* as the mask respirators were provided by the fumigator-in-charge. However, the chief officer failed to understand that during and soon after applying fumigant tablets inside a cargo hold, the phosphine gas in the cargo hold would not accumulate immediately to a sufficiently high concentration level which would affect human life. However, with the passage of time after the fumigant was applied, *the C/H* had been filled with poisonous phosphine gas. Wearing of wrong type mask respirator, coupled with oxygen depletion, the bosun was subsequently suffocated to his death inside *the C/H* (Figure 3).

- ii) seek prior advice from the fumigator-in-charge before opening sealed cargo holds under fumigation;
 - iii) provide training to the crew to enable them to understand the limitation of the use of mask respirator; and

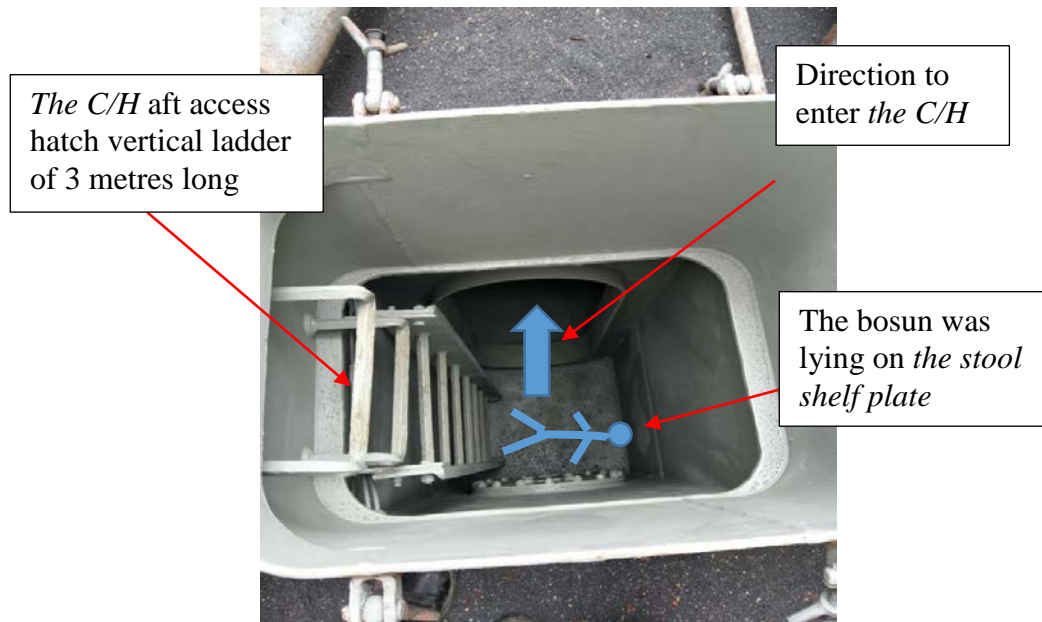
Figure 3 *The C/H aft access hatch and the stool shelf plate.*

- 3.7 At about 1015 hours when the chief officer arrived at *the C/H* aft access hatch, he found that the bosun was lying on the upper stool shelf plate (*the stool shelf plate*) about three meters underneath the access hatch. The chief officer immediately contacted the bridge and the duty officer (third officer) informed the master at once. The master went to *the C/H* aft access hatch and the third officer summoned the crew through public address for rescue operation.

- i) always conduct a full risk assessment before entering an enclosed space and issue entry permit in accordance with the requirements of the company's safety management system;

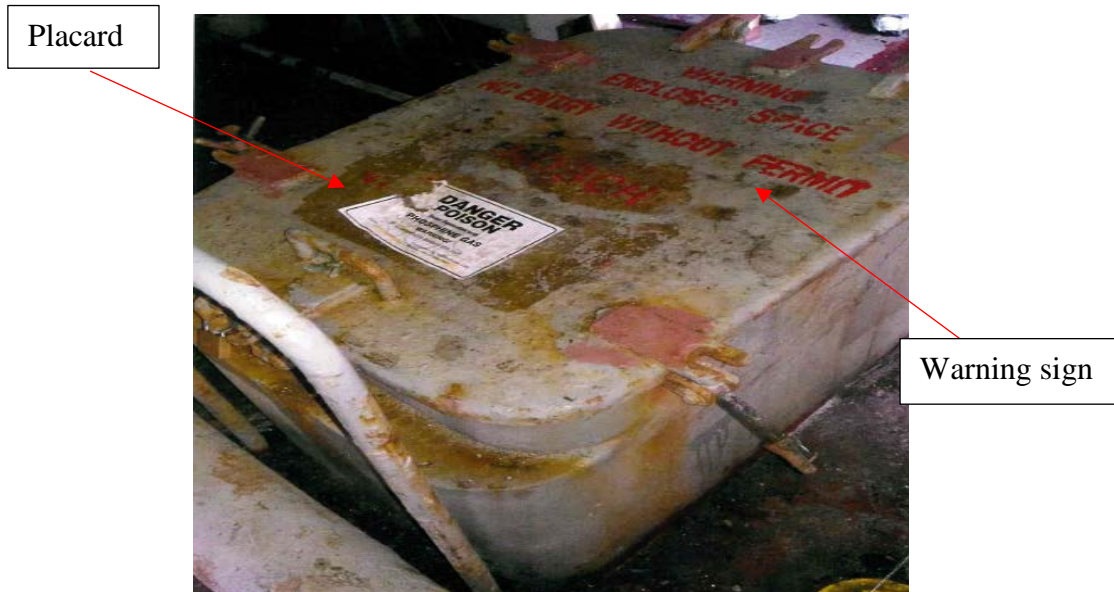
- 4.17 *The C/H* was sealed and the aft access hatch cover was labelled with a warning sign “***NO ENTRY WITHOUT PERMIT***” and a placard “***Under fumigation with PHOSPHINE GAS***” (Figures 4 and 5). However, the fact that the chief officer allowed the bosun wearing inappropriate mask respirator to enter the C/H without notifying the fumigator-in-charge indicated that both the chief officer and the bosun were in lack of safety awareness.

Figure 4 Warning sign and placard on *the C/H* aft access hatch cover
