**Report of investigation into  
the man overboard accident on board  
the Republic of Sierra Leone registered  
dry cargo vessel “*Lin Fung 16*”  
at Yau Ma Tei Anchorage, Hong Kong  
on 26 May 2018**

The Hong Kong Special Administrative Region  
Marine Department  
Marine Accident Investigation Section

16 April 2020

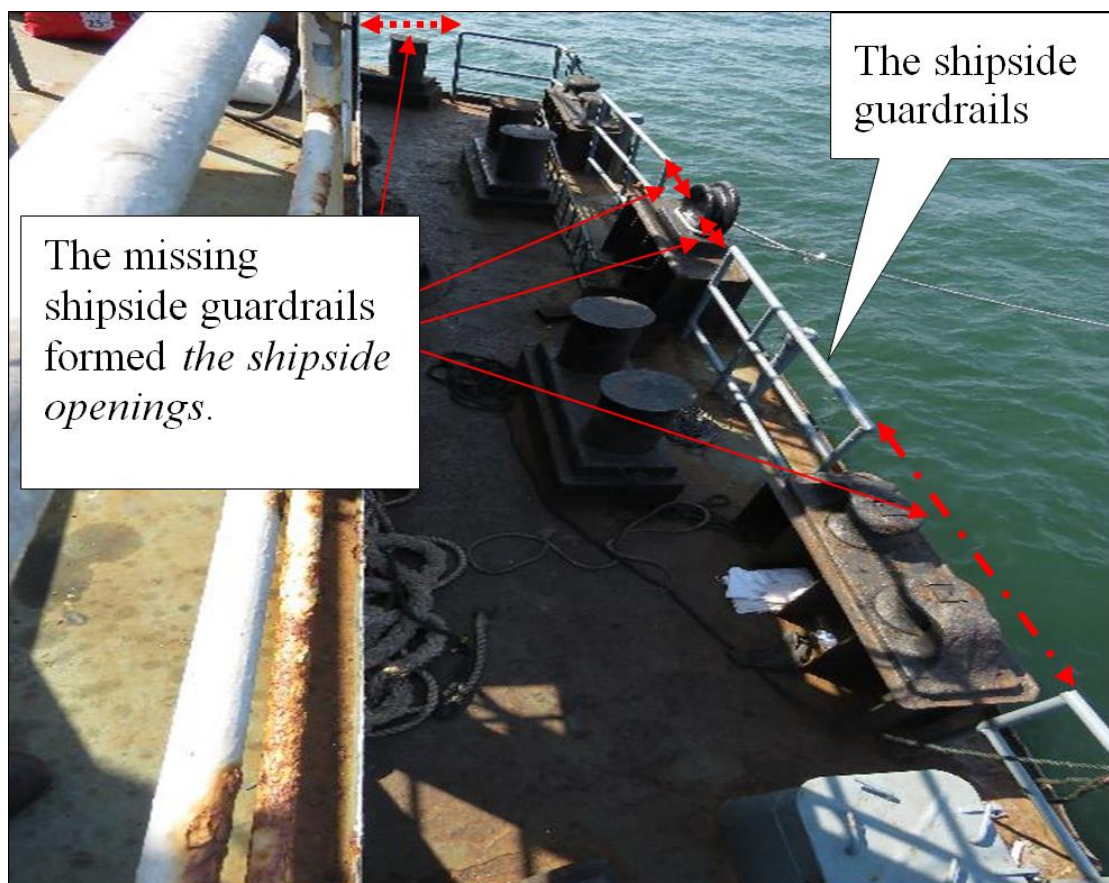
Figure 2: Poop deck aft

- 4.6 Shipside guardrails were fitted around the poop deck aft to prevent crew from falling overboard. As shown in Figure 2, however, there were certain places where *shipside openings* were found around the periphery of the poop deck aft.
- 4.7 Paragraph 2 of Regulation 25 "*Protection of the Crew*" of Annex I of the International Convention on Load Lines, 1966 (the Load Lines Convention) stipulates that "*Efficient guardrails or bulwarks shall be fitted on all exposed parts of the freeboard and superstructure decks. The height of the bulwarks or guardrails shall be at least 1 metre (39½ inches) from the deck, provided that where this height would interfere with the normal operation of the ship, a lesser height may be approved if*

*the Administration is satisfied that adequate protection is provided.”* As such, *the shipside openings* in way of the mooring fittings on the poop deck aft of *the vessel* did not comply with the above-mentioned requirement.

- 4.8 At the material time of the accident, there was no witness to the oiler's fall into the sea. It could only be deduced that he might have taken a walk on the poop deck aft after work. As the oiler was not aware of the inherent hazard of *the shipside openings*, he inadvertently fell into the sea.
- 4.9 The chance of the oiler's fall from either the port or starboard embarkation ladder on the poop deck could be ruled out since both of these ladders were properly secured in their stowed positions and provided proper protection of preventing crew from falling overboard (Figure 3).

- 5.1 At 2155 hours on 26 May 2018, the oiler of *the vessel* fell overboard and went missing when *the vessel* was anchored at Yau Ma Tei Anchorage. Three days later, the dead body of the oiler was found in the sea nearby.
- 5.2 The investigation revealed that certain shipside guardrails in way of deck fittings (e.g. bollards, fairleads, and mooring chocks) on the poop deck aft of *the vessel* were not fitted. These missing shipside guardrails forming openings to sea were not in compliance with the protection of crew requirements of the International Convention on Load Lines, 1966. There was no witness to the accident. However, it might deduce that the oiler was not aware of the inherent hazard of *the shipside openings* on the poop deck aft and inadvertently fell into the sea.

- 6.1 A copy of the investigation report should be sent to SLMA, the master and the management company<sup>2</sup> of *the vessel* advising them of the findings of the investigation.
- 6.2 The management company should:
- (a) arrange to provide efficient guardrails for *the shipside openings* to prevent crew from falling overboard in order to comply with the Load Lines Convention; and
  - (b) strengthen the crew safety awareness of falling overboard from exposed parts of the freeboard and superstructure decks.
