**Report of investigation  
into a fatal accident on the  
Hong Kong registered general  
cargo ship “*THORCO  
RAFFLES*” in Ehoala,  
Madagascar on 25 July 2019**

The Hong Kong Special Administrative Region  
Marine Department  
Marine Accident Investigation Section

27 April 2021

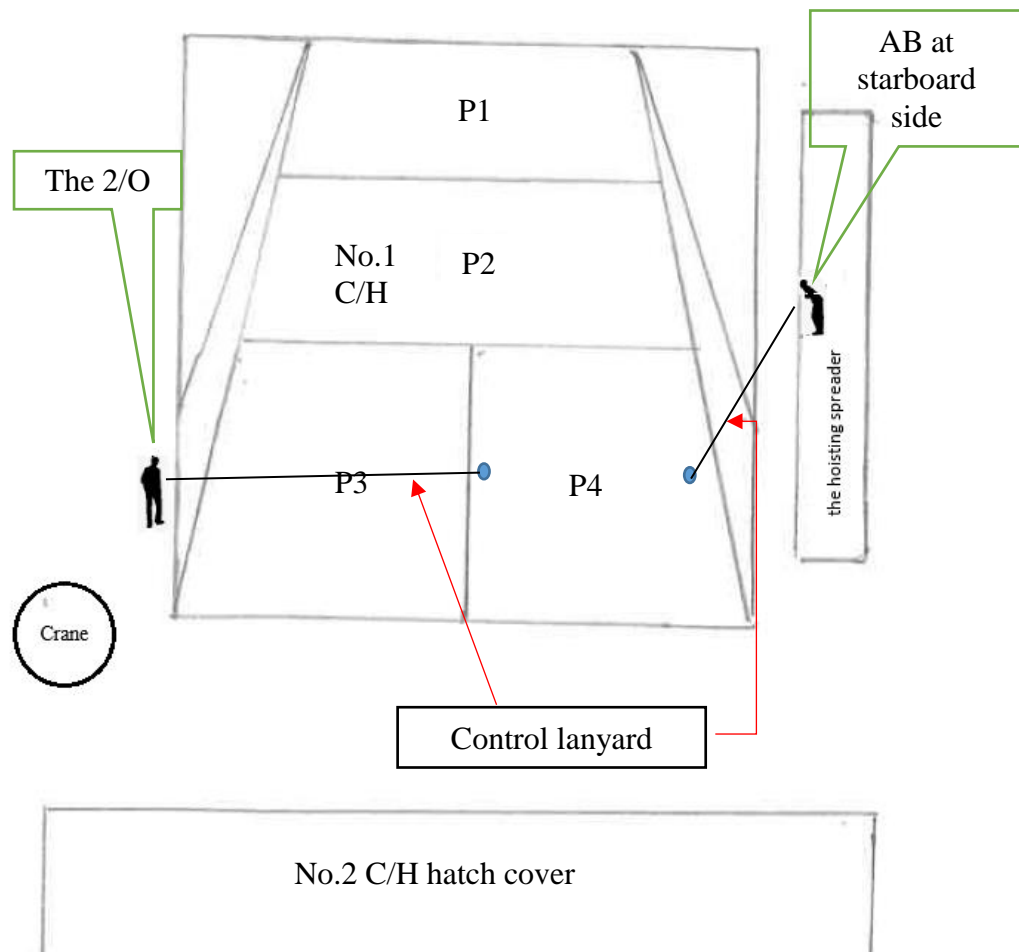
Figure 2 – Locations of the 2/O and the AB on main deck (*plan view*)

- 3.6 The 2/O stood on the main deck port side of No. 1 C/H, while the AB stood on the top of a hoisting spreader that was 1.73 metres high above the main deck and laid at the starboard side next to the No. 1 C/H hatch coaming. In the course of the lifting, both the 2/O and the AB were assigned to control the movement of the pontoon by holding the control lanyards tied to both sides of the pontoon.

- 4.10 No. 1 C/H was the first cargo hold counting from forward of *the vessel* and was equipped with four pieces of tween-deck pontoon (namely P1, P2, P3 and P4) to form the tween-deck inside No. 1 C/H. The hatch coaming of No. 1 C/H was 2 metres high. (Figures 2 and 3)

4.11 To prepare for the cargo loading of the No. 1 C/H, the team had to lift each of the pontoon separately by the crane starting from P4. The 2/O stood safely on the port side main deck holding the control lanyard and leant against the No. 1 C/H portside longitudinal hatch coaming which was about 2 metres high. On the contrary, the AB stood on the top of the hoisting spreader at a height level with the No. 1 C/H hatch opening. At that position, the risk of falling from height for the AB increased. (Figure 3)

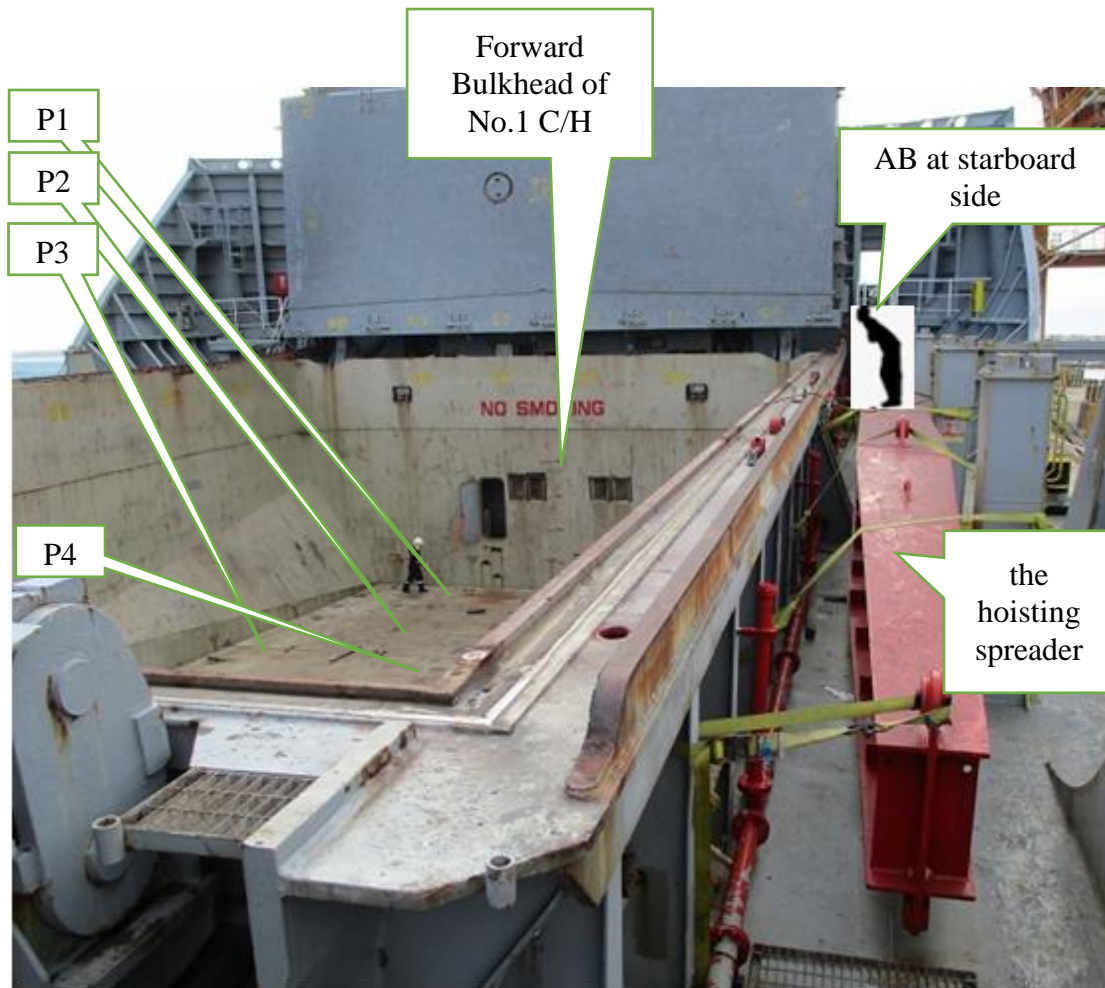
Figure 3 –No. 1 C/H

- 3.7 At about 1630 hours, when the crane hooked with the first piece of the No. 1 C/H tween-deck pontoon and was about to slew towards the No. 2 C/H (refer to 'P4' in figure 2 and figure 3), the AB fell into the No. 1 C/H.

- 4.13 There was no difficulty for a person stood on top of the hoisting spreader to step on the top of the No. 1 C/H hatch coaming as it was just 25 cm below the top flange of the hatch coaming. Also, there was no falling prevention fitted along the No. 1 C/H hatch coaming, e.g. fencing, lifeline, taut wire etc. Therefore, it was risky for the AB to work on the hoisting spreader where he was beside a large unfenced cargo hold hatch opening.
