**Report of investigation
into the fatal accident on board the
Hong Kong registered bulk carrier
“*Pelican Island*” in Alexandria,
Egypt on 14 August 2019**

**The Hong Kong Special Administrative Region
Marine Department
Marine Accident Investigation Section**

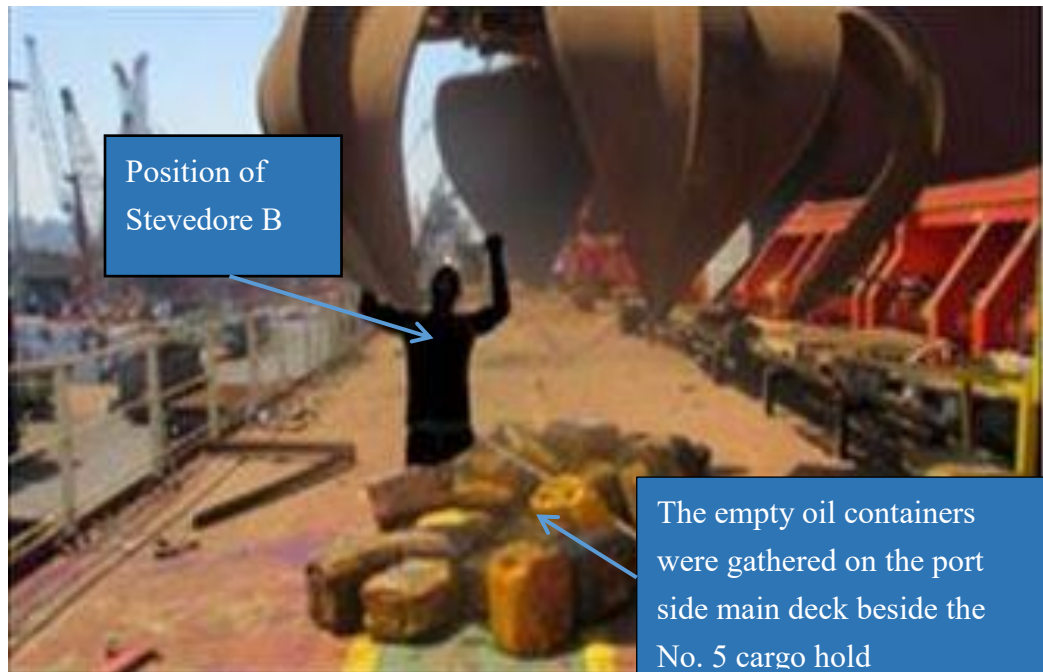
- 3.6 At about 1100 hours, when Stevedore B was still securing another end of the steel pipe to one of the tines of the grapple, the grapple suddenly closed and Stevedore B's neck was caught in by the tines of the grapple (Figure 2).

Figure 2 The Stevedore B's neck was caught in by the tines of the grapple

- 4.11 At the material time, no signalman was appointed to give instruction to *the crane operator* in operating the grapple safely including confirming no person in the hazardous area underneath and around the grapple before operation. Unfortunately, *the crane operator* operated the grapple without noticing that Stevedore B was still underneath the grapple resulting in the accident.

- 5.2 The investigation revealed that the main contributory factors causing the accident were as follows:
- (a) the stevedores had insufficient safety awareness and underestimated the risk of working underneath the grapple;

- (b) no stevedore signalman was assigned for the crane operation and *the crane operator* failed to confirm that there was no person in the hazardous area underneath and around the grapple before operating the grapple; and

- (c) the duty crew had not observed the unsafe operation of the stevedores on board.

- 6.1 After the accident, the management company of *the vessel* had issued a circular informing its fleet to take appropriate actions against any unsafe operation of stevedores on board, including suspension of unsafe operation if necessary.
- 6.2 The management company should inform all masters, officers and crew of its fleet to enhance safety patrol to monitor the safe working of stevedores on board.
- 6.3 A Hong Kong Merchant Shipping Information Note is to be issued to promulgate the lessons learnt from this accident.

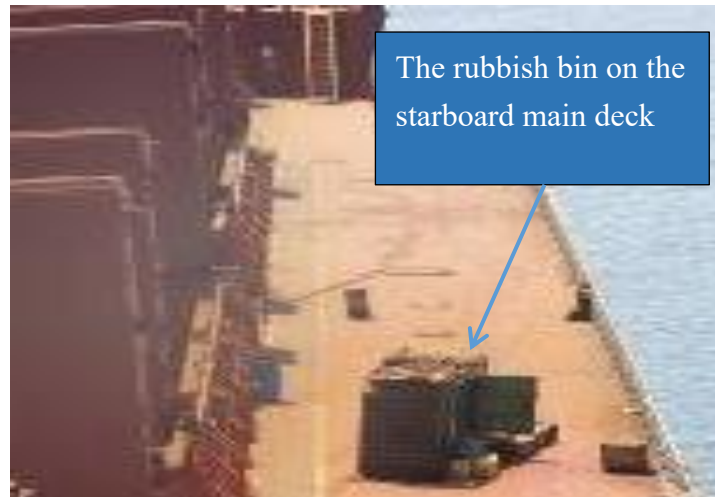
- 4.10 The proper way to dump the empty oil containers ashore was to put them in a rubbish bin on board and let the ship crane move the loaded rubbish bin ashore. As the rubbish bin was on the starboard main deck and the empty oil containers were at the port side, it would be necessary to relocate the rubbish bin to the port side for easy dumping (Figure 3). Stevedores A and B might have underestimated the risk of working underneath the grapple. The safety awareness of the stevedores was probably inadequate in attempting the shortcut to transfer the empty oil containers ashore by the grapple without using the rubbish bin.

Figure 3 The rubbish bin on the starboard main deck
