**Report of investigation
into the fatal accident on board the
Hong Kong registered bulk carrier
“*Unison Medal*” at Ilo, Peru
on 9 September 2019**

**The Hong Kong Special Administrative Region
Marine Department
Marine Accident Investigation Section**

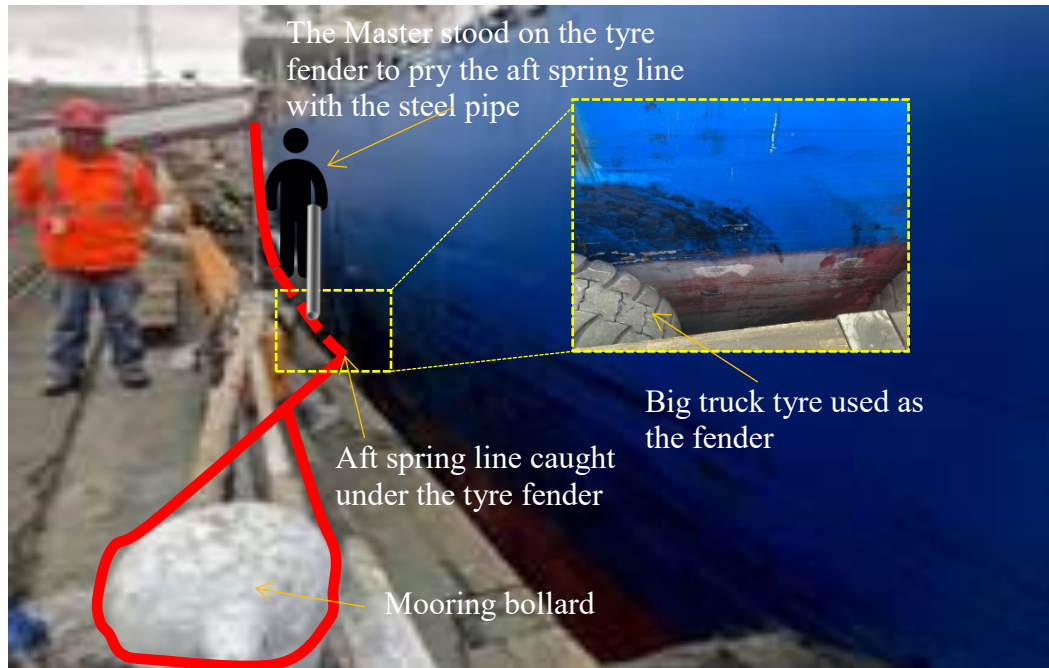
- 3.5 The Master stood on the tyre fender and attempted to pry the aft spring line with the steel pipe (Figure 2), but also failed. As *the vessel* rolled

and swayed occasionally, the 3/O at the quay noticed that the aft spring line would soon be parted or jerked free from the bottom of the tyre fender. He then reminded the Master to keep a safe distance from the aft spring line. However, the Master ignored the warning and kept on standing on the tyre fender beside the quay.

Figure 2 Reconstruction diagram showing the location of the Master.

- 3.6 At about 2239 hours, the aft spring line suddenly jerked free from the bottom of the fender. The neck of the Master was hit by the aft spring line, and he fell into the water from the gap between *the vessel* and the quay.
- 3.7 At the material time of the accident, the C/O, who finished his work on the crane, came to the quay asking the 3/O the condition of the aft spring line. Both of them noticed the Master was hit and fell into the water. The C/O immediately organized a rescue team and informed the local agent to arrange shore medical assistance. A crew together with one stevedore upon arrival at the scene jumped into the water to rescue the Master.
- 3.8 At about 2245 hours, the Master was recovered from the water. First

- 4.10 In the accident, the aft spring line was in tension. It was unsafe to pry the aft spring line with a steel pipe. Both the 3/O and the Master underestimated the whipping effect of the tensioned aft spring line when freed or parted. There was also no room for them to get a shelter when standing on the uneven tyre fender. To release the aft spring line caught by the tyre fender, the 3/O had suggested slackening the line and adjusting it from the mooring bollard onshore. But they finally did not apply standard seamanship practices and took a shortcut that put themselves into a risky situation. The situation was worse, when the Master stood on the tyre fender and the aft spring line would jerk out or part at any moment due to *the vessel’s* movement. Unfortunately, the aft spring line slipped off suddenly and hit the neck of the Master resulting in his death.

- 4.11 In this accident, the Master did not adhere to the Code and did not utilize standard seamanship practices to free the aft spring line by shifting the load of the aft spring line to another line in advance. It revealed that the Master probably had inadequate safety awareness to consider a safe way to free the aft spring line.

- 6.1 The management company should issue notice/circular informing all masters, officers and crew of its fleet of the findings of the investigation and lessons learnt from this accident and instruct them to:
- (i) strictly carry out risk assessment to identify the potential risks and well plan key operations with all the necessary safety precautionary measures;
 - (ii) follow the Code and utilize the standard seamanship practices during daily mooring operation; and
 - (iii) enhance the safety awareness, including the awareness of the risks and hazards associated with the mooring operation, to improve the safety culture onboard.
- 6.2 A Hong Kong Merchant Shipping Information Note is to be issued to promulgate the lessons learnt from this accident.

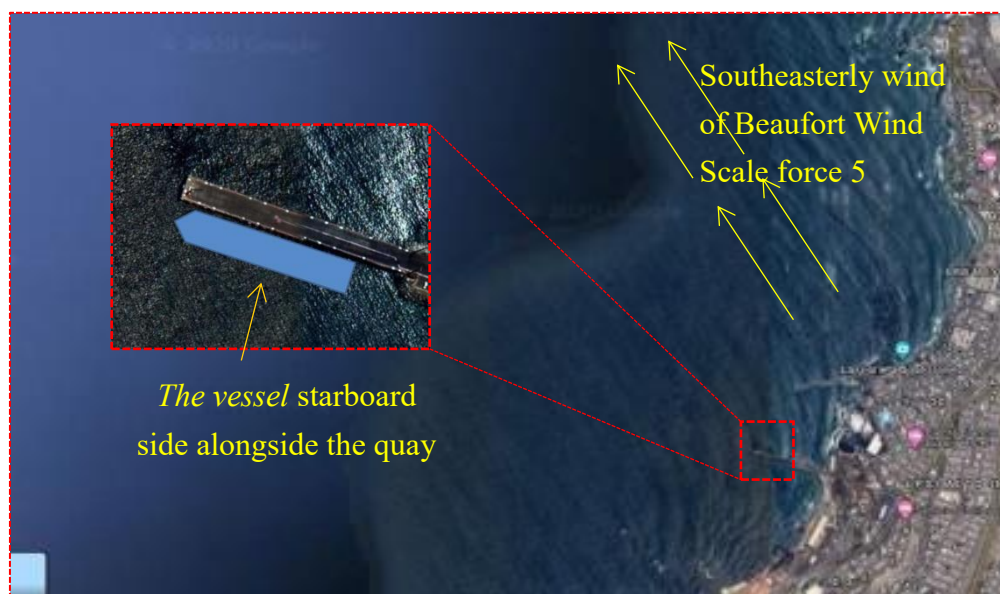
- 4.5 The weather was partly cloudy with southeasterly wind of Beaufort Wind Scale force 5 with fresh breeze, rough sea and moderate swell. *The vessel* was exposed to wind and swell without the protection of breakwater or barrier (Figure 3). Although *the vessel* was moored to the quay, she still rolled and swayed moderately resulting in the aft spring line caught under the tyre fender.

Figure 3 *The vessel was exposed to wind and swell without the protection of breakwater or barrier.*

to show that a risk assessment and proper preventive measures had been made when the mooring line was chafed and broken. This was indicated by the Master's arrangement of using an old fire hose to wrap the mooring line as its abrasive guard. Furthermore, there was no enhanced patrolling to closely monitor the mooring situation and timely adjust the mooring lines to avoid the mooring line broken or trapped at the fender, etc.
