**Report of investigation
into the fatal accident on board the
Hong Kong registered oil tanker
“DHT Hawk” at sea
on 29 February 2020**

**The Hong Kong Special Administrative Region
Marine Department
Marine Accident Investigation Section**

9 November 2021

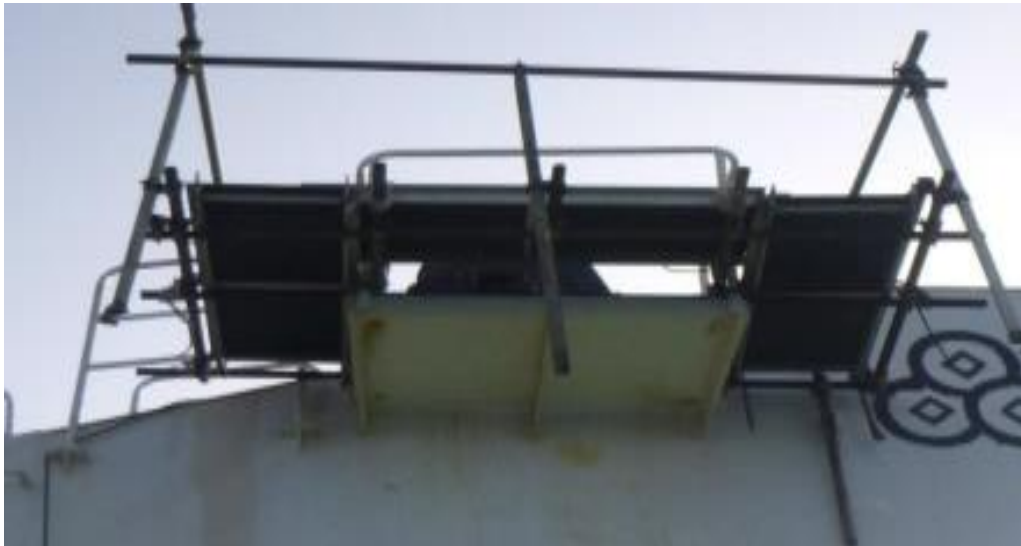
Figure 2 Scaffolding extension rigged to the outboard maintenance platform (Looking Upward)

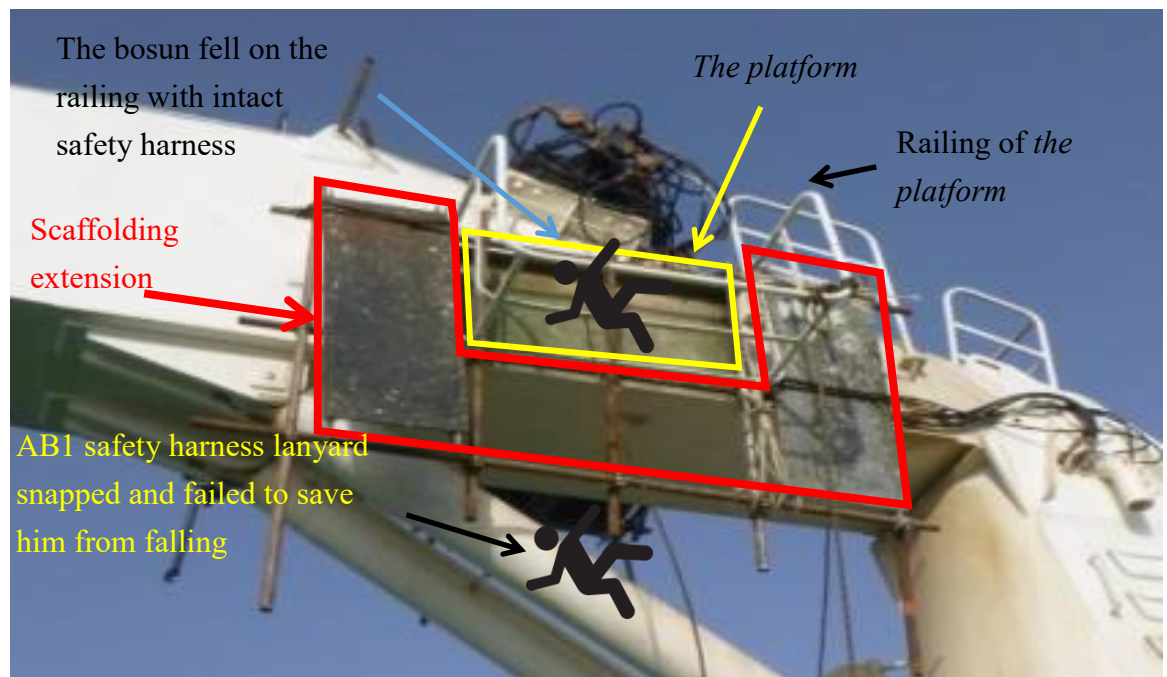
- 3.7 At about 1130 hours, when *the vessel* was approximately in position 22°12.9'N 061°38.2'E, *the platform* suddenly collapsed together with the scaffolding extension (Figure 3). At that juncture, the bosun stood on the inner side of *the platform* while AB1 stood on the outer side of *the platform* close to the railing. With his safety harness anchored at a strong point of the boom, the bosun was able to climb back onto the boom safely. Although AB1 also wore a safety harness anchored at the railing of *the platform*, the safety harness lanyard snapped and failed to save him from falling onto the main deck. AB1 sustained serious injury.

Figure 3 The scaffolding extension together *the collapsed platform* flipped over to the boom of *the crane*.

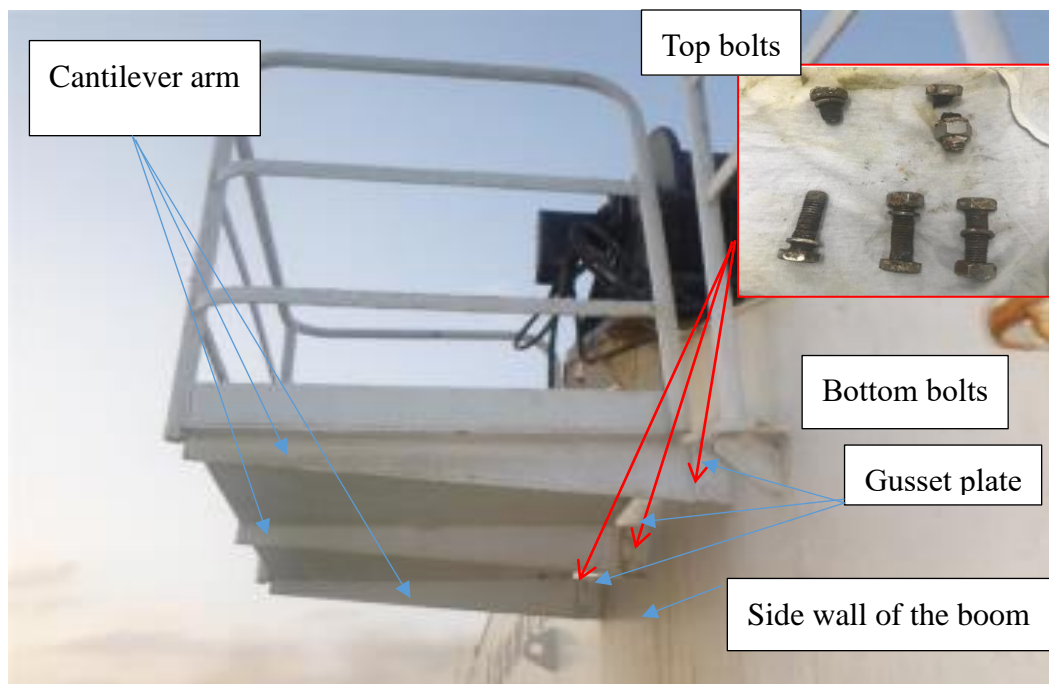
- 4.10 *The platform* was cantilever constructed, and its end was supported by three gusset plates welded onto the sidewall of the boom. Each cantilever arm of *the platform* was secured to the gusset plate by two securing bolts of 12mm in diameter (Figure 4).

Figure 4 *The platform* was secured by two bolts to each of the three gusset plates on the boom.

- 4.11 *The platform* was used for routine maintenance and inspection work of the hoisting motor of *the crane*. After the accident, all the gusset plates top securing bolts were sheared, and the bottom securing bolts remained intact in position. *The platform* collapsed to flip over 90 degrees and hung up on the boom by the bottom securing bolts. Examination revealed that all three top securing bolts were severely

corroded (Figure 4). Two out of the three top securing bolts might be parted by corrosion before the accident. The remaining top bolt had a small fresh fracture surface, indicating that a crack had existed inside the bolt and then propagated rapidly by the weight of the scaffolding extension and the crew. It was conceivable that the paint applied on the surface of securing bolts had hampered the discovery of the cracks of the securing bolts by the crew.

- 4.12 Despite *the crane* had a major repair in 2019, there was no evidence showing that particular attention had been paid to the condition of *the platform* and the securing bolts. If the securing bolts had been diligently checked and renewed before the preparation work, the accident could be avoided.

- (ii) ensure effective implementation of the shipboard SMS, particularly, the maintenance of personal protection equipment and deck fittings.
- 6.2 The management company of *the vessel* should consider revising the SMS documents, if found appropriate, so as to:

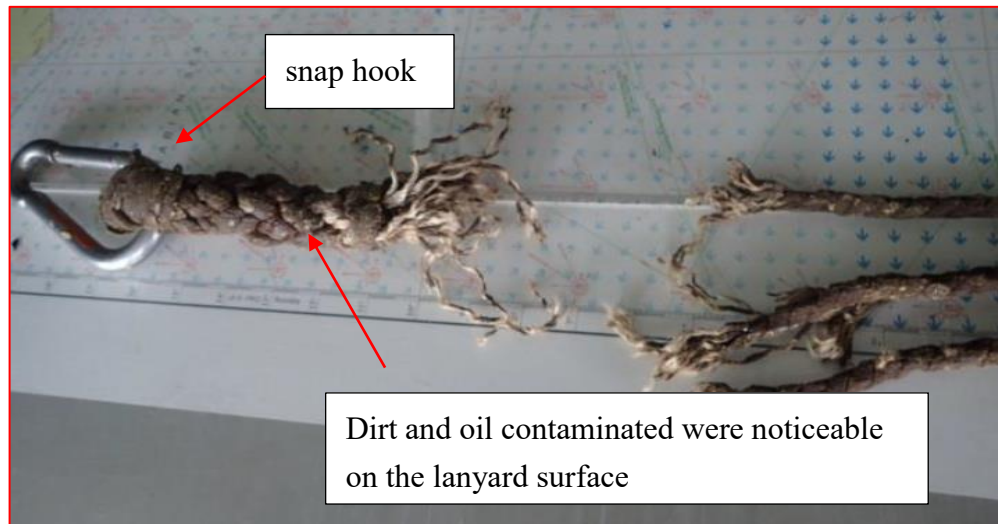
- (i) wrong hooking method of using the snap hook to tie the lanyard on the railing as made by AB1 was not recommended by the manufacturer of the safety harness, since it may reduce the lifting capacity to 75-80%;

- (iii) no safety harness inspection and maintenance record, including the lanyard could be found onboard. Considering the poor appearance of the lanyard, e.g., dirt and oil contaminated (Figure 5), the lanyard was probably out of its service life, and it was picked up by AB1 inadvertently for the work.

Figure 5 The lanyard of AB1

- (i) enhance working procedures, plans and instructions, including checklists as appropriate, for scaffolding work and working aloft;
 - (ii) enhance maintenance and inspection procedures, and safety instructions, including checklists as appropriate, for safety harness; and
