**Report of investigation
into the fatal accident on board the
Hong Kong registered bulk carrier
“*Simon Brother*” at Kupiano,
Papua New Guinea on 27 March 2020**

**The Hong Kong Special Administrative Region
Marine Department
Marine Accident Investigation Section**

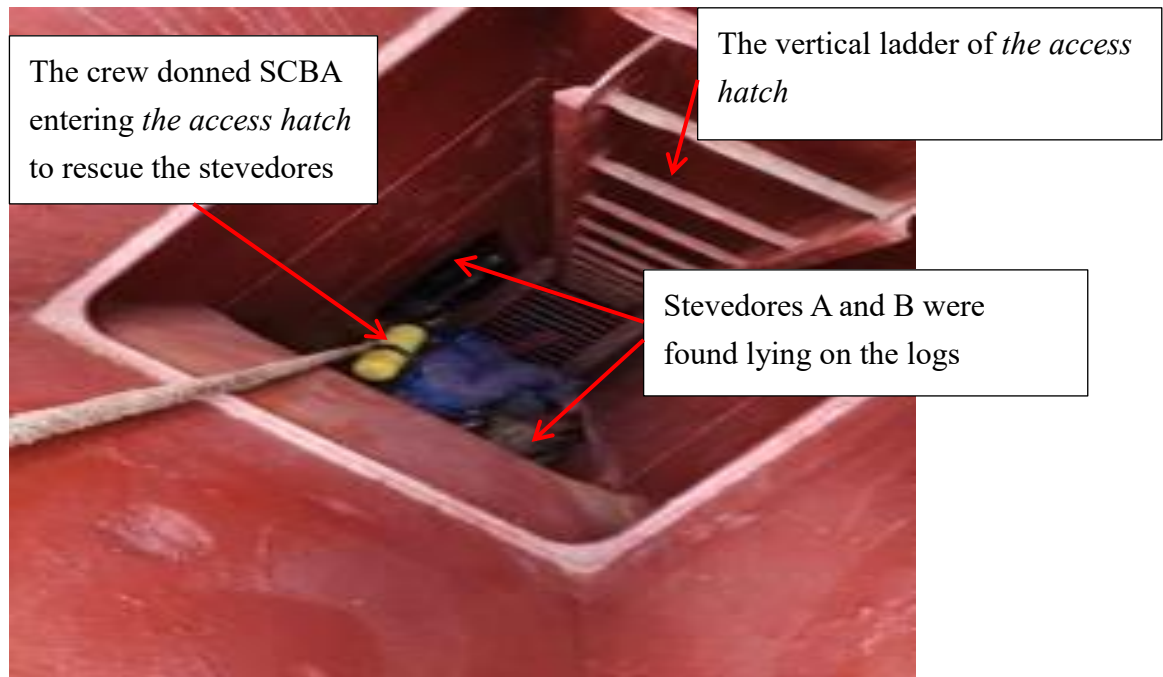
- 3.7 At 0830 hours, a rescue team was organized. Two crew donned self-contained breathing apparatus (SCBA) and climbed down the vertical ladder of *the access hatch* to rescue stevedores A and B. (Figure 2)

Figure 2 The crew donned SCBA to rescue stevedores A and B

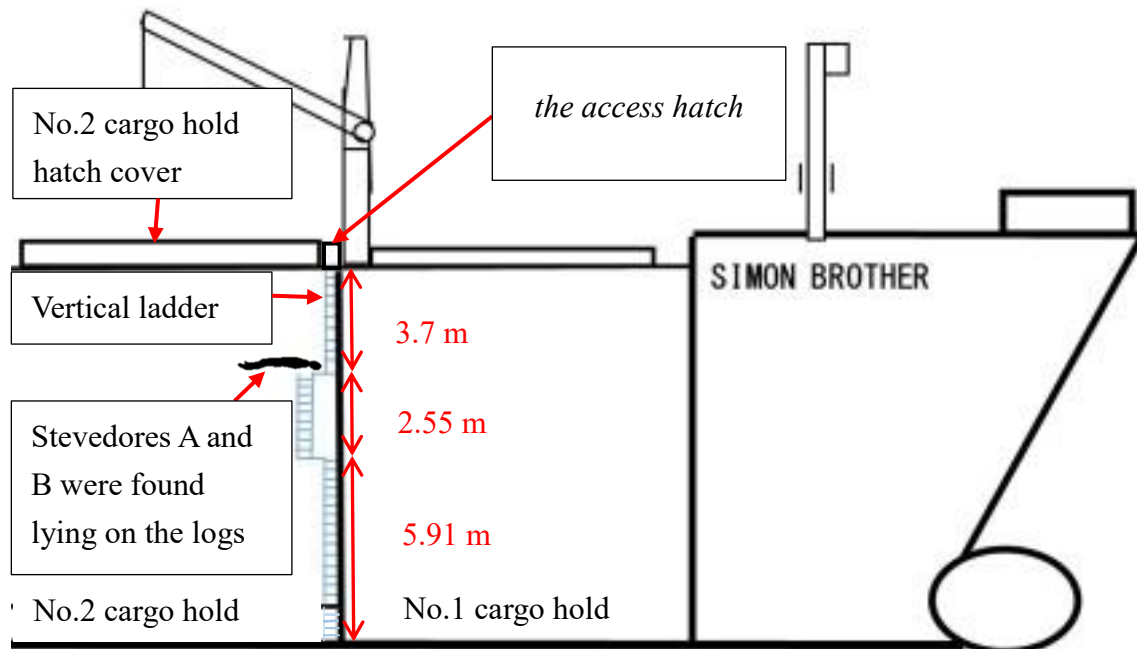
4.9 No. 2 cargo hold was fully loaded with logs. The hatch cover and *the access hatch* had been closed since 19 March 2020. It was likely that oxygen had been depleted and carbon dioxide had also been accumulated inside the cargo hold. Stevedores A and B were found at a location about 3.7 meters under *the access hatch*. (Figure 3)

Figure 3 No.2 cargo hold forward access and vertical ladders

4.10 To prepare for the enclosed space entry and rescue, the crew opened the cargo hold hatch cover and switched on the blower of No.2 cargo hold. The oxygen level then measured at scene by the Third Officer was less than 19%. It may be inferred that when the accident happened the oxygen level of the scene would be much lower and ventilation through *the access hatch* alone was unlikely adequate.

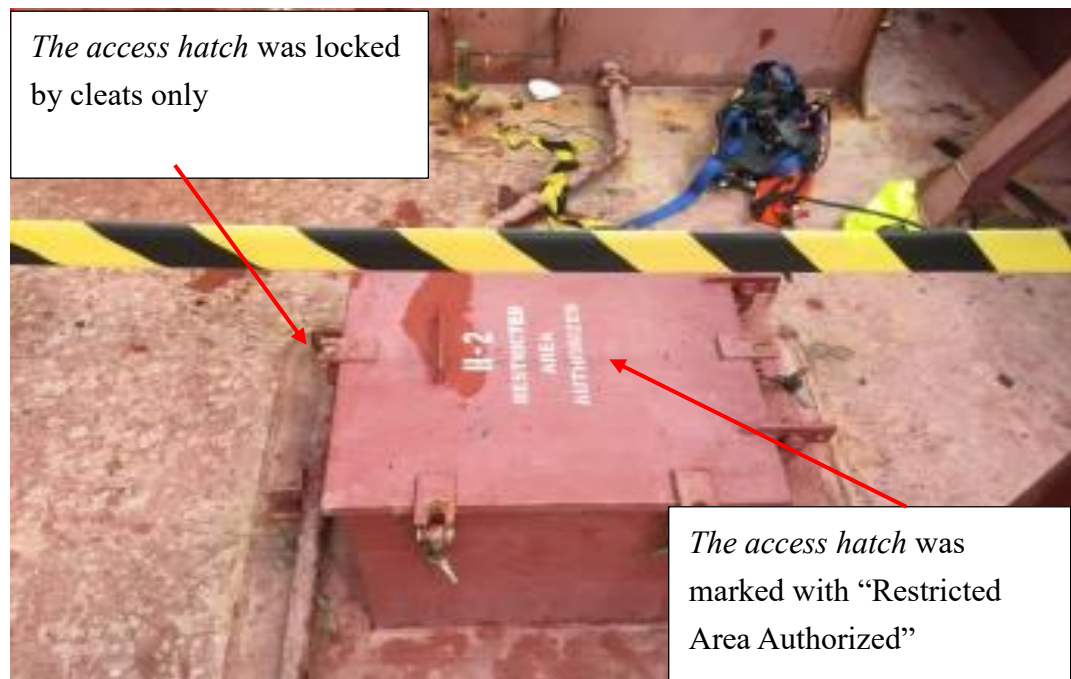
- 4.14 Instead of displaying the marking as the entrance to dangerous space, *the access hatch* only maintained marking “Restricted Area Authorized”, (Figure 4) which did not fully meet the requirement of the Code.

- 4.16 The investigation revealed that *the access hatch* was simply locked with cleats for weathertightness but no preventive device fitted for unauthorized entry. (Figure 4)

Figure 4 *The access hatch*

- 4.17 Despite *the access hatch* was marked with "Restricted Area Authorized", stevedores A and B might be unaware of the associated risk entering such restricted area. Hence, they disregarded the warning notice and entered No.2 cargo hold without authorization. It indicated that the crew did not take reasonable control measures to secure and to prevent unauthorized entry.

- (c) follow the Code, to lock all entrances to all unattended dangerous spaces against unauthorized entry, and mark the entrances to dangerous spaces as applicable if they were readily accessible.
