**Report of investigation
into the fatal accident on board the
Hong Kong registered bulk carrier
“*Victoria Harbour*” at Kwangyang,
South Korea on 16 June 2020**

**The Hong Kong Special Administrative Region
Marine Department
Marine Accident Investigation Section**

24 August 2021

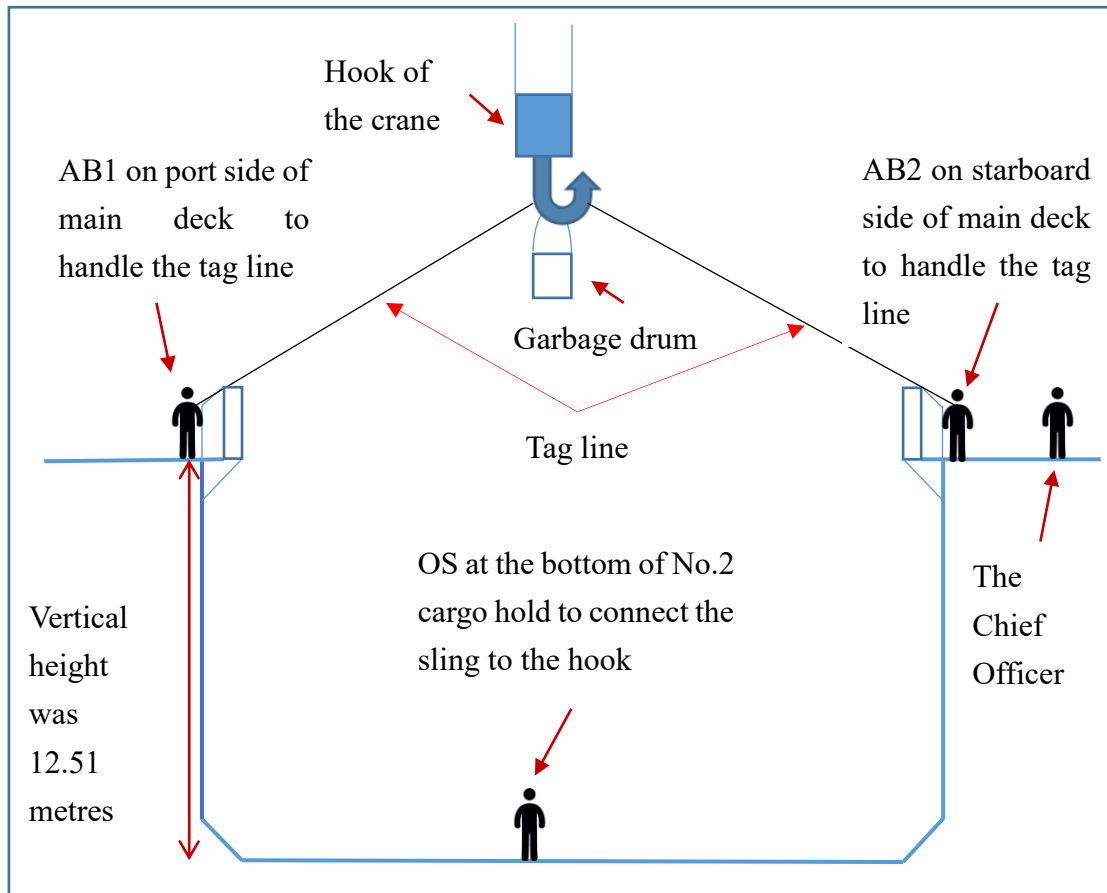
hold with the Bosun stayed in the crane cabin waiting for instructions. The OS stayed at cargo hold bottom to put the sling of the garbage drum to the hook. AB1 and AB2 on main deck besides the longitudinal hatch coaming port and starboard sides respectively were tasked to hold the tag lines (Figure 2). It was planned to place the garbage drum on the main deck starboard side.

Figure 2 Diagram showing the positions of the lifting team members.

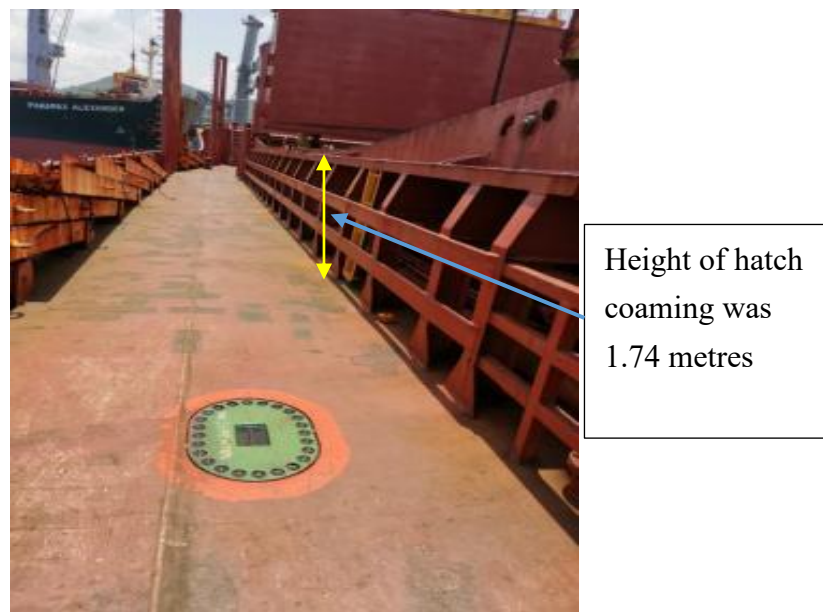
- 4.12 No one witnessed the process of how AB1 had crossed over the portside longitudinal hatch coaming of 1.74 metres high (Figure 3) and fell to the cargo hold bottom. In accordance with OS's statement, he was at the cargo hold bottom watching the lifting and did not see anyone protruding from the top of portside longitudinal hatch coaming. However, OS noticed that the portside tag line was in tension and then at about 8 to 10 seconds later, he saw AB1 flying off sideways to the starboard side. OS's statement indicated that AB1 had been subjected to enormous pulling force in a flash.

Figure 3 Overview on port side main deck.

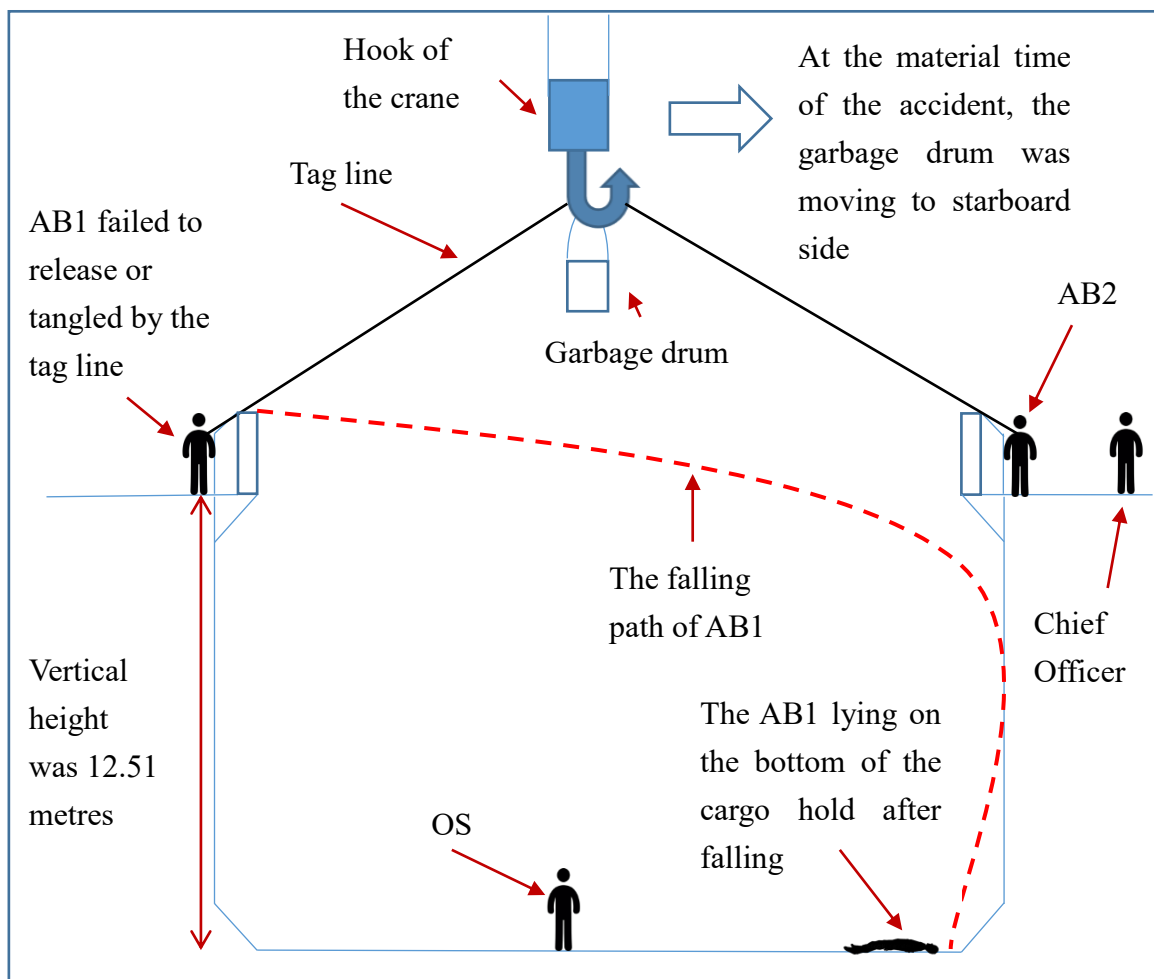
They could only feel the tag line tension and correspondingly release or tighten the lines as appropriate in order to prevent the drum from swinging. In the accident, AB1 might have no sufficient time or be lack of skill to control the tag line and keep the tag line clear from himself. It was likely that AB1 might fail to release the tag line in time or suddenly be tangled by the tag line when the latter was abruptly tensioned by the fast slewing crane without any warning. Consequently, AB1 was hauled by the tag line resulting in pulling him over the portside longitudinal hatch coaming and subsequently falling down to the cargo hold bottom. (Figure 4)

Figure 4 Simulation the falling path of the AB1
