**Report of investigation
into the fatal accident of a fitter on
board the Hong Kong registered gas
carrier “*Pacific Mars*” at sea on 27
July 2020**

**The Hong Kong Special Administrative Region
Marine Department
Marine Accident Investigation Section**

23 August 2021

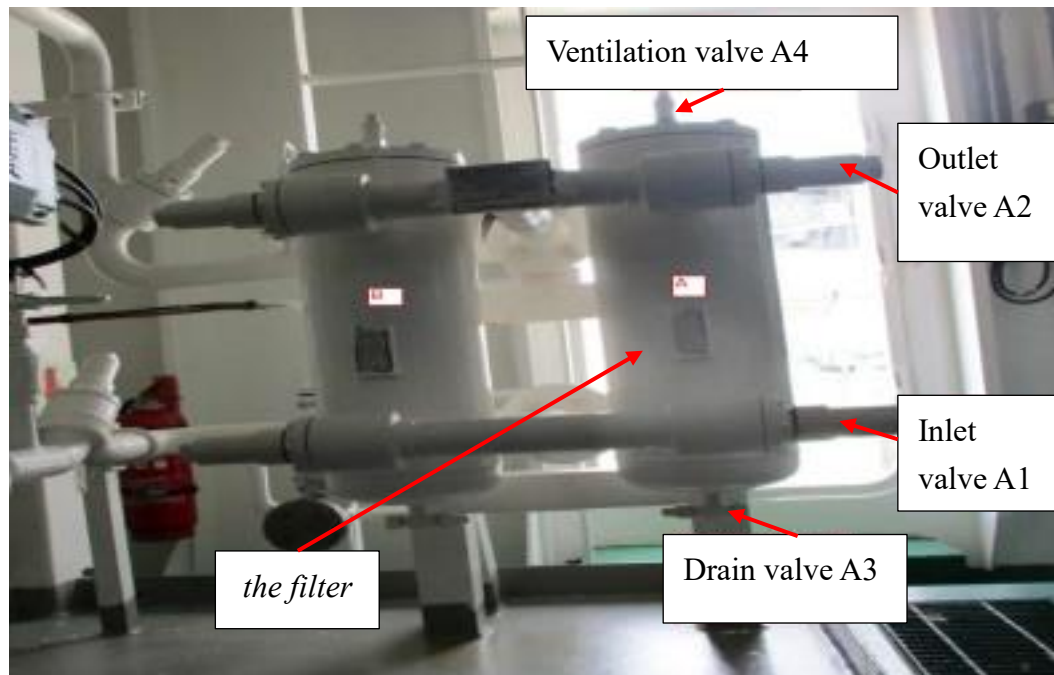
- 3.3 At about 0820 hours, the deck fitter and *the trainee* went to the compressor & motor room to carry out the planned maintenance job to replace the filter element. The deck fitter ordered *the trainee* to isolate *the filter* by closing the inlet valve A1 and outlet valve A2. The deck fitter checked and confirmed that the valves were in a fully closed position by using a spanner. He then opened the drain valve A3 to drain the oily effluent and release the pressure inside *the filter*. Upon noticing no effluent spout from the drain valve A3, the deck fitter closed the valve and opened the ventilation valve A4 to release pressure inside *the filter* (Figure 2).

Figure 2 Overview of *the filter*

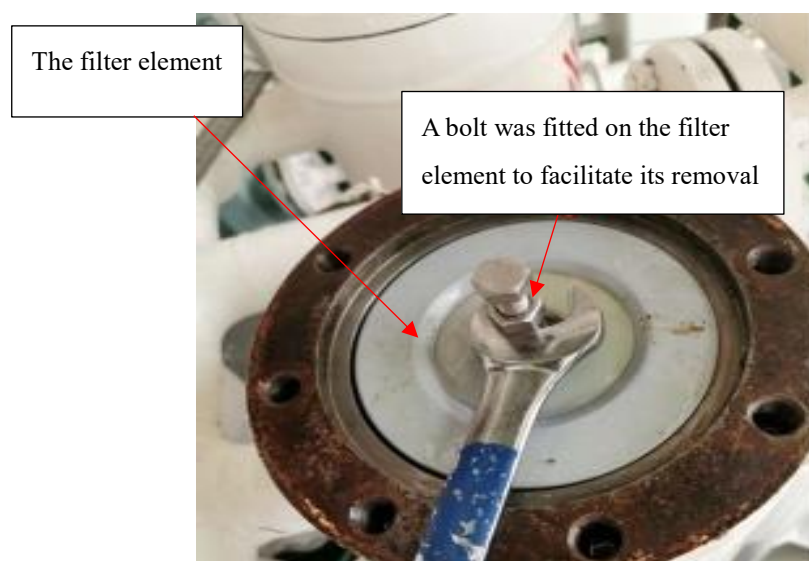
- 3.4 After noticing that there was no gas emitted from the ventilation valve A4, the deck fitter commenced to slacken the bolts and removed the top cover of *the filter*. The deck fitter then screwed down a bolt onto a nut attached to the top of the filter element in order to lift up the filter element by hand but in vain (Figure 3). The filter element was jammed hardly in *the filter* and failed to be taken out. Subsequently, the deck fitter took a crowbar trying to lift the filter element but also failed.

Figure 3 Top view of the filter element with the gasket removed

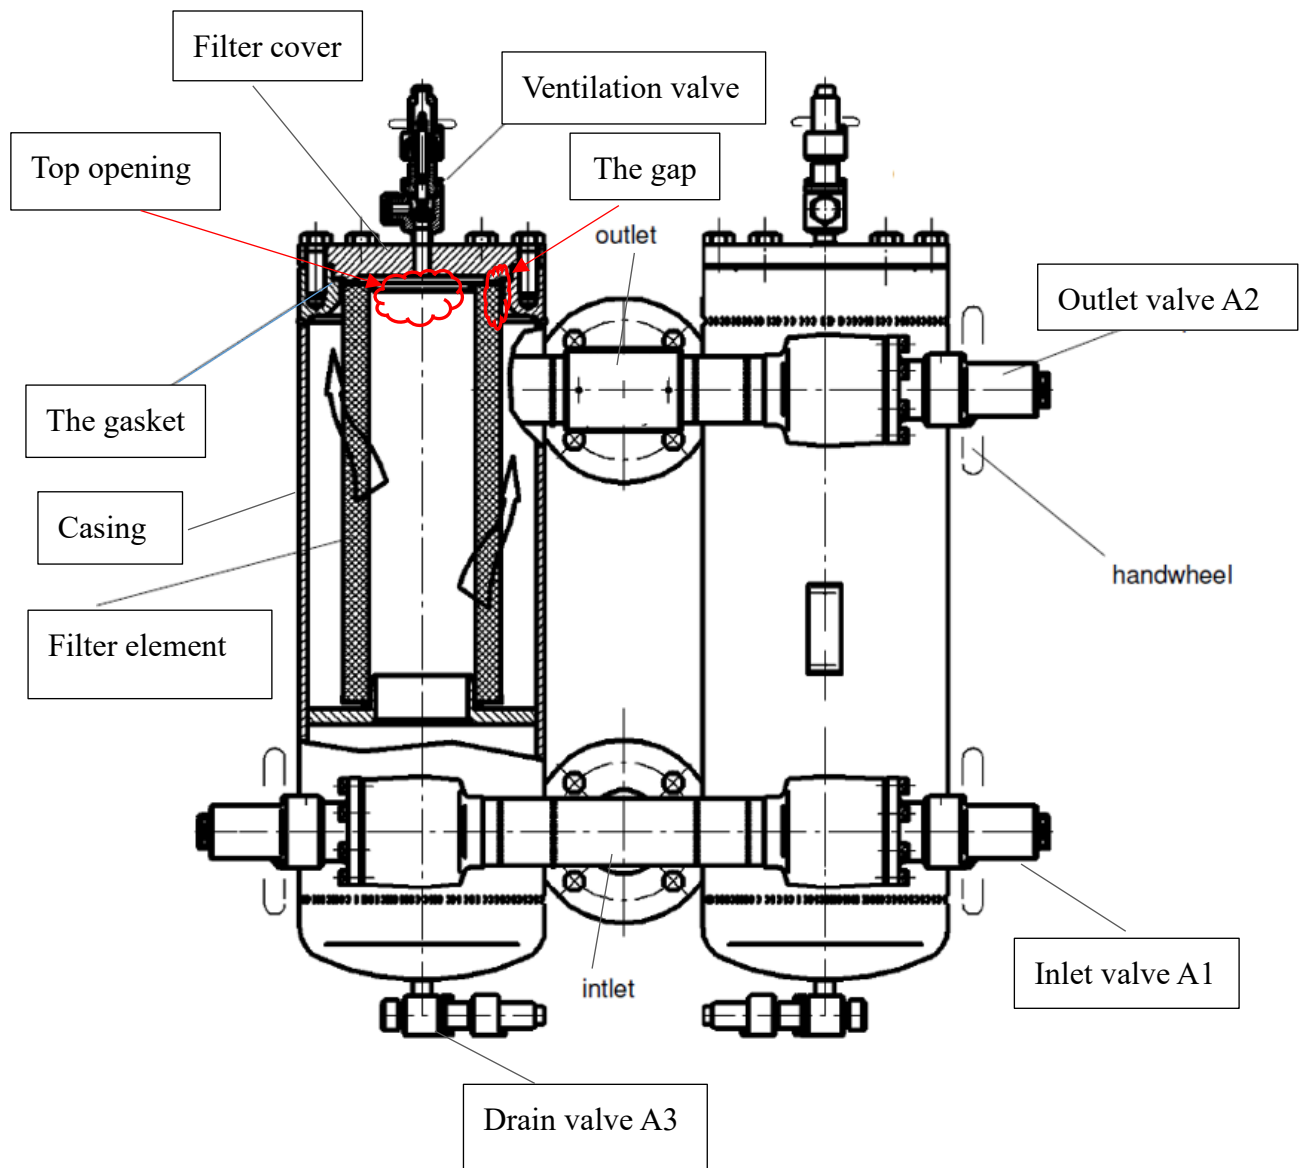
- 4.14 The cross sectional diagram of *the filter* assembly as shown in figure 4 indicating that a ventilation valve A4 was fitted on the filter cover. Of the gap between the filter cover and the casing, a gasket was placed such that the gasket would be compressed and embedded with its inner periphery into the gap when the top cover was closed and tightened by bolts. In doing so, the gasket separated the interconnection between the inlet and outlet sides of *the filter* forcing refrigerant to pass through the filter element and preventing the refrigerant from leakage.

Figure 4 The cross sectional diagram of *the filter* assembly

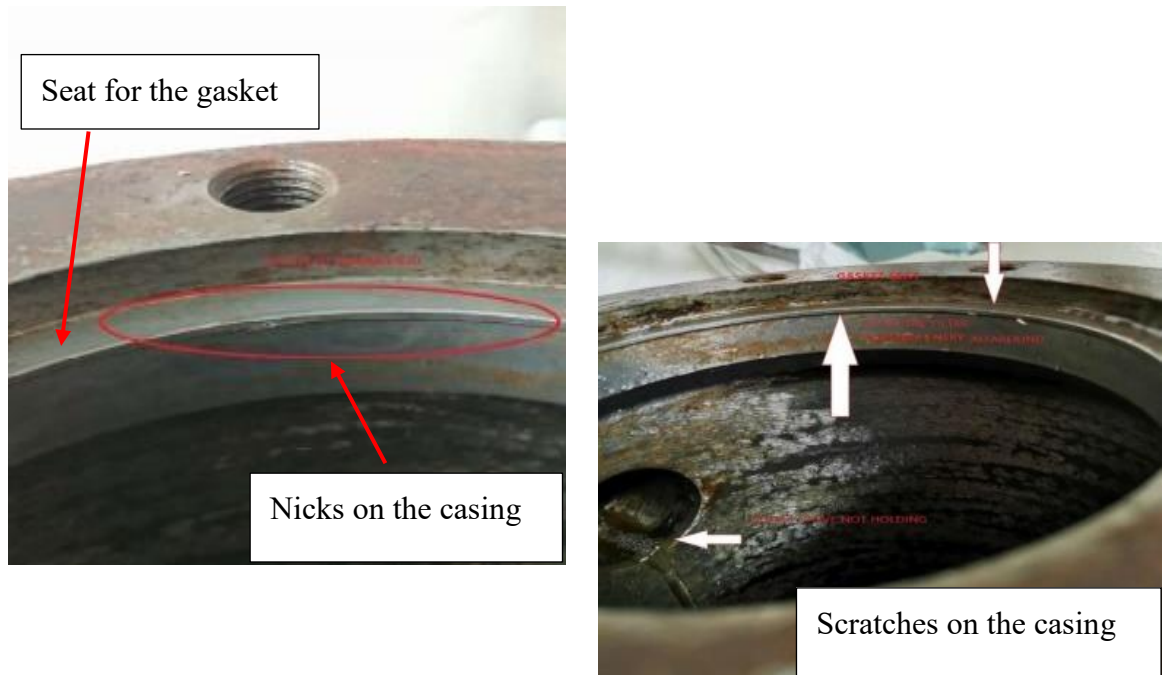
- 4.15 The investigation noticed that some minor damages, including nicks and scratches, were found on the casing in the way of the gasket. These might be caused by the crew during routine maintenance or by the filter element being tilted to one side during assembling (Figure 5).

Figure 5 Minor damages on the casing of *the filter*.

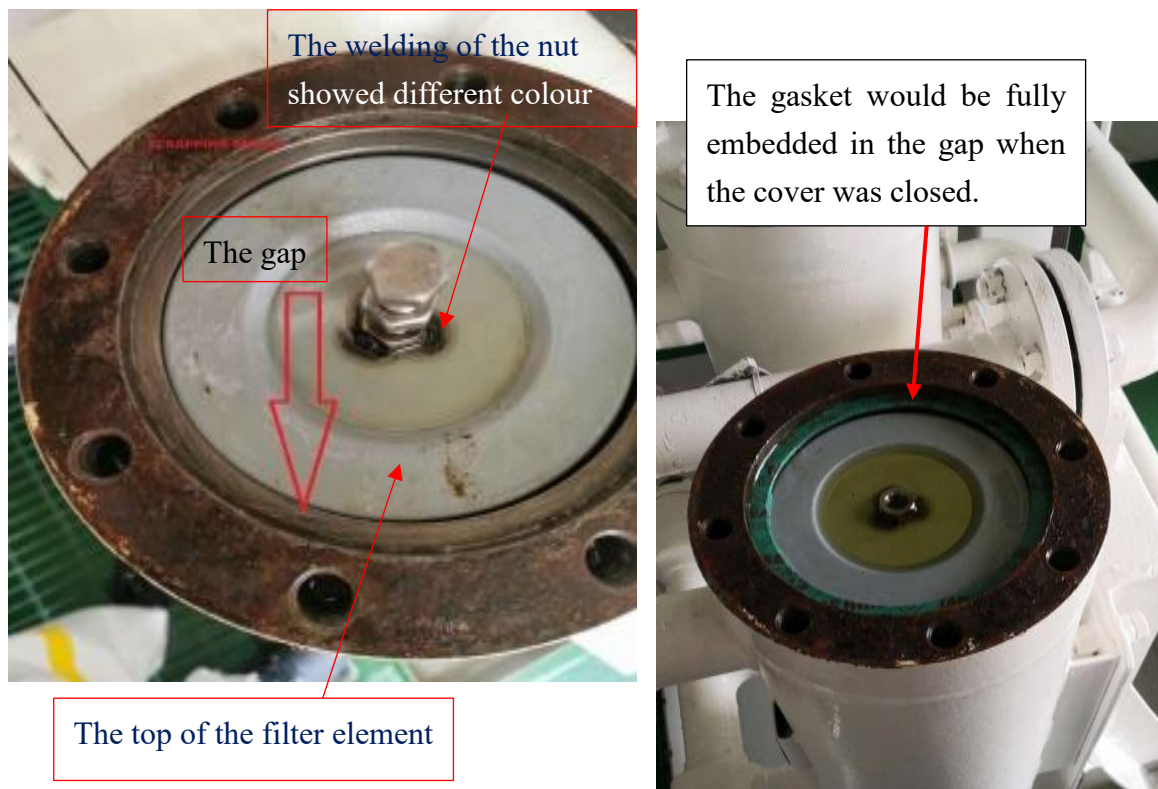
4.17 The top of the filter element was welded with a nut to facilitate lifting up the filter element in normal routine maintenance (Figure 6). However, the presence of the nut did not match the top part design as shown in the maker's manual (Figure 4). It could not be determined if the nut was a design feature from the maker.

Figure 6 Top view of *the filter* when opened

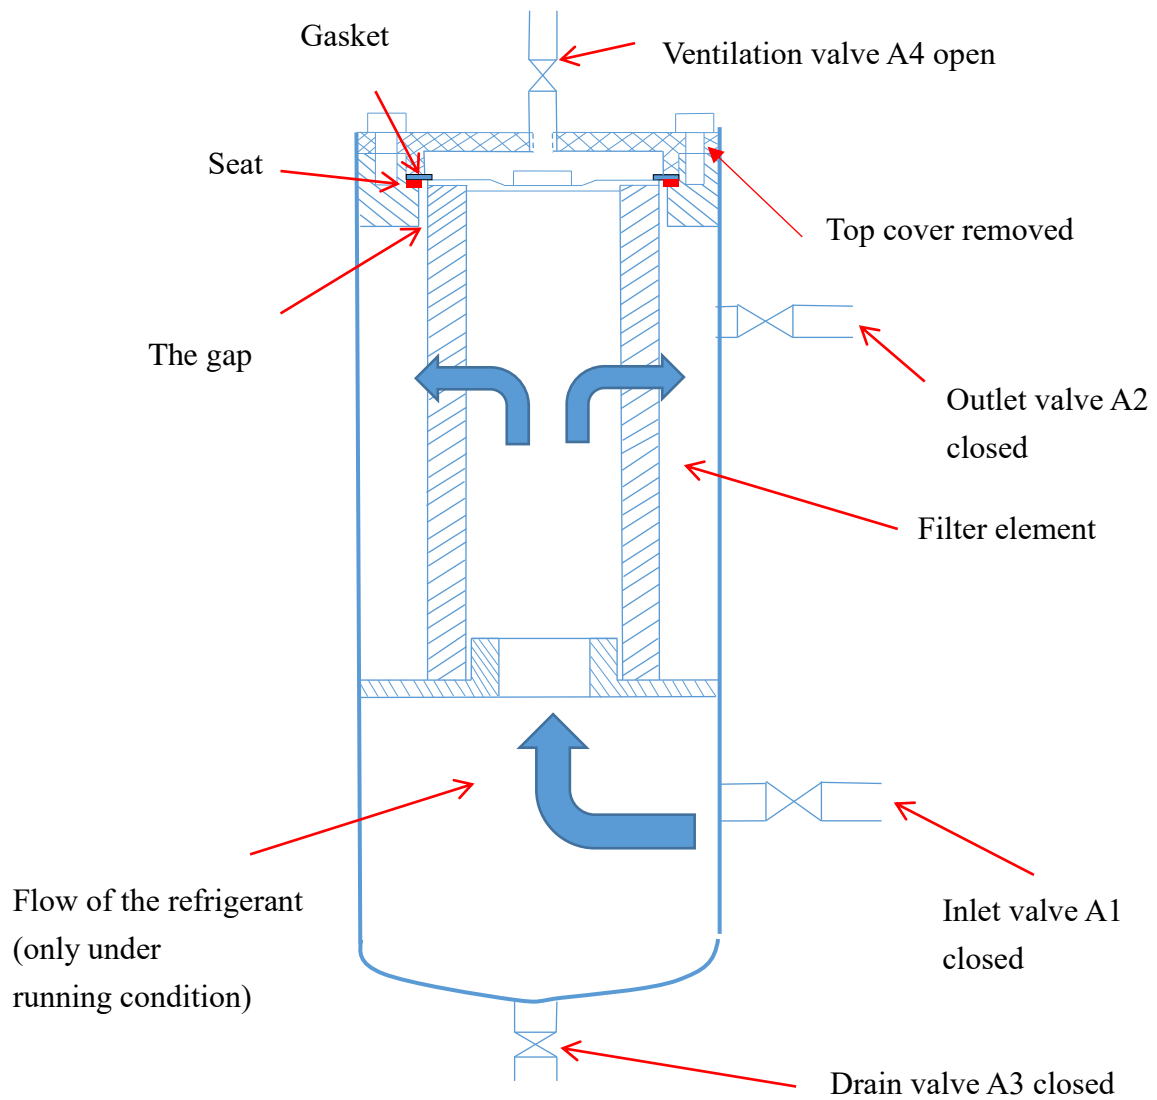
- 4.18 Figure 7 shows the cross section of *the filter* with the valves' positions during the maintenance. According to the maker's manual, the drain valve A3 and the ventilation valve A4 should be kept open when replacing the filter element. However, the deck fitter had closed the drain valve A3 in the maintenance (Figure 7).

Figure 7 Cross section of *the filter* with valves' positions during the maintenance

- 4.19 With the inlet valve A1, outlet valve A2, and the drain valve A3 in closed position, the residual oil and the refrigerant inside *the filter* would generate refrigerant vapour which could build up pressure inside the filter element. As sealed by the gasket, the gas pressure inside *the filter* could not be released properly even though the ventilation valve A4 was opened and that the cover of *the filter* was removed.

- 4.20 When the deck fitter tried to scrap the gasket, he might accidentally free the gasket thus releasing the gas pressure in a sudden to eject the filter element. As a result, the deck fitter was hit by the filter element on his forehead and died.
- 4.21 In accordance with the safety instructions of the maker manual, the drain valve A3 should be kept in open position in order to ensure that the filter casing was depressurised and adequately ventilated when replacing the filter element. However, these instructions were not followed possibly due to insufficient safety awareness and underestimating the risk of replacing filter element.

- 6.1 The management company of *the vessel* should issue circulars informing all Masters, officers, and crew of its fleet of the findings of the investigation and lessons learnt from this accident, and instruct them to:
- (a) conduct maintenance work for refrigeration system strictly in accordance with the maker's safety instructions; and
 - (b) enhance the safe working practices onboard, especially to ensure that any pressurised equipment and system should be completely depressurised before the commencement of maintenance work.
- 6.2 A Hong Kong Merchant Shipping Information Note is to be issued to promulgate the lessons learnt from this accident.
