**Report of investigation into
the fatal accident on board
the Hong Kong registered bulk carrier
“*Shandong Hai Yao*” at Port Dickson,
Malaysia on 19 August 2020**

**The Hong Kong Special Administrative Region
Marine Department
Marine Accident Investigation Section**

21 December 2021

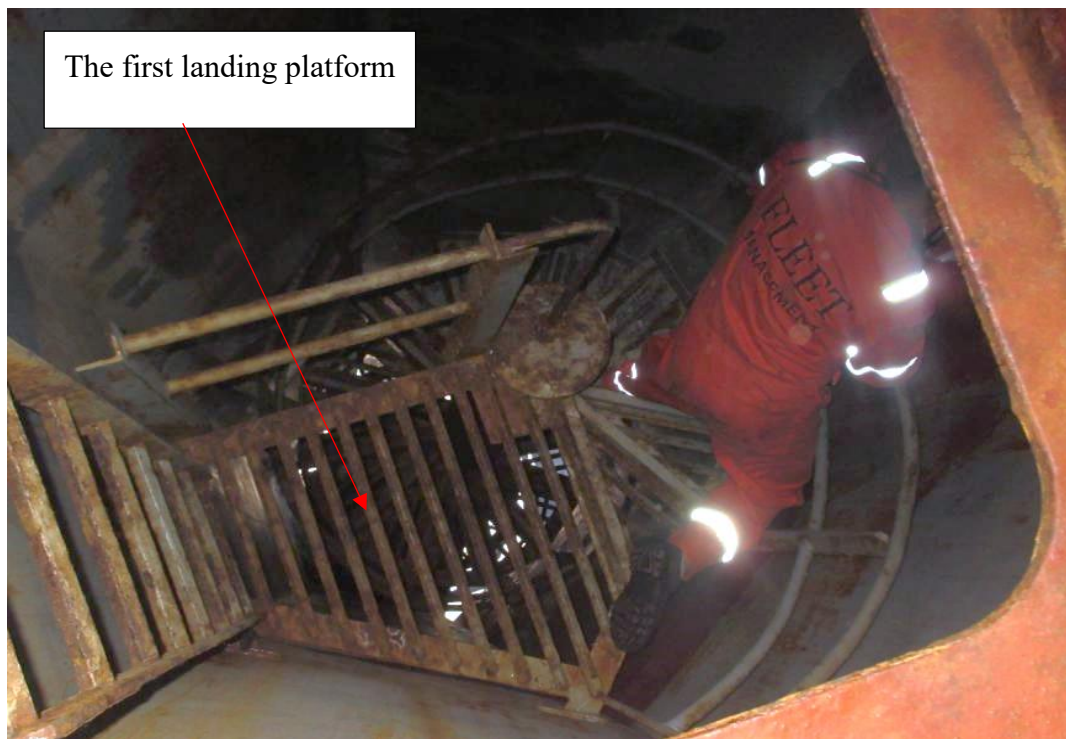
- 3.9 Accommodation area and the Bosun's cabin were searched without findings. At around 1040 hours, when the C/O and the 3/O searched the main deck area, they found *the forward access* was opened and they saw the Bosun lying on the first landing platform about 2.5 metres under the hatch (Figure 2).

Figure 2 The first landing platform where the Bosun's body was found

- 3.10 An enclosed space rescue team was summoned and successfully lifted the Bosun's body out of the cargo hold. In the rescue, it was observed that the safety helmet chin strap was still in place on the Bosun's chin, but the safety helmet was broken and partly fell off. There was an open wound on the Bosun's forehead and the Bosun's body was cold and rigid.
- 3.11 Although first aid treatment was applied, the Bosun did not show any vital signs. Eventually, his body was permitted to land ashore on 21 August 2020.

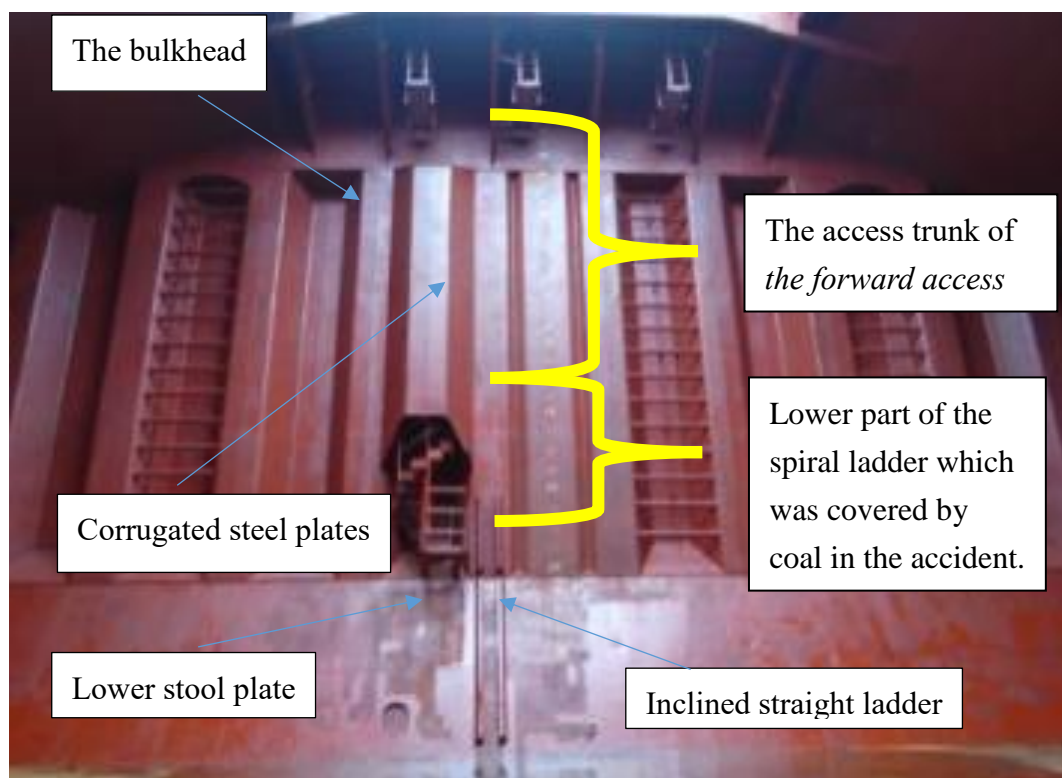
- 4.9 The ladders of *the forward access* comprised a vertical ladder linking between the access hatch and the first landing platform inside No.7 cargo hold. Then a spiral ladder led from the first landing platform to reach the lower landing platform fitted on the lower stool. Connecting the lower landing platform to the cargo hold bottom was an inclined straight ladder (Figure 3).

Figure 3 *The forward access*

- 4.10 When the Bosun entered the No.7 cargo hold through *the forward access*, the cargo hold was fully loaded and the access trunk bottom was completely blocked by coal. As such, the inside of the access trunk was an enclosed space.

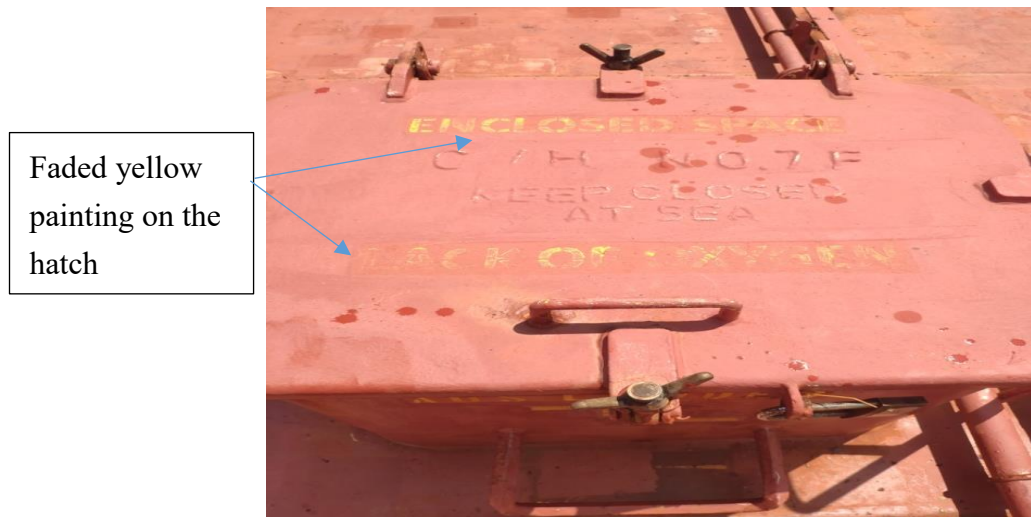
- 4.16 In fact, the letters “ENCLOSED SPACE” and “LACK OF OXYGEN” were painted in yellow on the hatch of *the forward access* (Figure 4). However, the painting had faded and hence was difficult to draw the crew attention to it. The Bosun might therefore consider that *the forward access* was safe for entry as the cargo hold was fully opened without realizing that the access trunk was still an enclosed area. As a result, the Bosun opened the padlock and entered the access trunk of *the forward access* without seeking a work permit from the C/O or the Master, resulting in his death.

Figure 4 The hatch of *the forward access*
