**Report of investigation into
the man overboard accident on board
the Hong Kong registered bulk carrier
“*King Loong*” at Malacca Strait
on 20 August 2020**

**The Hong Kong Special Administrative Region
Marine Department
Marine Accident Investigation Section**

24 August 2021

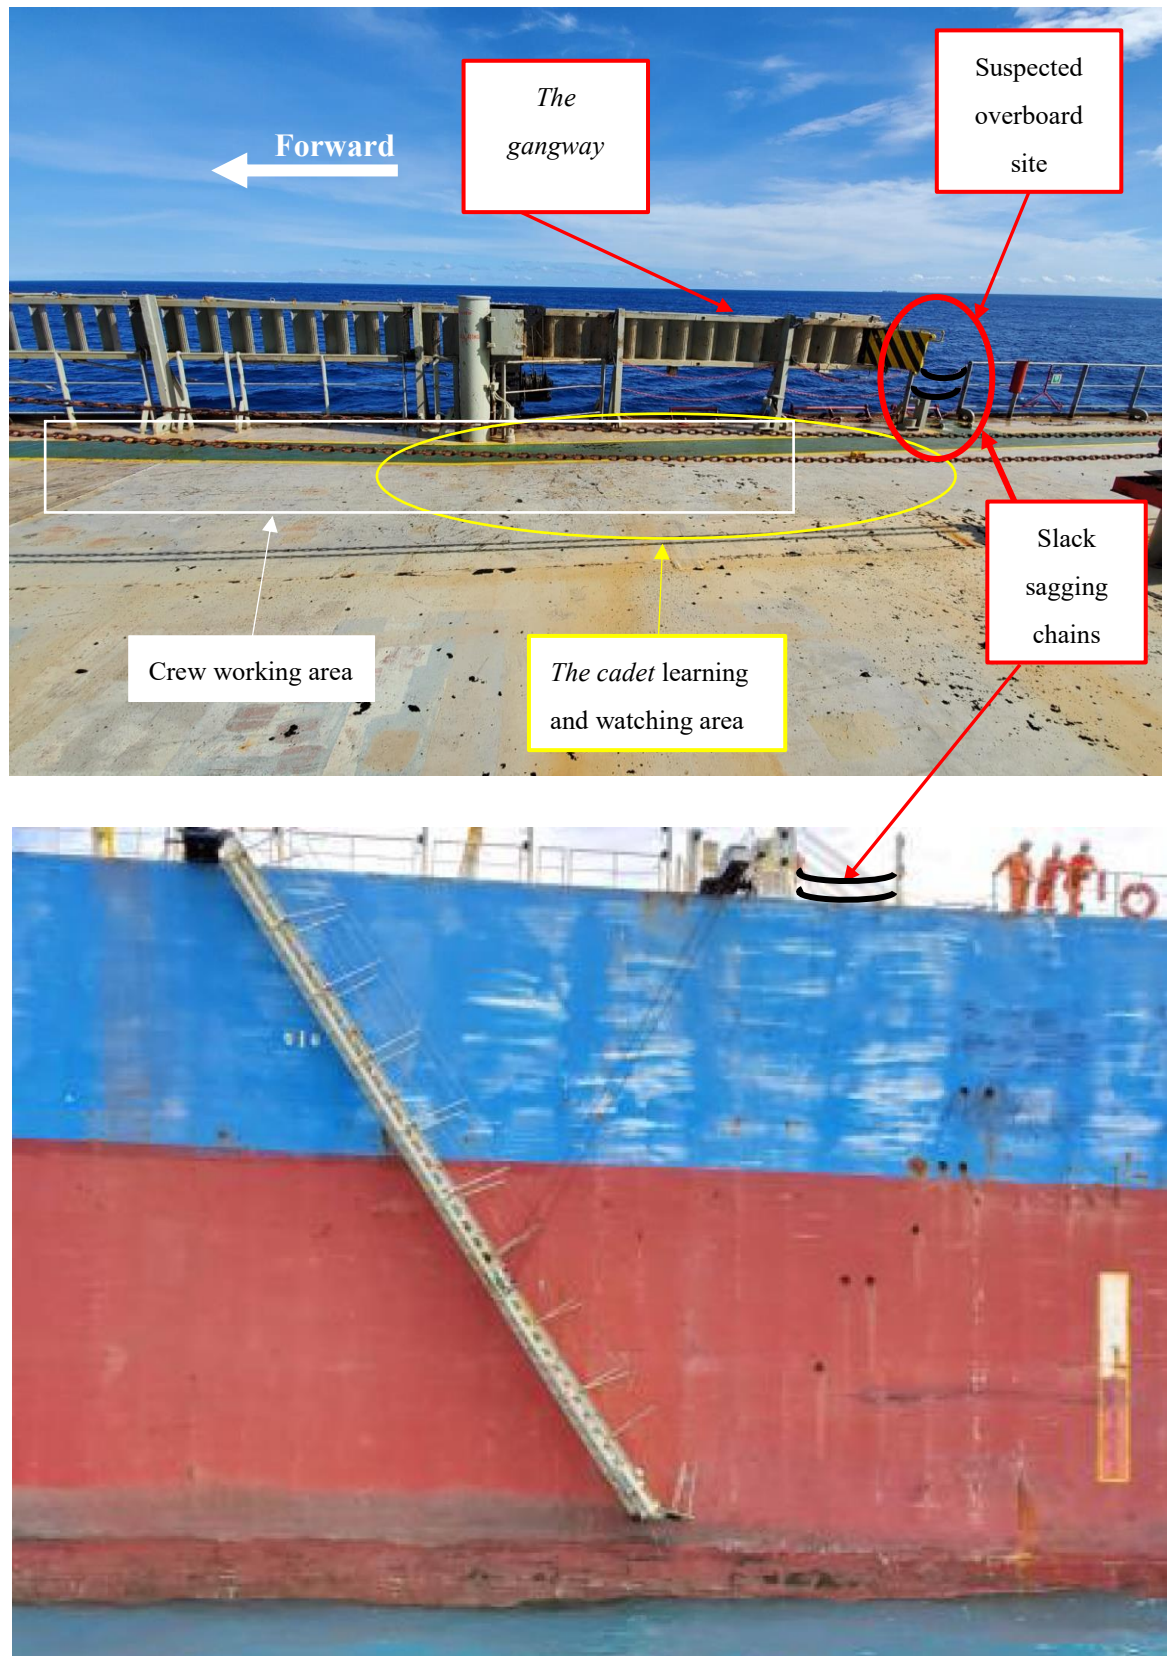
- 4.10 *The vessel* appeared to meet the above regulation in such a way that certain guard rails around *the gangway* on the main deck were replaced by chains (Figure 2), since it was necessary for lowering *the gangway*, to facilitate normal operation of *the vessel*.

- 4.11 The investigation, however, revealed that the chains running through the guard rail stanchions were sagging that failed to comply with the above regulation to give protection of at least 1 metre from the deck. Therefore the arrangement of the shipside guard rails should not be considered as in full compliance with the LLC.

Figure 2 *The gangway and the suspected overboard site*

- 4.12 Nobody noticed how *the cadet* fell overboard. The suspected spot where *the cadet* fell overboard was located just at the aft end of *the gangway* (Figure 2). Without sufficient experience and supervision, *the cadet* could have been unaware of the hazard and leaned on to the chains instead of the fixed guard rail, thus causing him to lose his balance falling overboard.

- 5.2 The investigation identified the following contributory factors:
- (a) the use of chains for the replacement of shipside guard rails was set at a sagging position, thus failing to comply fully with the LLC Regulation 25 “Protection of the Crew” in respect of the height requirement;

- (a) ensure effective guard rails for the shipside openings in complying with the Load Lines Convention in order to provide better protection in preventing the crew from falling overboard;

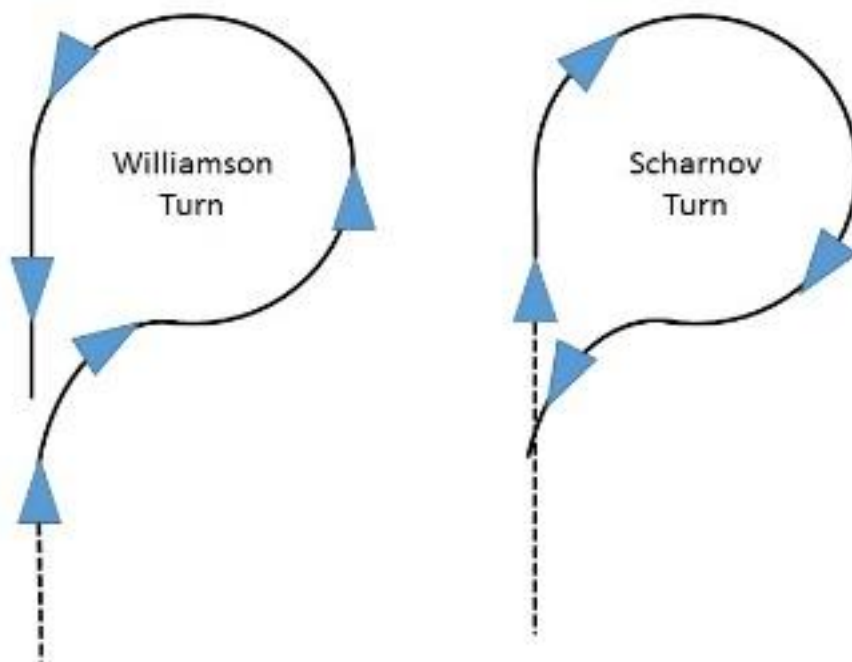
Scharnov turn or Williamson turn (Figure 3) as an alternative when a man overboard happened at night.

Figure 3 Williamson turn and Scharnov turn

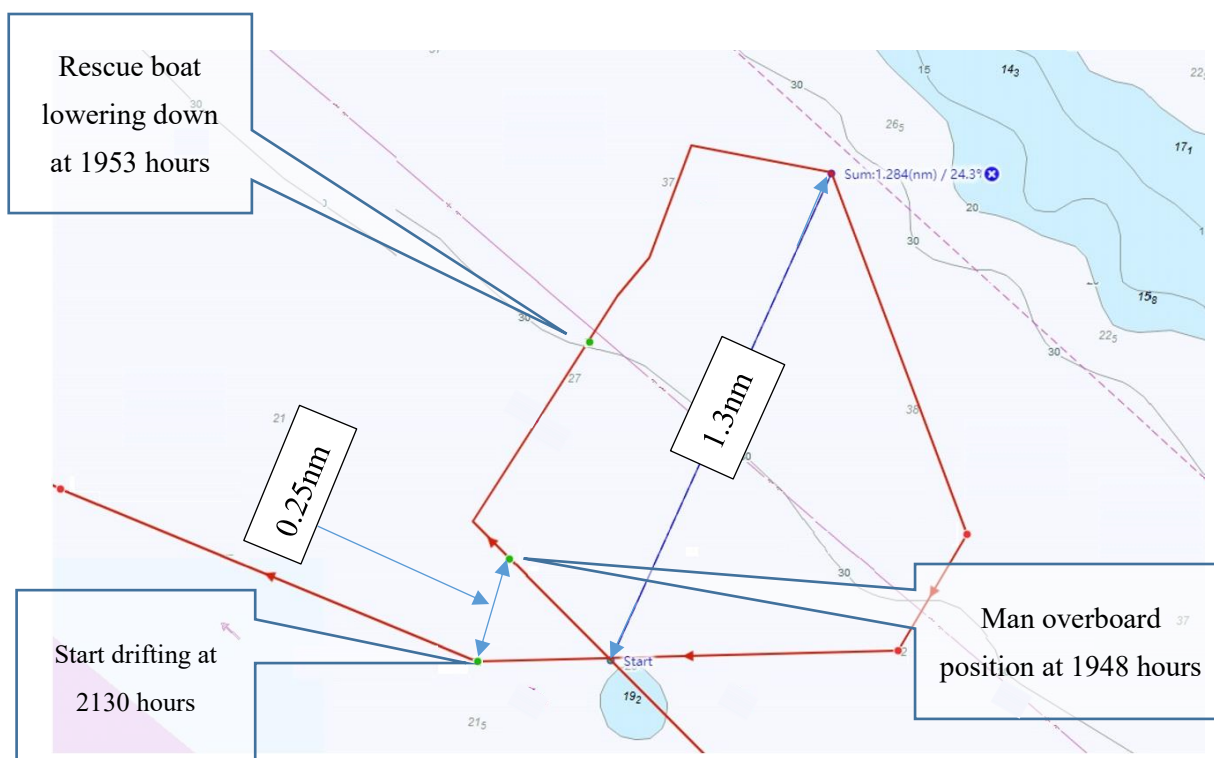
- (a) as the sunset began after 1900 hours on the accident day, *the vessel* might consider following either the Scharnov turn or the Williamson turn depending on the field of vision. However, the AIS⁴ record of *the vessel* (Figure 4) showed that *the vessel* followed neither the Scharnov turn nor the Williamson turn for conducting the search and rescue operation;
- (b) whilst failing to follow *the plans and procedures* for search and rescue operation, *the vessel* was busy to lower rescue boat instead; and
- (c) as *the vessel* failed to conduct search and rescue operation in a proper manner, she only managed to return to the location around the man overboard position about 90 minutes later. The prolonged time of returning to the man overboard position had minimized the chance of finding the missing cadet.

Figure 4 AIS record of *the vessel* from 1948 hours to 2130 hours

- 5.3 The investigation also revealed that *the vessel* did not manage to return to the man overboard position as soon as possible for better search and rescue in accordance with *the plans and procedures* of IAMSAR as adopted by the SMS. It was also found that the permit-to-work of the SMS did not fully meet the relevant requirements of the COP.

- (c) enhance familiarization with the permit-to-work procedures and safety instructions on working over shipside; and
 - (d) enhance man overboard rescue training and drill.
