**Report of investigation  
into the fatal accident on board the  
Hong Kong registered bulk carrier  
“Tokyo Spirit” at sea on 2 September  
2020**

**The Hong Kong Special Administrative Region  
Marine Department  
Marine Accident Investigation Section**

21 December 2021

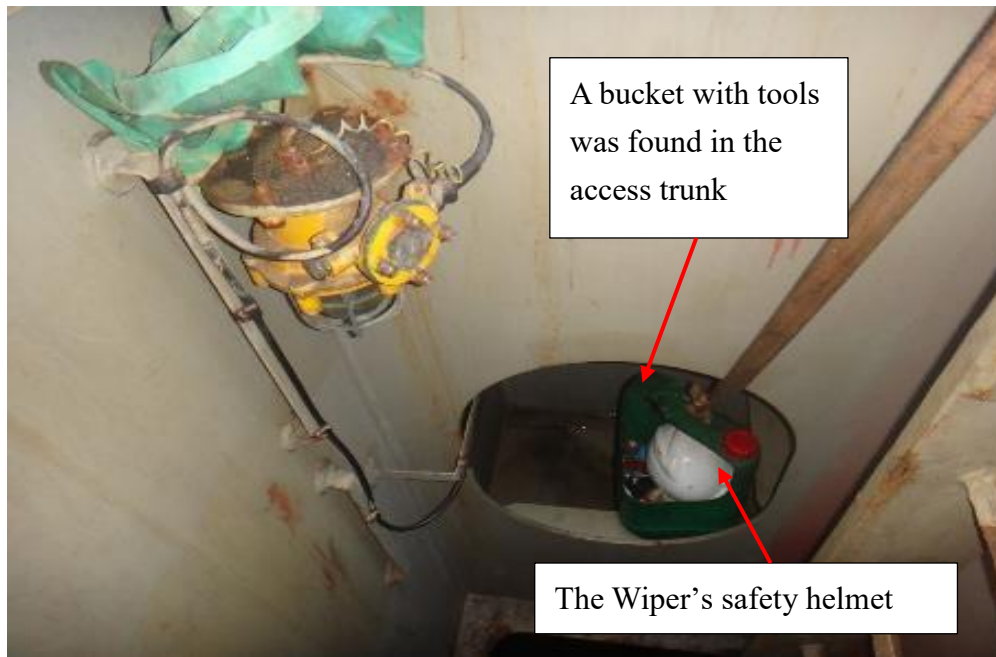
Figure 2 No.2 cargo hold forward access trunk

- 3.6 After the lunch at about 1135 hours, the Master, the 2/E, and the 4/E started looking for the Wiper by searching on the deck of *the vessel*.
- 3.7 At about 1143 hours, the Master spotted that the hatch of No.2 cargo hold forward access (*the forward access*) was opened and a bucket with tools could be observed inside the access trunk from *the forward access* (Figure 2). The Master believed the Wiper was probably inside the No.2 cargo hold and asked the 2/E to inform the duty officer on the bridge to activate the enclosed space rescue operation.

- 3.8 At about 1145 hours, when *the vessel* was approximately at position  $41^{\circ}36.6'N$   $175^{\circ}33.9'W$ , the Third Officer (3/O) as the duty officer on the bridge raised an emergency alarm and summoned a search and rescue team through the public address system. Afterwards, the crew mustered on the deck beside *the forward access* to prepare for the enclosed space rescue operation. The Bosun and the Fitter donned the self-contained breathing apparatus to enter No.2 cargo hold through *the forward access* to search for the Wiper. Finally, they found the Wiper lying on the scrap metal cargo beside the vertical ladder of the No.2 cargo hold.

- 4.16 The Wiper did not follow the shipboard enclosed space entry procedure and entered the No.2 cargo hold without informing any crew members on board. Eventually, the Wiper was defeated by the oxygen depletion and the high carbon monoxide concentration resulting in his fatality inside the cargo hold. It was probable that the Wiper had inadequate safety awareness and underestimated the risks of working inside the No.2 cargo hold.
