**Report of investigation into  
the fatal accident on board  
the Hong Kong registered  
general dry cargo ship “*CSC Rui Hai*”  
at Changshu, China on 21 September 2020**

**The Hong Kong Special Administrative Region  
Marine Department  
Marine Accident Investigation Section**

04 January 2022

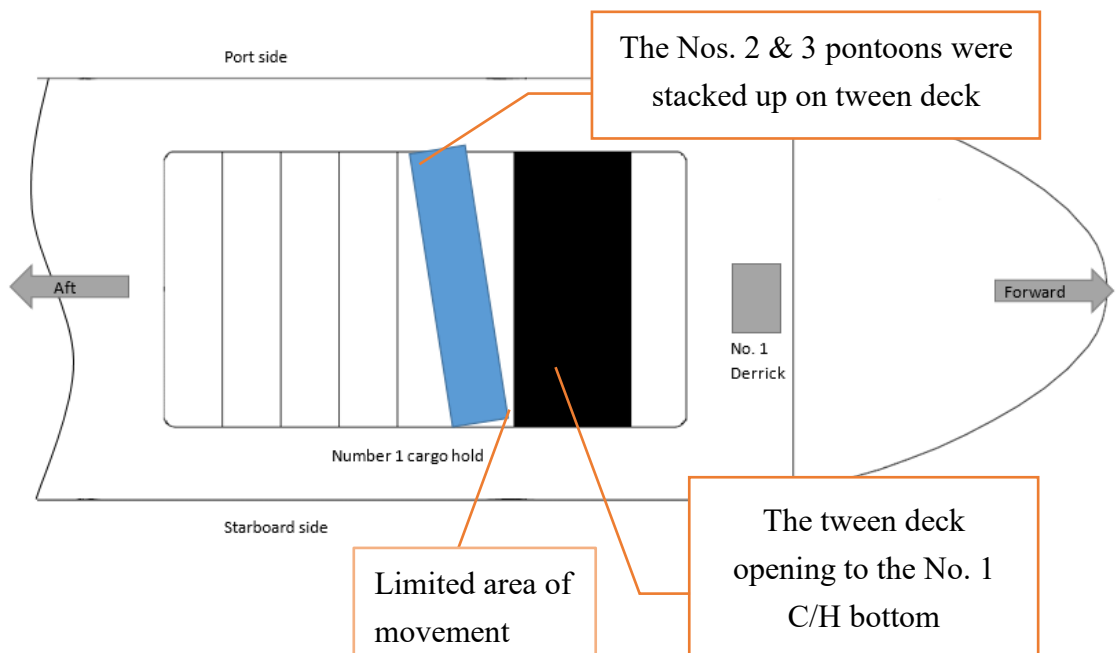
- 3.7 The Bosun entered the No. 1 C/H and saw that the Nos. 2 and 3 pontoons counting from forward were stacked up and placed on top of the No. 4 pontoon. Since the pontoons were not placed in parallel to port-starboard direction, only a limited area was left at the starboard forward corner for personnel movement (Figure 2). At around 0200 hours, the C/O, the Bosun and *the testing crew* gathered on deck for a toolbox meeting. The C/O briefed the Bosun and *the testing crew* that the two stacked up pontoons should be lifted together by the derrick. The AB3 was assigned to operate the derrick.

Figure 2 Layout of the pontoons on tween deck in the No. 1 C/H

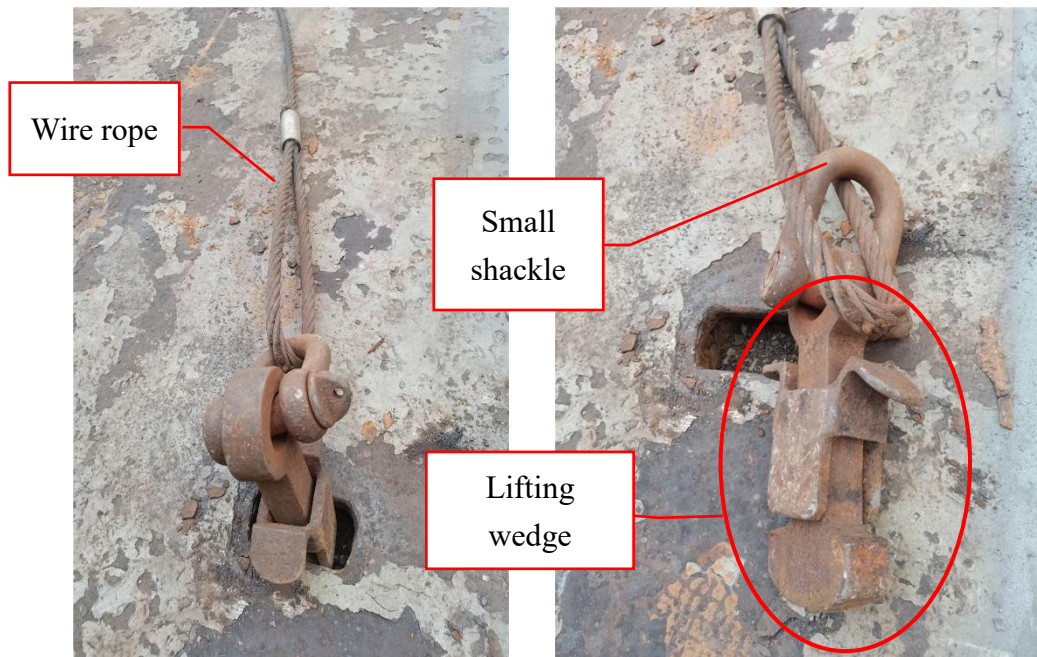
- 3.8 Since *the vessel* was scheduled to depart at 0800 hours on the same day, the C/O did not want to spend extra time to search for wire ropes of larger diameter thus delaying the testing and the departure time. The C/O therefore instructed *the testing crew* to take the wire ropes (Figure 3) specially fabricated for *the gears* from the No. 2 C/H to replace the broken webbing sling.

Figure 3 *The gears of the pontoon*

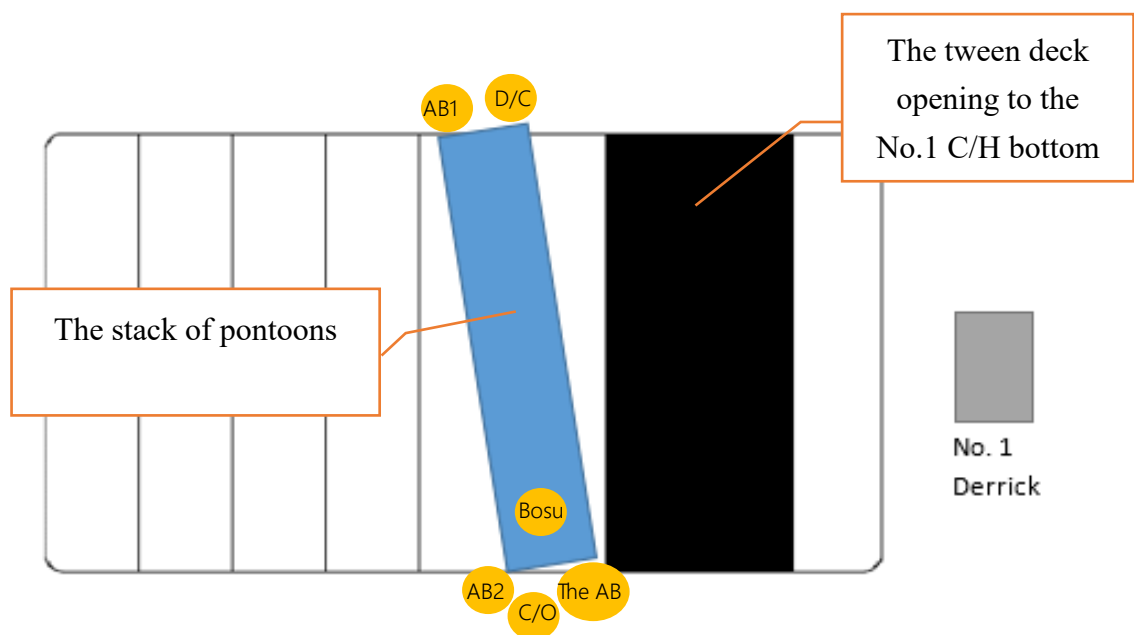
- 3.9 After gathering the required wire ropes, the AB1 and D/C went to the port side of the hold. The C/O together with the AB2 and the AB went to the starboard side of the hold to secure the wire ropes on the pontoons. The Bosun stood on top of the stack of pontoons to overlook the entire securing arrangement (Figure 4).

Figure 4 *Standing position of the testing crew, the Bosun and the C/O*

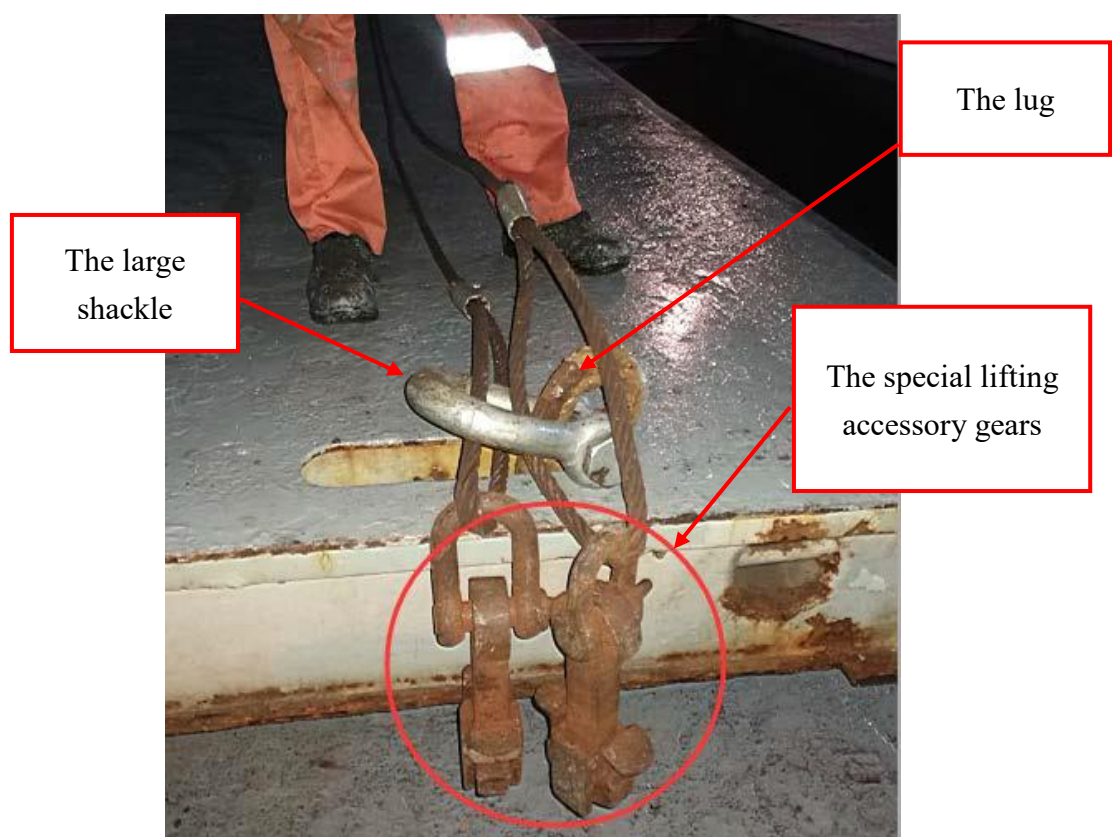
- 3.10 Each pontoon by itself was designed to be lifted by four wire ropes attached to its four corners. In order to lift the stack of two pontoons together, two wire ropes were required at each corner of the bottom pontoon of the stack. *The testing crew* used a large shackle to secure each corner of the bottom pontoon of the stack, and connected the two wire ropes to the large shackle at each corner. However, *the gears* that were not applicable to the testing, was not removed from each of the wire ropes before linking to the large shackle (Figure 5).

Figure 5 Two wire ropes connected by one large shackle

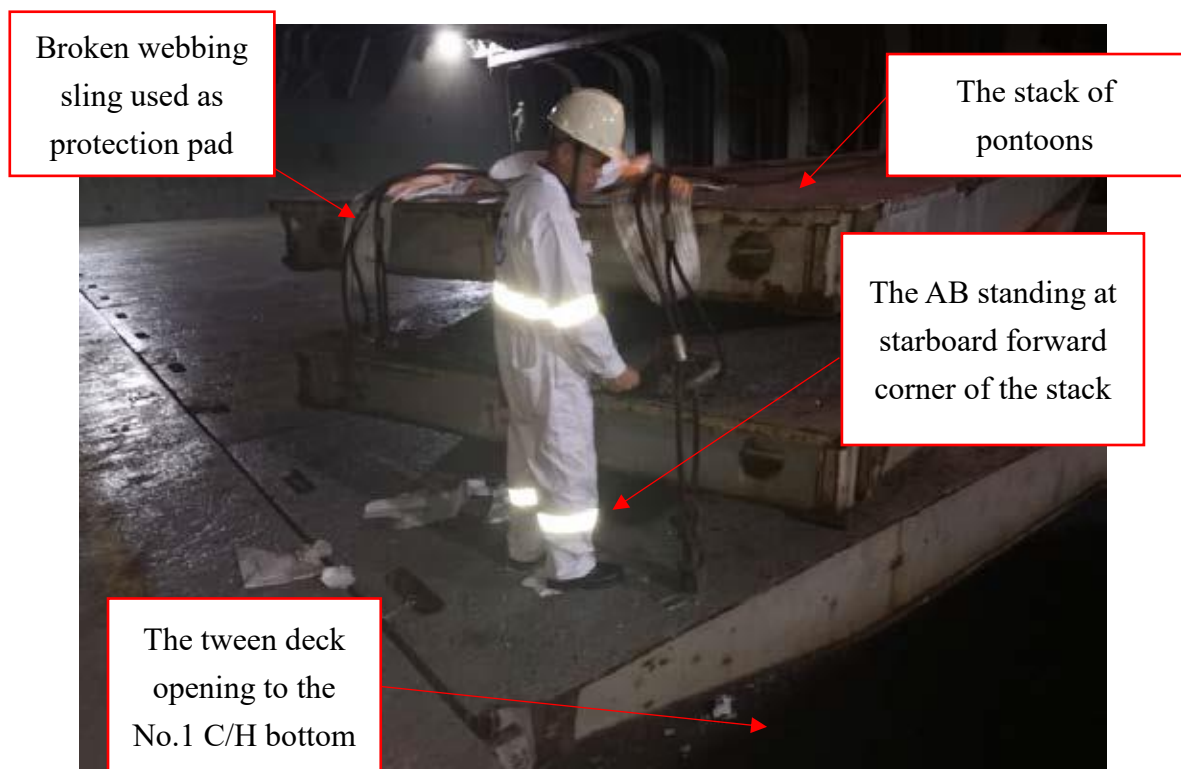
- 3.13 At around 0218 hours, the AB standing at the starboard forward corner (Figure 6), tried to lift *the gears* and placed them on the large shackle. When he was lifting *the gears*, he lost his balance and fell onto the bottom of the No. 1 C/H through the tween deck opening next to him (Figure 7). The vertical distance was about 7.3 metres between the tween deck and the bottom of the C/H.

Figure 6 Indicative standing position of *the AB*

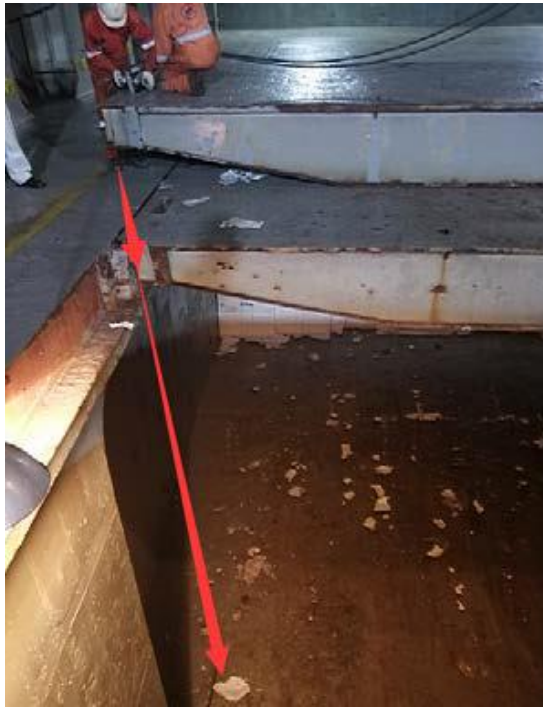
Figure 7 The AB fell from tween deck to the No.1 C/H bottom

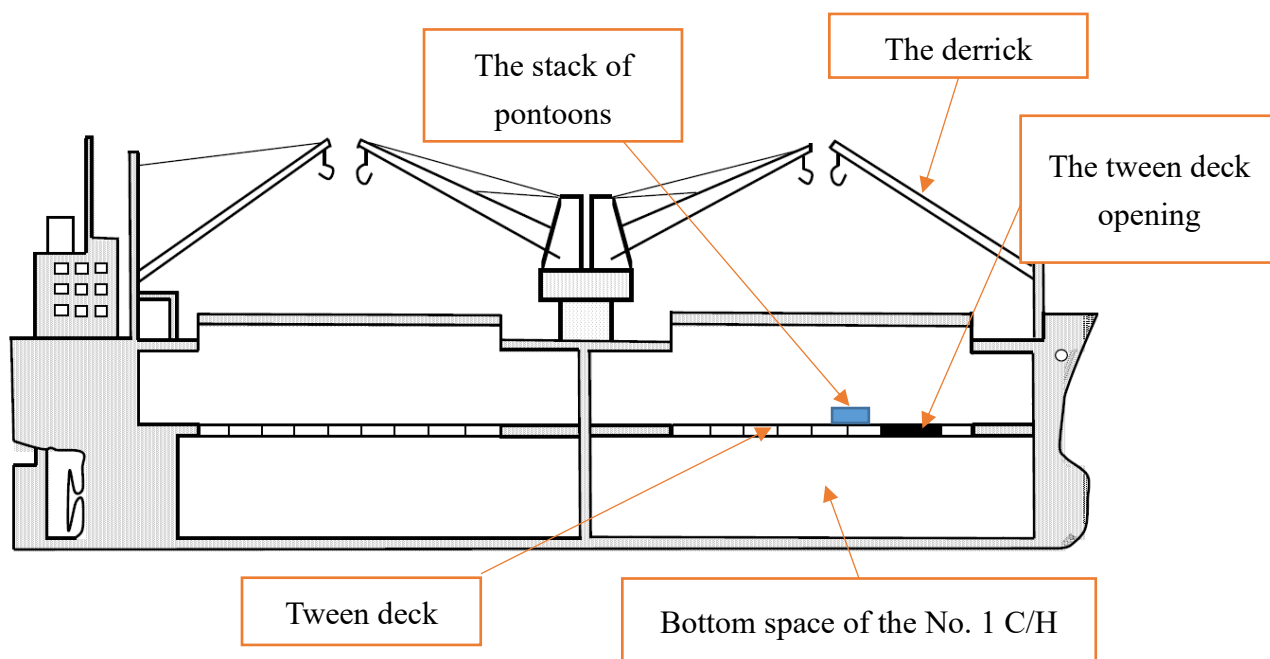
- 4.9 On *the vessel*, there were 4 main cargo lifting appliances including two derricks and two cranes. The derrick was located at the forward of *the vessel* (Figure 8), with a safe working load (SWL) of 25 tonnes. The “Certificate of Test and Thorough Examination of Lifting Appliances” was issued by China Classification Society (*the Class*) on 28 February 2017. After the last annual thorough examination of all the cargo lifting appliances on board was done on 7 March 2020 by *the Class*, however, it was found that the derrick could only work with a maximum load of 15 tonnes. After about 6 months later, the management company arranged the contractor to repair the derrick by which the accident happened.

Figure 8 Location of the derrick and the No. 1 C/H

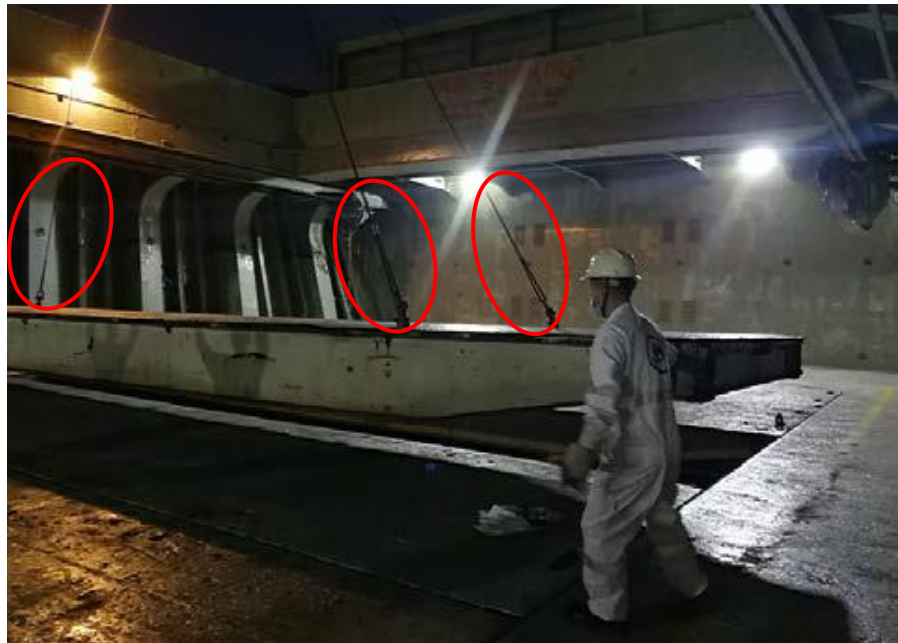
- (c) an in-depth pre-work inspection was probably not carried out satisfactorily at the work site before commencing the work. The inability of *the gears*, which was a combination of a small shackle and a lifting wedge, in gripping the stack should be identified before commencing the work (Figure 9). As a substitution, large shackles with lugs were used to grip the pontoon at the bottom of the stack.

*The gears* had been attached to the wire slings connected to the bottom pontoon through the large shackles and lugs before commencing the lifting. As a result, the wire slings were later

entangled by *the gears* affecting the balance of weight at the four corners of the stack of *pontoons* in lifting. Had an in-depth pre-work inspection been carried out, the hazard of the wire slings being entangled by *the gears* would have been identified. Furthermore, the AB would not have gone close to the tween deck opening to release the entanglement of the wire sling by pulling up *the gears* above the large shackle; and

Figure 9      *The gears at each corner of the pontoon*

- (a) accomplish preparation work including the assurance of the establishment of a safe work plan and procedure, the availability of special tools and acceptance standards for the job going to be done by contractors;
- (b) carry out a cautious pre-work inspection for identifications and evaluation of the risks inherent particularly in the environment of non-routine work and take effective control measures;
- (c) ensure that work plan, safety precautions and hazards involved were fully understood by crew members in toolbox talk before commencing work;
- (d) carry out site supervision of all key operations by experienced officers; and
- (e) monitor working at height to be carried out strictly according to the SMS.
