**Report of investigation
into the fatal accident on board the
Hong Kong registered bulk carrier
“*Darya Tapti*” at sea on 9 October
2020**

**The Hong Kong Special Administrative Region
Marine Department
Marine Accident Investigation Section**

04 January 2022

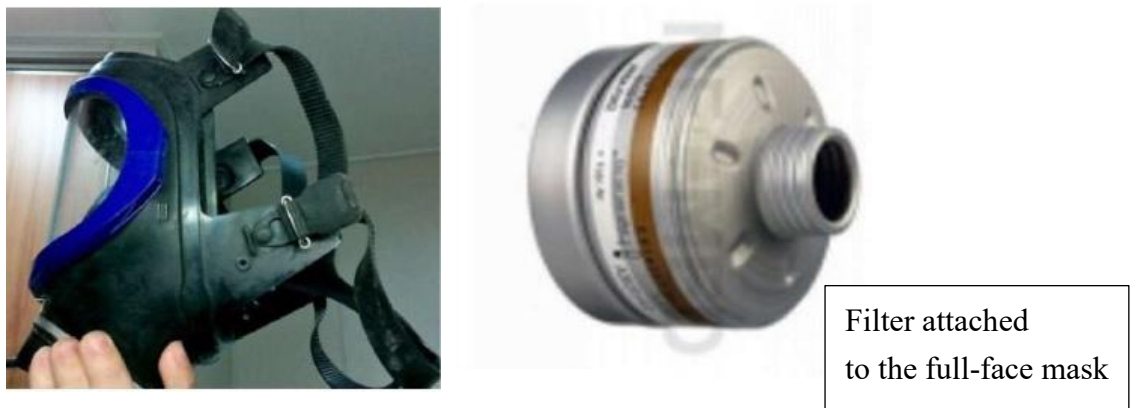
Figure 2 The full-face mask and filter

- 4.23 The fumigation company had supplied three sets of full-face mask and 14 pieces of filter for the remaining fumigation process on board, as shown in Figure 2. The mask worn by the Bosun belonged to the air-purifying type rather than the air-supplied type which could supply breathable air to the wearer.
- 4.24 According to the Safety Data Sheet of the tablets provided by the fumigation company to *the vessel*, a close-fitting gas mask with self-contained breathing apparatus is required if the concentration inside cargo holds unknown. Therefore, the masks supplied on board were not suitable for the usage in either the unknown concentration of phosphine gas or the oxygen-deficient atmosphere inside cargo holds under fumigation. The mask supplied on board failed to protect the Bosun from entering the access trunk resulting in his death.

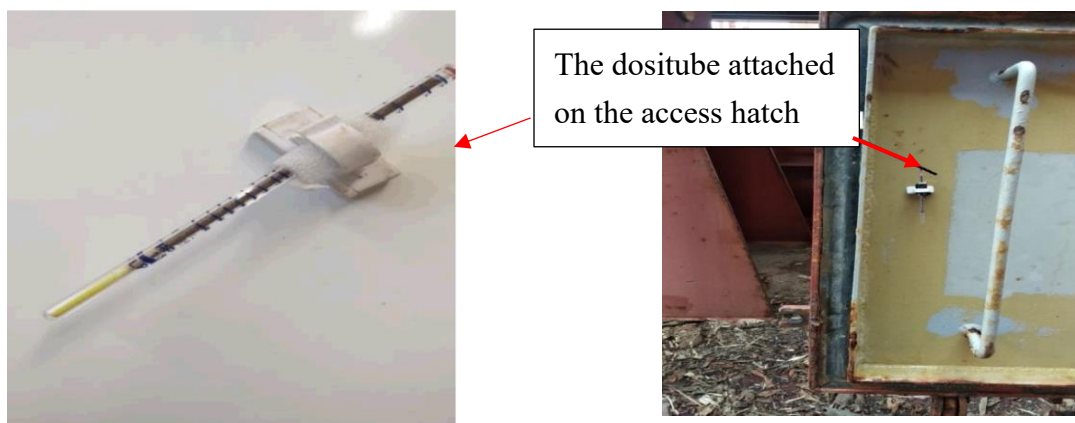
- 4.20 The access trunks under the cargo hold access hatches were part of the cargo holds. They were deficient in oxygen and contained highly toxic fumigants of phosphine gas. For safety reasons, the fumigation company required the crew to wear the masks and stand upwind during the fumigant top-up process in order to protect them from being affected by the phosphine gas when pouring the tablets into the access trunks. Nevertheless, cargo hold entry was strictly prohibited.
- 4.21 In the accident, the Bosun with the mask went into the access trunk with his lower body supported by the rungs of the vertical ladder under the access hatch. He tried to squat down to pick up the detached dositube stuck at about 1 metre from the access hatch beside the vertical ladder. Nevertheless, cargo hold entry was strictly prohibited.

Figure 3 The dositube attached on internal side of the access hatch cover

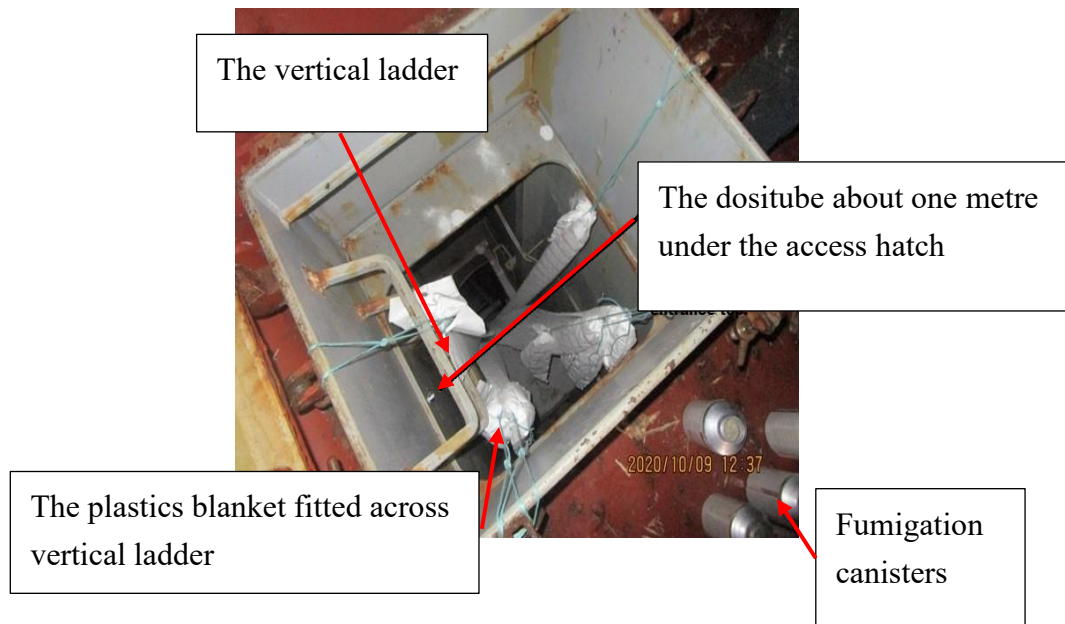
- 3.10 At about 1645 hours, they proceeded to the forward access of the No. 5 cargo hold to continue fumigation work. After opening the No. 5 cargo hold forward access hatch cover, they failed to find the dositube on the internal side of the hatch cover. The Bosun instructed GPD3 to bring a cargo light to illuminate the cargo hold access trunk under the access hatch. After that, they found the dositube stuck on the access trunk about one metre below the access hatch. The 3/O and Bosun tried to take it out by hand but in vain.

- 3.12 At about 1650 hours, *the vessel* was at approximate position 20°39.57'S, 163°05.10'E. When the 3/O was preparing to take photographs, he suddenly heard a loud sound from No. 5 cargo hold forward access. The 3/O quickly moved to the access hatch and spotted the Bosun slipping on the inclined ladder below the vertical ladder under the access hatch.

Figure 4 Top view of the No.5 cargo hold forward access
