**Report of investigation  
into the fatal accident on board the  
Hong Kong registered chemical/oil  
tanker “*Calm Lake*” at sea  
on 22 October 2020**

**The Hong Kong Special Administrative Region  
Marine Department  
Marine Accident Investigation Section**

04 January 2022

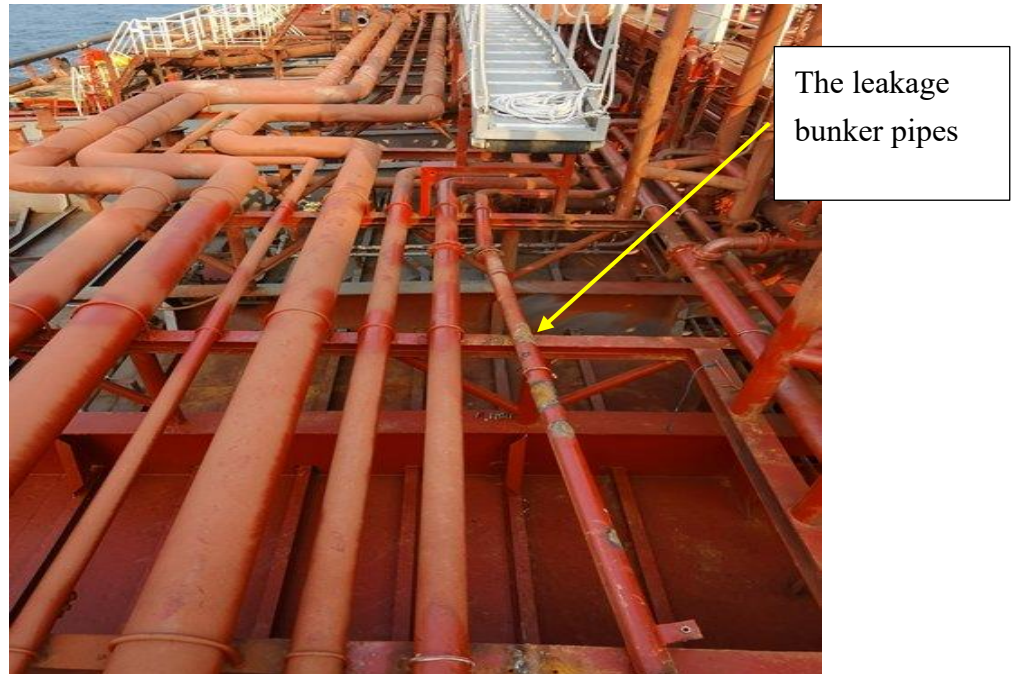
- 3.7 After the toolbox meeting, the Fitter went to the main deck to weld the leakage bunker pipes beside the No. 5 (P) COT (Figure 2). The 2/E kept fire watch for the welding work, but he sometimes went to render assistance for the C/E and Mechanic on renewing the sealing rings of the hydraulic pipe flanges.

Figure 2 The leakage bunker pipes were welded on deck

4.24 As the Fitter was working alone and busy in welding the leakage bunker pipes, the Fitter failed to notice the flammable liquid/vapor flowing to him. The flammable liquid/vapor was ignited by the hot slag of the welding, and then the fire spread forward to the No. 2 COT. When the Bosun came out from the No.2 (P) COT, his boiler suit was on fire and caused a severe burn.

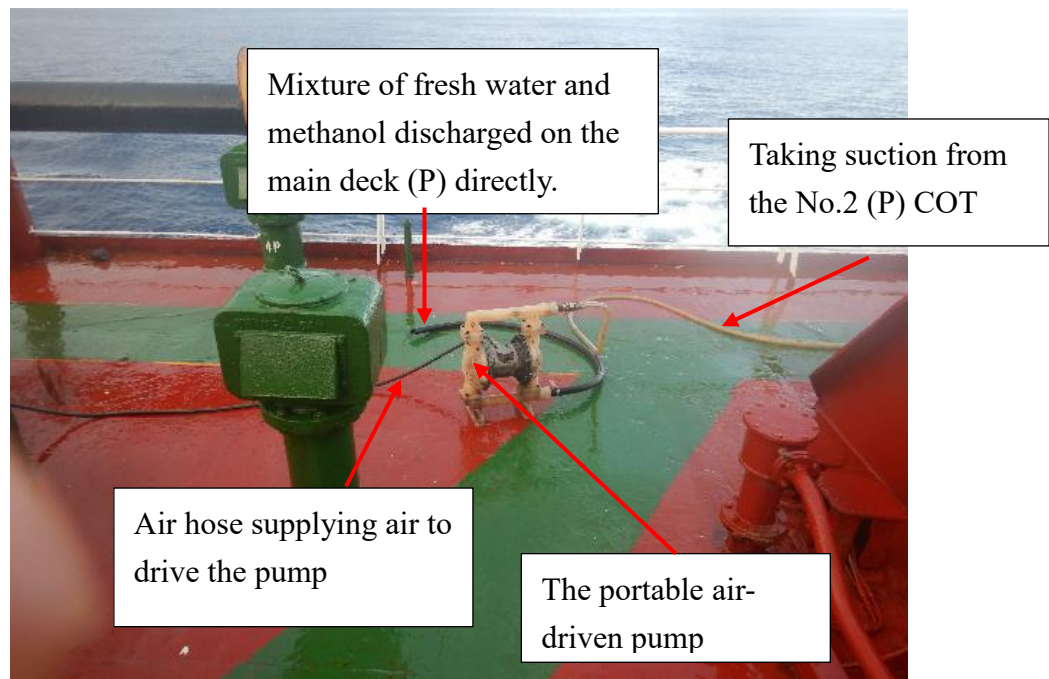
- 3.8 On the forward part of the main deck, the Bosun, Pump-man (PM) and AB carried out No. 2 (P) COT cleaning by flushing fresh water. At about 1400 hours, they commenced cleaning the No. 2 (P) COT with methanol. The Bosun was working inside the No.2 (P) COT with assistance from the PM and AB on the main deck. Afterwards, the mixture of fresh water and methanol was pumped out from the No.2 (P) COT by portable air-driven pump (Figure 3) onto the port side main deck directly without collecting into drums. The deck crew members used about 80 liters of methanol for the No. 2 (P) COT cleaning.

Figure 3 The portable air-driven pump

- 4.23 Deck crew members conducted the COT cleaning with fresh water and methanol. They pumped out the mixture of fresh water and methanol onto the main deck directly. At the time of the accident, the forward and aft draughts of *the vessel* were 5.4 metres and 8.2 metres respectively. As such, the effluent mixture of fresh water and methanol flew from the forward to aft direction on the port side main deck.
