**Report of investigation
into the fatal accident on board
Hong Kong registered bulk carrier
“CSSC *He Mei*” in position
25°15'.50 N, 120° 41'.90 E
on 21 November 2020**

**The Hong Kong Special Administrative Region
Marine Department
Marine Accident Investigation Section**

04 January 2022

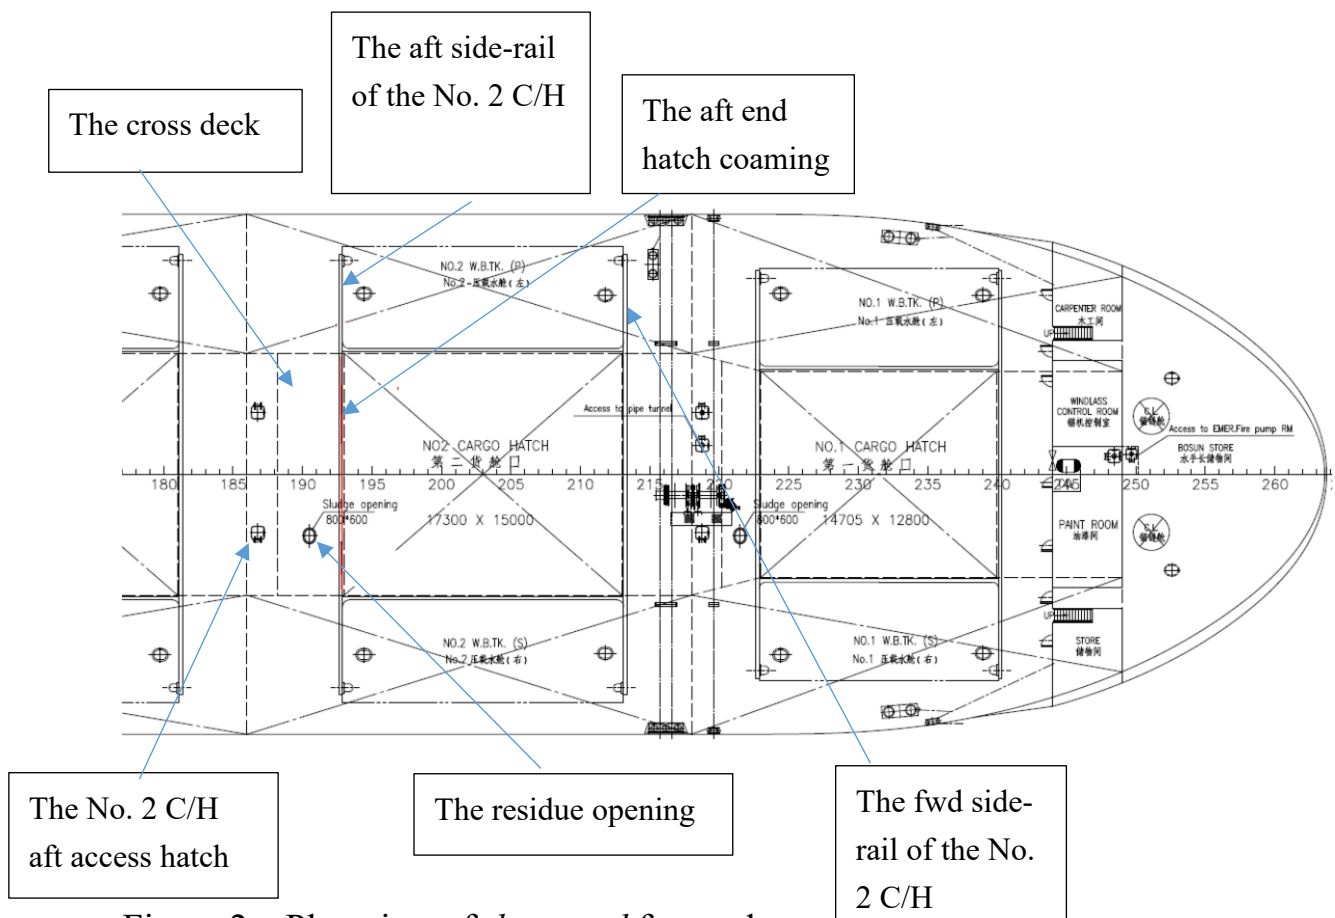
Figure 2 Plan view of *the vessel* forward

another fire hose to wash the forward and aft side-rails of the No. 2 C/H hatch cover. (Figure 2)

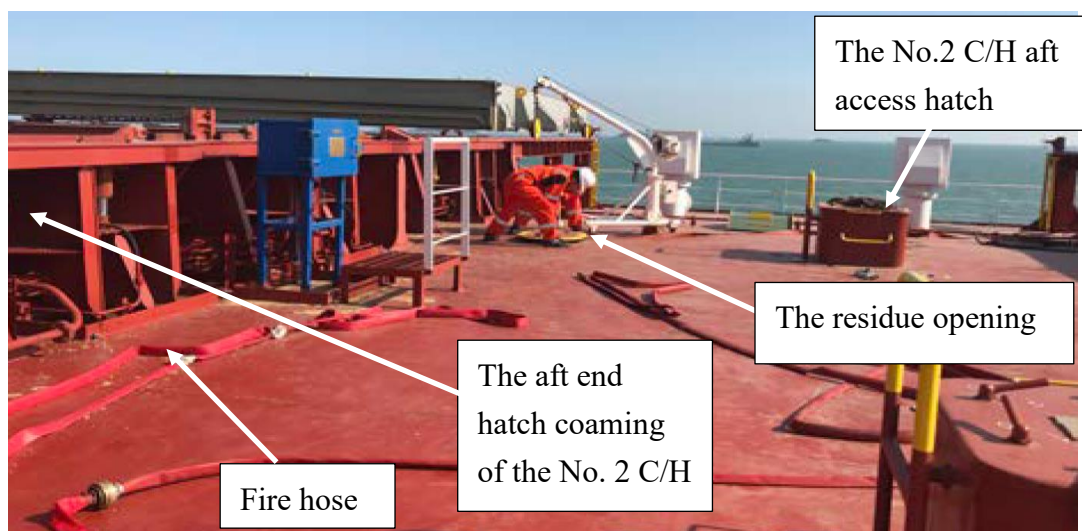
Figure 3 The No.2 C/H aft access hatch on the cross deck

- 4.9 *The vessel* was built with seven cargo holds for stowing cargoes in bulk. Each cargo hold was provided with an accessible entrance at forward and aft sides of the cargo hold.
- 4.10 The No. 2 C/H aft access was located on the cross deck through a booby hatch having a height of 620 mm in conjunction with the access ladders inside leading to the bottom of the cargo hold (Figure 3).
- 4.11 In the cleaning work, the crew members selected to open the residue opening (a flush type opening) of size 600 mm x 800 mm on the cross deck behind the aft end hatch coaming of the No. 2 C/H for the removal of the residue (Figure 4).

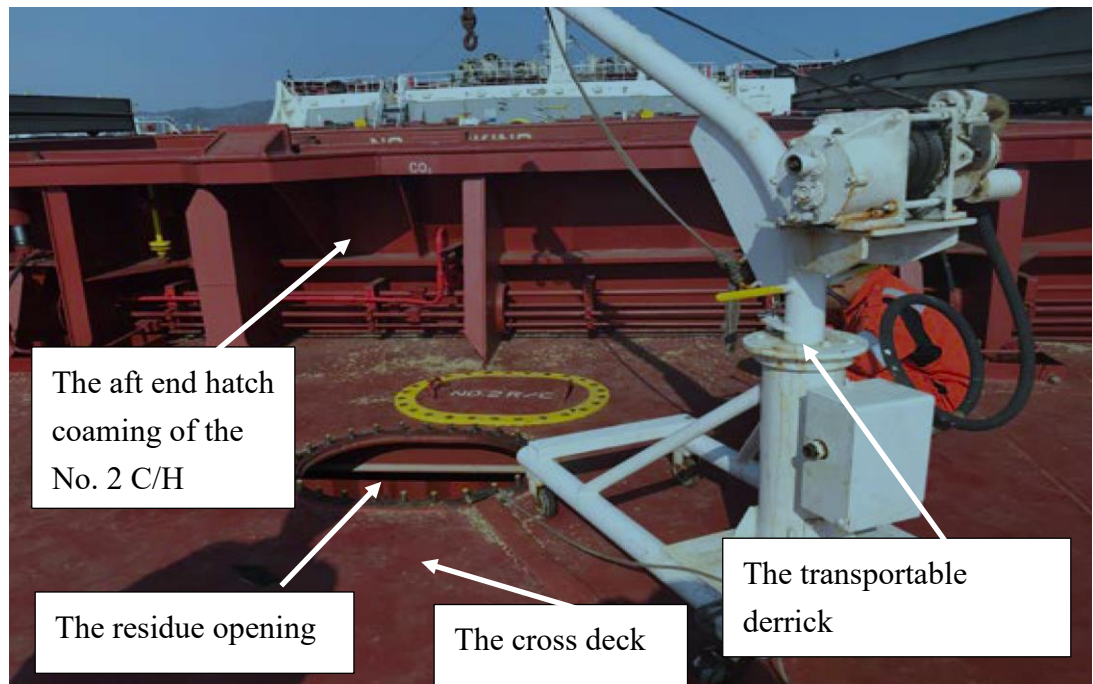
Figure 4 The residue opening and the transportable derrick

- 4.17 However, the residue opening was left open during the cleaning work for the fire hose passing through to the cargo hold bottom without any temporary guardrails or fencing or warning signs placed around the residue opening.
- 4.18 Had the residue opening been secured by temporary guardrails or fencing with intermediate taut wire rail at a sufficient height of more than one metre, AB1 would have been saved from stepping into the opening. Had apparent warning signs been posted around the residue opening, AB1 would have been aware of the opening nearby to avoid the accident.

- 6.1 The management company should issue circulars to inform all masters, officers and crew members of the findings of the investigation and the lessons learnt from this accident and instruct them to ensure that:
- (a) guardrails should be erected, or apparent warning signs should be displayed around manholes and other deck accesses when they are open;
 - (b) appropriate control measures should be implemented corresponding to risk assessment results; and
 - (c) toolbox talk should be carried out thoroughly to ensure the work plans, safety and hazards involved are clearly understood in accordance with the requirements of SMS.
- 6.2 A Hong Kong Merchant Shipping Information Note should be issued to promulgate the lessons learnt from the accident.

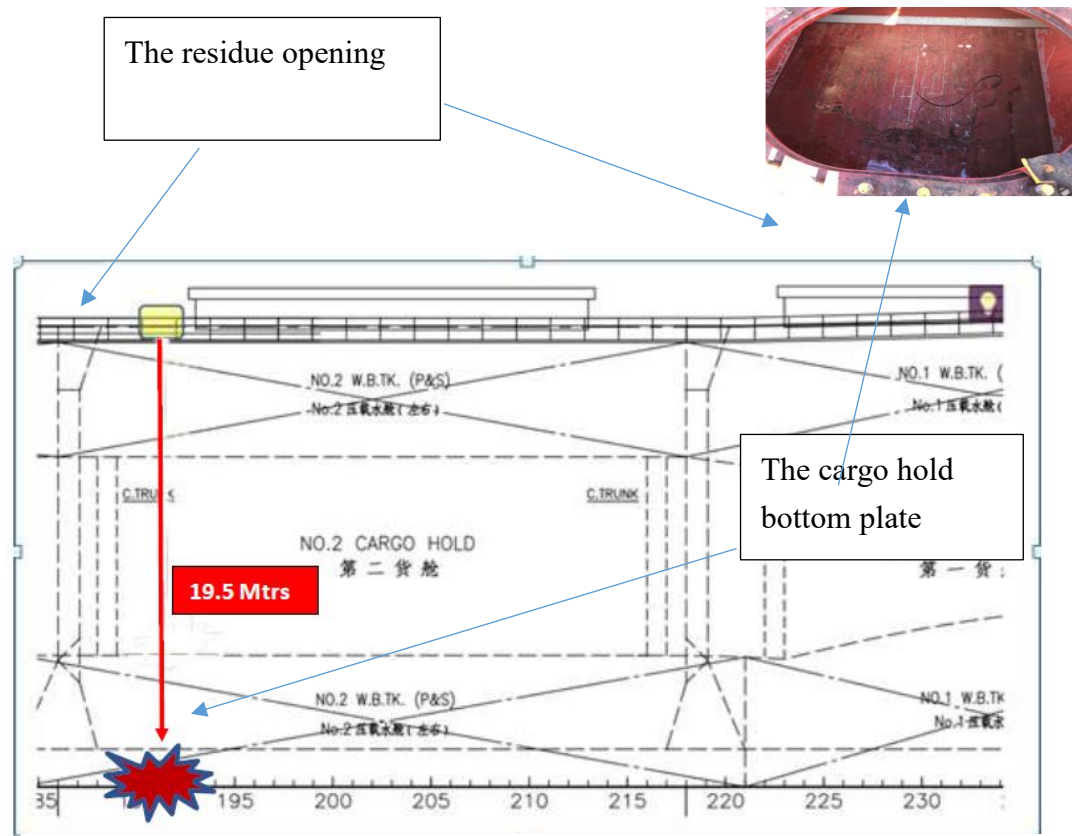
Figure 5 The height between the cargo hold bottom plate and the residue opening

- 4.12 The height between the cargo hold bottom plate and the residue opening was about 19.5 metres without any obstruction in between which greatly facilitated the removal of cargo residue from the hold. The crew members only needed to place a transportable derrick directly above the residue opening to winch up easily the collected residue underneath (Figure 5).
- 4.13 The size of the residue of opening of 600 mm x 800 mm was big enough to allow a person wearing a self-contained air-breathing apparatus and protective equipment to pass through without obstruction. As such, when AB1 stepped into the residue opening, he would fall straightly down to the cargo hold bottom.
