**Report of investigation
into the fatal accident on board the
Hong Kong registered general cargo
ship “*Ocean Gold*” at Kwangyang,
South Korea on 15 January 2021**

The Hong Kong Special Administrative Region
Marine Department
Marine Accident Investigation Section

04 January 2022

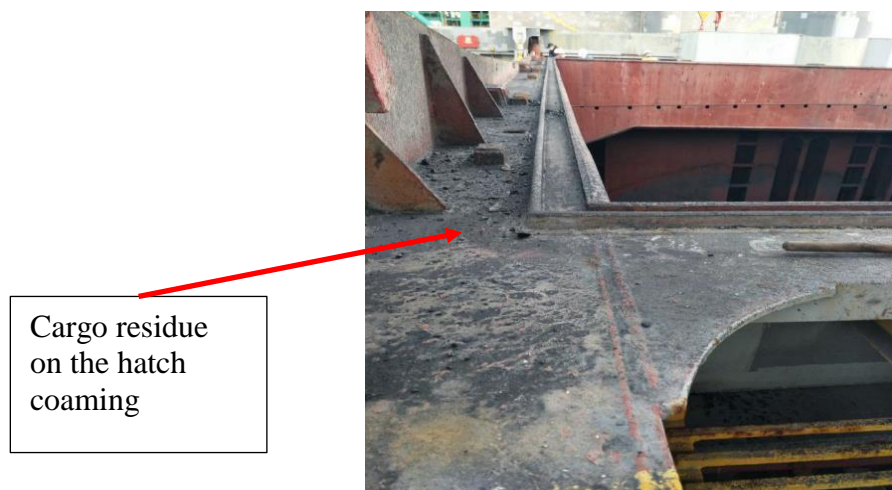
- 4.11 The cargo in *the hold* was completely discharged. The hatch coaming was covered by cargo residue which was slippery in nature (Figure 2).

Figure 2 The cargo residue on the hatch coaming of *the hold*

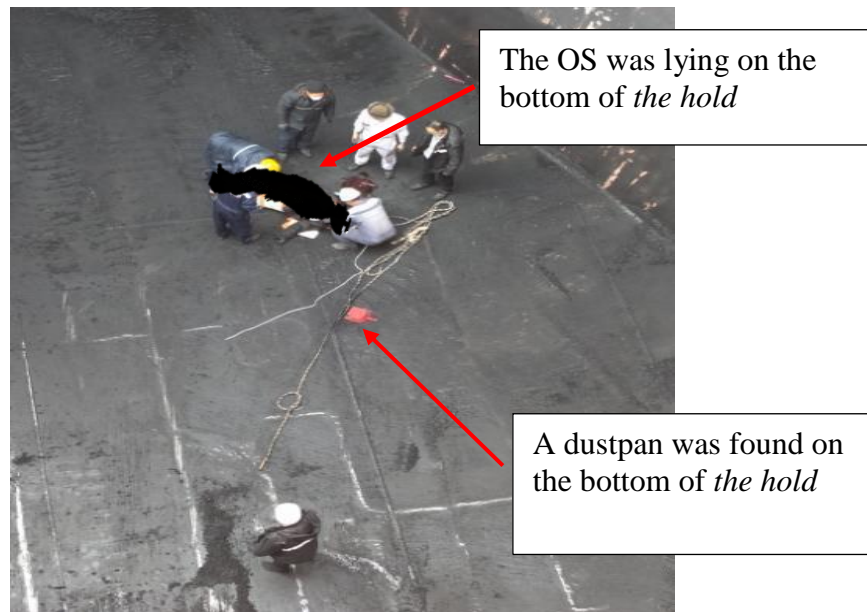
- 4.12 At the accident scene, it was found that a dustpan was located on the bottom of *the hold* about 1 metre beside *the OS* (Figure 3) and a broom was left on the hatch coaming (Figure 4). *The 2/O* confirmed that there was no dustpan on the bottom of *the hold* when he was inspecting *the hold*. No one noticed how the OS fell onto

the bottom of the hold. The suspected spot where *the OS* fell onto the bottom of the hold was at the hatch cover coaming.

Figure 3 The OS was found lying on the bottom of *the hold*

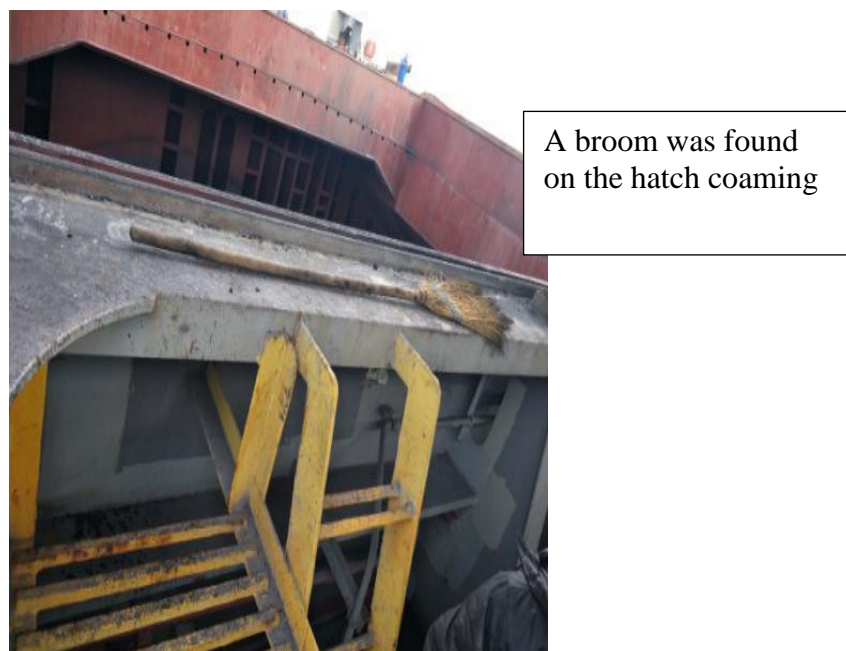
Figure 4 A broom was left on the hatch coaming

4.13 In normal practice, the broom and the dustpan were used together for cleaning purpose. A broom and dustpan which were respectively left on the hatch coaming and the bottom of the hold

might deduce that *the OS* probably lost his balance and fell onto *the hold* when he was working on the hatch coaming without informing anyone, thus resulting in the fatal accident.

- 6.1 The management company should issue circulars informing all masters, officers and crew of its fleet of the findings of the investigation and lessons learnt from this accident and instruct them to:
- (a) enhance safety awareness and safety culture on board to ensure the permit to work system to be followed before working aloft;
 - (b) strictly follow the requirements of the COP and SMS in *the hatch cover operation*;
 - (c) enhance the communication among the crew during the key operations especially when carrying out *the hatch cover operation*; and
 - (d) enhance the shipboard safe operation training, such as work at height and *the hatch cover operation* and assess its effectiveness.
- 6.2 A Hong Kong Merchant Shipping Information Note is to be issued to promulgate the lessons learnt from this accident.
