**Report of investigation
into the fatal accident on board the
Hong Kong registered bulk carrier
“*Bao Run*” at sea on 18 January 2021**

The Hong Kong Special Administrative Region
Marine Department
Marine Accident Investigation Section

5 January 2022

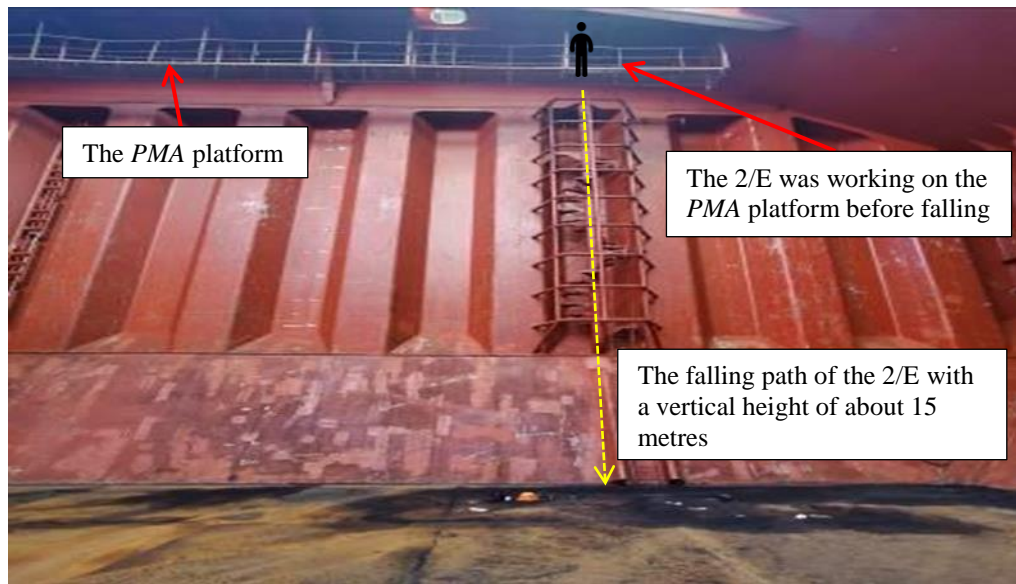
- 3.5 *The cargo hold* was planned to wash by the engine crew members by mixed chemical waters in the afternoon of 18 January 2021. *The 2/E* and Motorman 1 wore a chemical suit and full-face mask proceeded to the *PMA* platform to wash the upper part of *the cargo hold* after cleaning the lower part (Figure 2).

Figure 2 The aft bulkhead of *the cargo hold* including the *PMA* platform

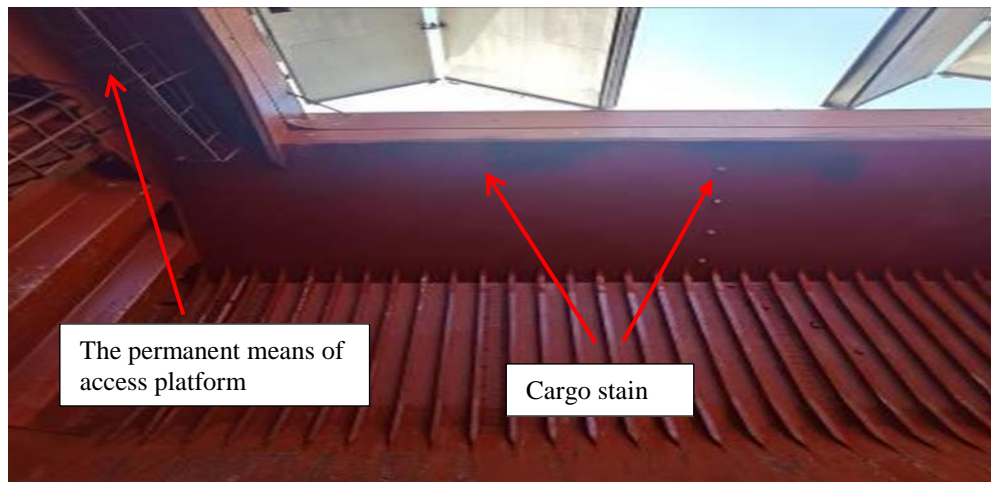
- 3.6 At about 1530 hours, *the vessel* was approximate at position 17°29.3'N 058°07.0'E. Noting that his position at the *PMA* platform could not reach the stain area on the portside hopper, *the 2/E* asked Motorman 1 to bring a pipe extension of the spray lance for him in order to extend it to clean the cargo stain on the portside hopper (Figure 3). *The 2/E* was working alone on the *PMA* platform. Before the Motorman 1 went back to *PMA* platform to bring the pipe extension to *the 2/E*, the Wiper suddenly heard an abnormal sound coming from his backside when he was washing at forward tank top of *the cargo hold*. He then turned around and saw *the 2/E* lying on the tank top adjacent to the bilge well having a serious head injury with bleeding.

Figure 3 The view of the topside tank bottom of *the cargo hold*

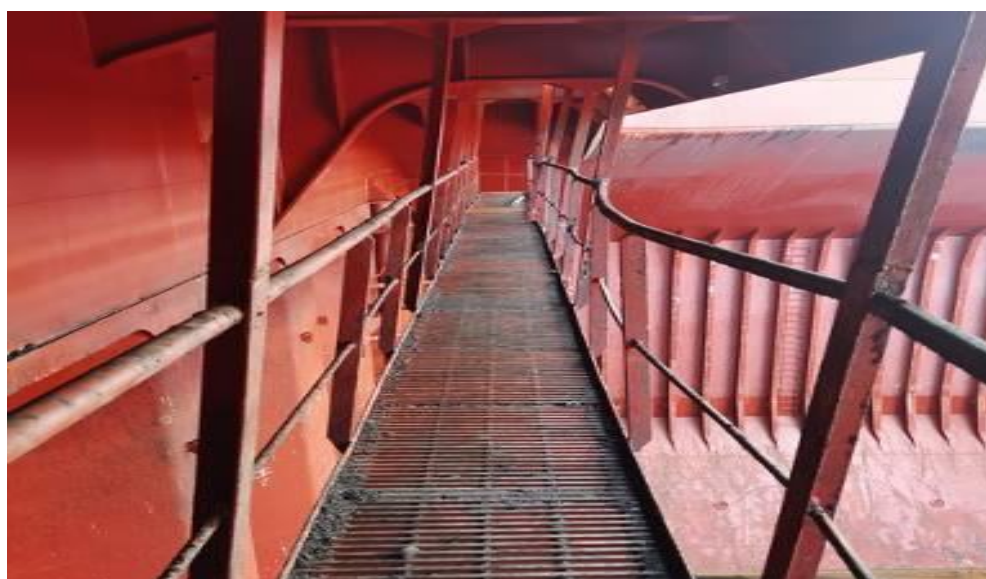
- 4.10 *The vessel* was fitted with elevated passageways forming sections of a PMA platform in *the cargo hold* for close-up inspections and routine maintenance purposes. The PMA platform at about 15 metres above the tank top was assembled with guardrails, stanchions and rectangle grating. The guardrails consisted of an upper rail at the height of 1.05 metres with an intermediate bar at the height of 0.5 metres and stanchions not more than 3 metres apart, the construction of which complied with the requirements of International Convention for the Safety of Life at Sea (SOLAS) regulation II-1/3-6² (Figure 4).

Figure 4 The Permanent Means of Access platform

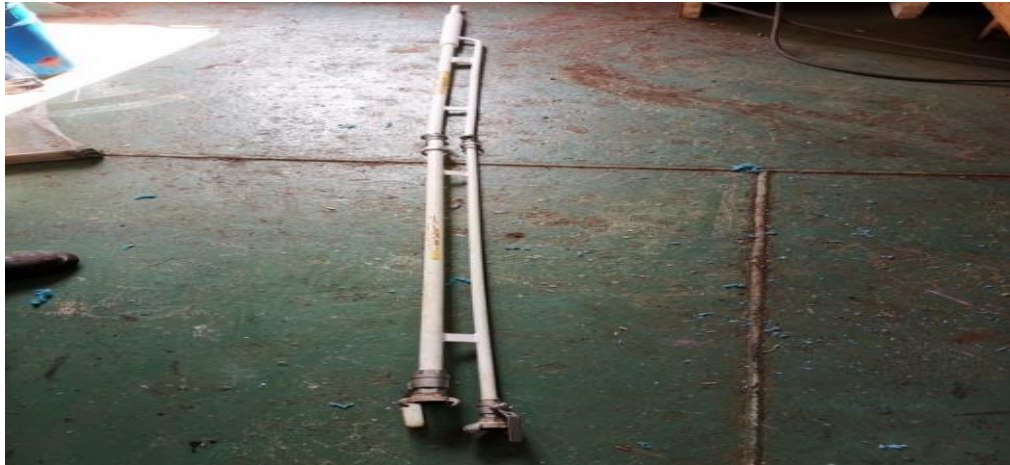
- 4.15 There was no eyewitness on how *the 2/E* fell onto the tank top of *the cargo hold*. It could be deduced that *the 2/E* overstretched his upper body out of the railing of the *PMA* platform to clean the cargo stain with the 4 metres spray lance causing him to lose his balance and fall from a height about 15 metres onto the tank top while he was concentrating on the cleaning work (Figure 5).

Figure 5 The spray lance

4.16 The investigation revealed that the work was carried out without sufficient site supervision, lack of safety awareness, and underestimating the risk of falling from the *PMA* platform by not strictly following the requirements of the “General Safe Working Practice” of shipboard *SMS* while working at height. The *SMS* required that *the 2/E* had to wear a safety belt while working on the *PMA* platform, and a responsible person had to be assigned to supervise onsite to ensure the crew members worked at height with proper safety protective measures. The fatal accident might be avoided if the requirements of the *SMS* were strictly followed.

- 6.1 The management company should issue circulars informing all masters, officers and crew of its fleet of the findings of the investigation and lessons learnt from this accident and instruct them to:
- (i) enhance safety culture onboard to ensure the permit to work system to be followed and wear safety belt before working at height; and
 - (ii) strictly follow the requirements of the Code and shipboard *SMS* manual when working at height.
- 6.2 A Hong Kong Merchant Shipping Information Note is to be issued to promulgate the lessons learnt from this accident.
