**Report of investigation  
into the fatal accident on board the  
Hong Kong registered bulk carrier  
“*Qing Ping Shan*” at Astoria  
anchorage, Columbia River, USA on 30  
January 2021**

The Hong Kong Special Administrative Region  
Marine Department  
Marine Accident Investigation Section

7 April 2022

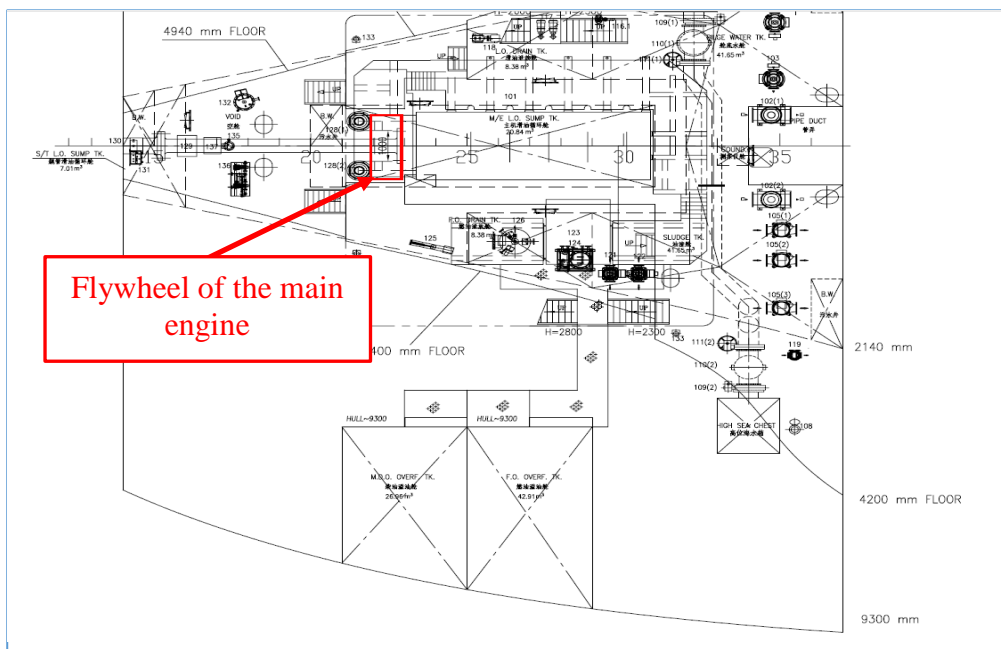
Figure 3: The location of the main engine flywheel

- 3.7 As instructed by the C/E, the 1/E arranged the engine room cleaning and made a telephone call to the cabin of the Fitter, but nobody answered. The 1/E then looked for the Fitter in the engine room. At about 1500 hours, the Fitter was found lying on the E/R tank top between the main engine flywheel and the main lubrication oil pump with a paint bucket and a roller at his side. The 1/E called the Fitter, but no response. He then rushed upstairs for assistance. The duty officer on the bridge was informed of the incident.

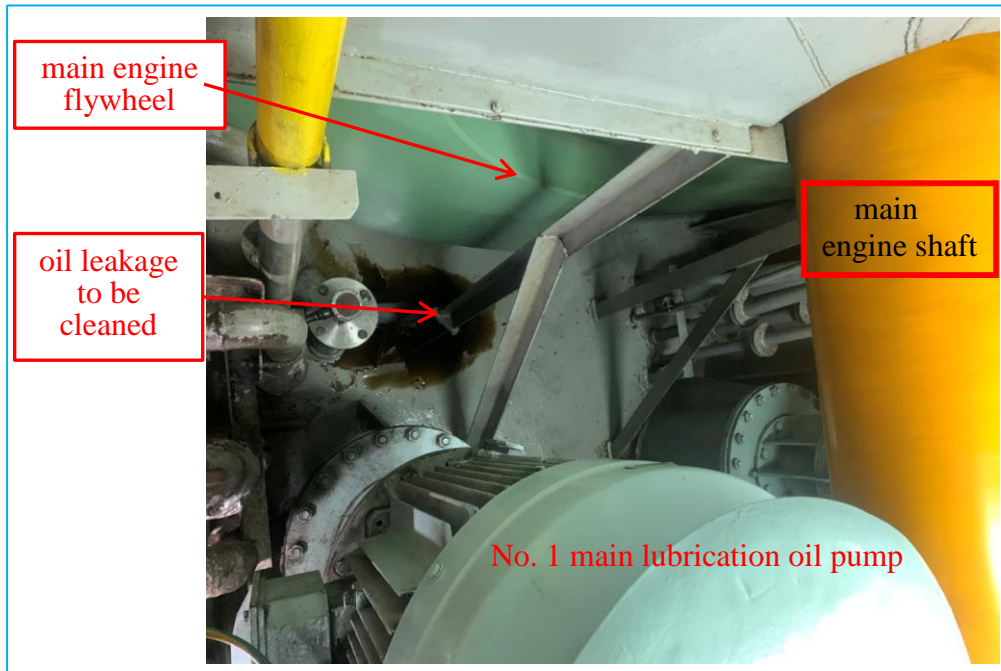
Figure 4: The accident scene

- 4.9 The Certificate of Death issued by the Oregon Health Authority stated that the deceased was crushed by an engine flywheel while painting the floor adjacent to or beneath the engine. The immediate cause of death was internal decapitation due to blunt force injury of the neck.
- 4.10 According to the accident investigation report from *the Company*, the Fitter was found lying on the E/R tank top between the main engine flywheel and the main lubrication oil pump with a paint bucket and a roller at his side. It was deduced that the Fitter might be doing some cleaning or painting work at the accident scene. (Figure 4)

- 4.11 The investigation also deduced that the rotating flywheel hit the Fitter during the main engine test when he was alone doing some cleaning or painting work near or underneath the flywheel. The Fitter failed to dodge quickly to keep himself clear of the rotating flywheel due to the limited space around him when the flywheel of the main engine suddenly moved, resulting in his death.

- 4.17 Although the Fitter had about 6 years of experience at the rank of a fitter and also being a safety work supervisor for engine room ratings according to paragraph 2.2.3(1) of the SMI-S-J06, it was incomprehensible that the Fitter chose to carry out the routine maintenance work at the E/R tank top near the flywheel when the main engine was on standby under the bridge control mode. The only reason that could explain the Fitter's decision to work there was that he did not realize that the main engine might start at any moment. The investigation revealed that the Fitter was lack of safety awareness and underestimated the risk of working adjacent to the flywheel of the main engine.

- 6.1 The management company should issue circulars informing all masters, officers and crew members of its fleet of the findings of the investigation and lessons learnt from this accident and instruct them to:
- (a) enhance safety awareness and safety culture onboard to ensure a risk assessment to be conducted before commencing work to determine the potential hazards;
  - (b) strictly follow the requirements of the “Shipboard Safe Working Instruction” of the shipboard SMS, especially for the routine maintenance work of the engine room; and
  - (c) enhance the communication among the crew members before conducting the key operations such as main engine test, maintenance or repairs work adjacent to moving machinery, etc.
- 6.2 A Hong Kong Merchant Shipping Information Note is to be issued to promulgate the lessons learnt from this accident.
