**Report of investigation  
into the explosion accident on board the  
Hong Kong registered bulk carrier  
“*CSSC Cape Town*” at Gibraltar on 19  
February 2021**

The Hong Kong Special Administrative Region  
Marine Department  
Marine Accident Investigation Section

8 February 2022

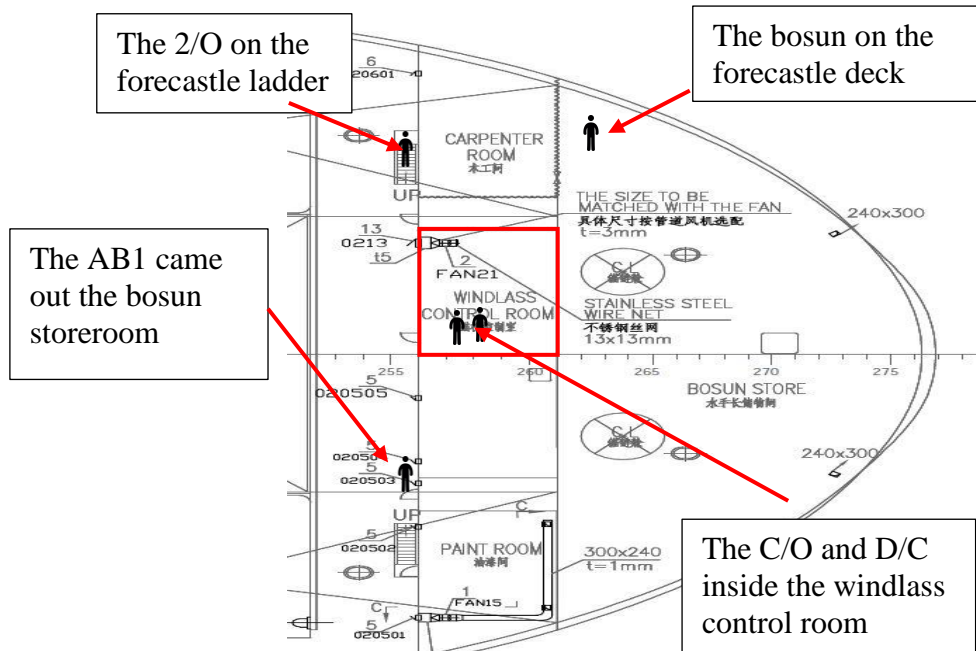
Figure 2 The location of the crew when the accident happened

hydraulic pump motors. The second officer (2/O) also arrived at the port side forecastle ladder to familiarize the anchoring operation (Figure 2).

- 3.7 At about 2110 hours, the AB1 came out the bosun storeroom and intended to proceed to the forecastle deck. The C/O and D/C entered the windlass control room to switch on the hydraulic pump motors. While the D/C was pressing the power switch of the hydraulic pump motor located at the starter and control cabinet, an explosion happened and followed by smoke rising.

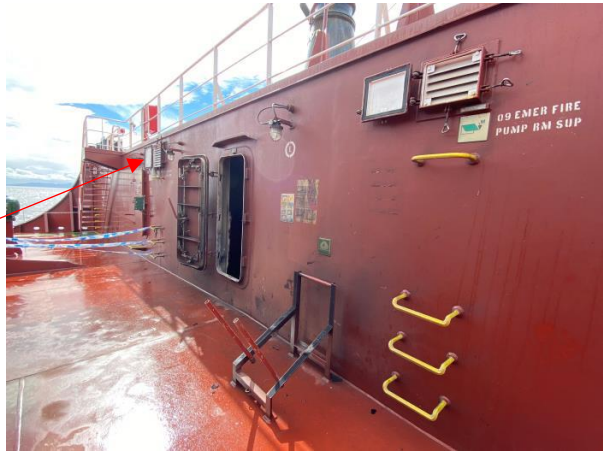
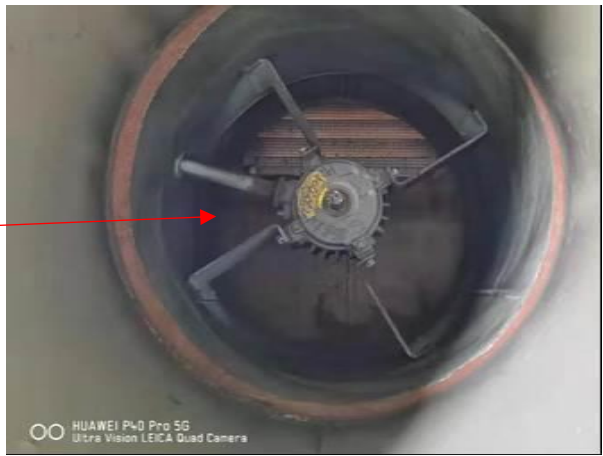
Figure 3 Ventilation flap and motor driven fan of windlass control room

4.14 The windlass control room located in the ship forward was designated for storing the hydraulic tank, hydraulic pumps with their motors of the windlass system, and their starter and control cabinet. The No.1 cargo hold access was located within the windlass control room and isolated by the access hatch cover. The windlass control room was provided a ventilation flap for natural ventilation and a motor driven-fan for mechanical ventilation (Figure 3).

4.19 Although there was no evidence to ascertain the level of flammable methane/air mixture accumulated inside the starter and control cabinet and the windlass control room, the ventilation flap of the windlass control room was closed, and the mechanical ventilation also had not been switched on since departure. It was deduced that the methane gas had reached its flammable limits which could be ignited by a spark. Upon the D/C switched on the hydraulic pump motor, the spark generated inside the starter and control cabinet could ignite the methane gas resulting in the explosion.

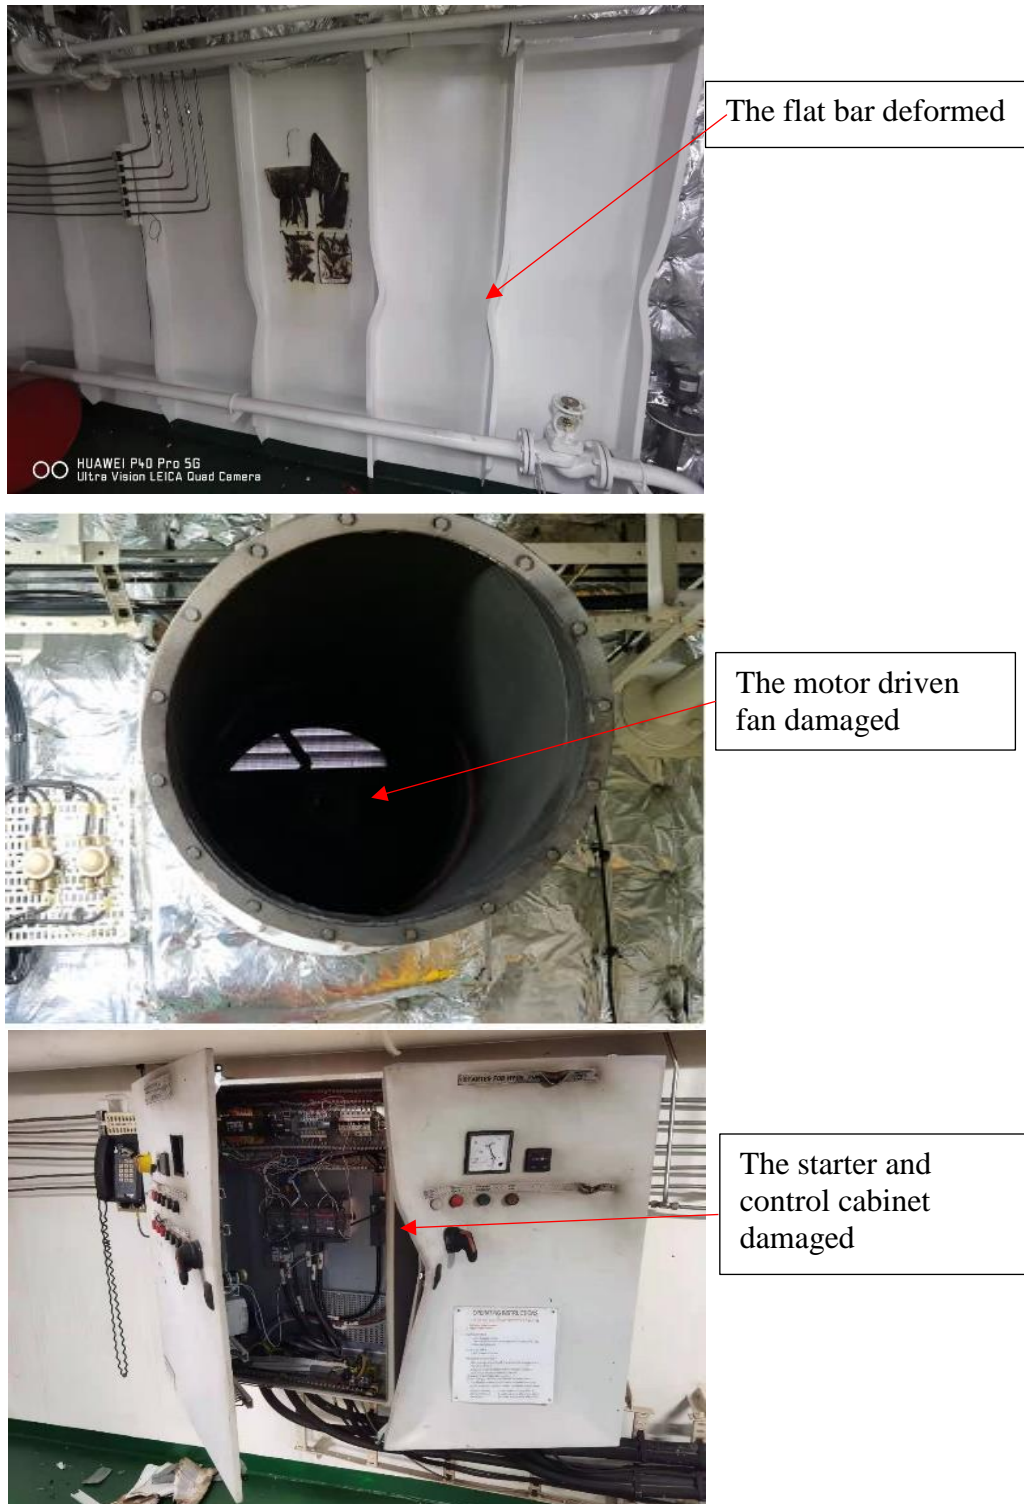
Figure 4 Photos showing the damaged after the explosion

4.15 As a result of the explosion, the starboard bulkhead and port bulkhead of the windlass room were buckled, and the flat bars of these bulkheads were deformed. The starter and control cabinet and the ventilation were damaged (Figure 4). The windlass system was out of order.

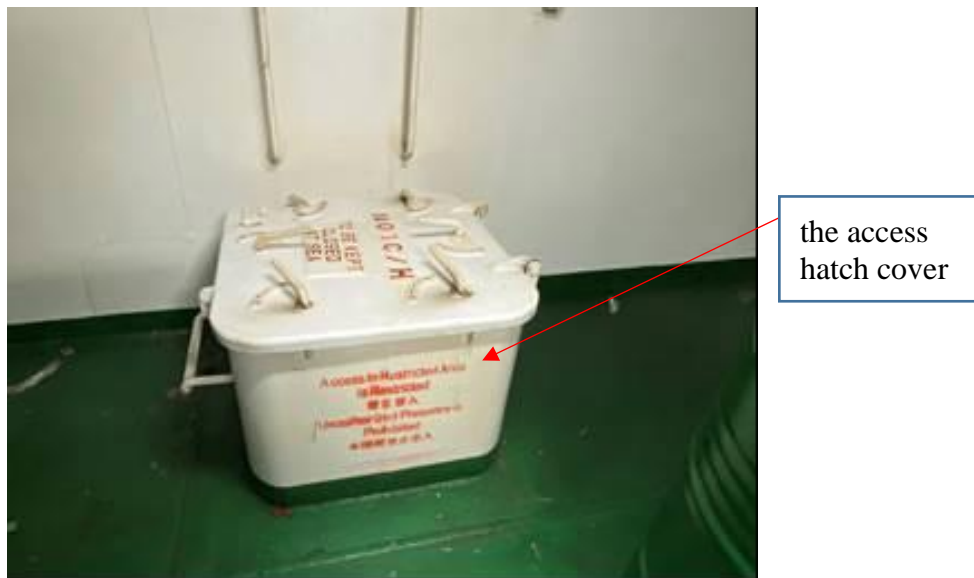
Figure 5 The access hatch of the No.1 cargo hold was located in the windlass control room

- 4.16 *The vessel* was fully loaded with coal cargo, including the No.1 cargo hold (*the hold*). Flammable methane gas emitted from coal would accumulate at the bottom of the hatch cover and the access hatch cover of *the hold*. The methane gas can seep into the windlass control room through the access hatch when the access hatch cover is not gastight.

- 4.18 After the accident, *the Company* had investigated the condition of the access hatch cover of *the hold* at the port of Gangavaram, India. It was found that the access hatch cover of *the hold* was slightly leaking through the ultrasonic test. It was deduced that the methane gas emitted from the coal cargo seeped into the windlass control room and accumulated inside the starter and control cabinet through the access hatch (Figure 5).

- 6.2 The management company should consider revising the shipboard SMS to identify additional dangerous spaces on board and conduct an internal audit on *the vessel* to ensure that the crew members strictly follow the safety requirements when carrying coal cargo.
