**Report of investigation
into the fatal accident on board the
Hong Kong registered multi-purpose
dry cargo ship “Caribbean Harmony”
at Onsan, Korea on 16 April 2021**

**The Hong Kong Special Administrative Region
Marine Department
Marine Accident Investigation Section**

05 January 2022

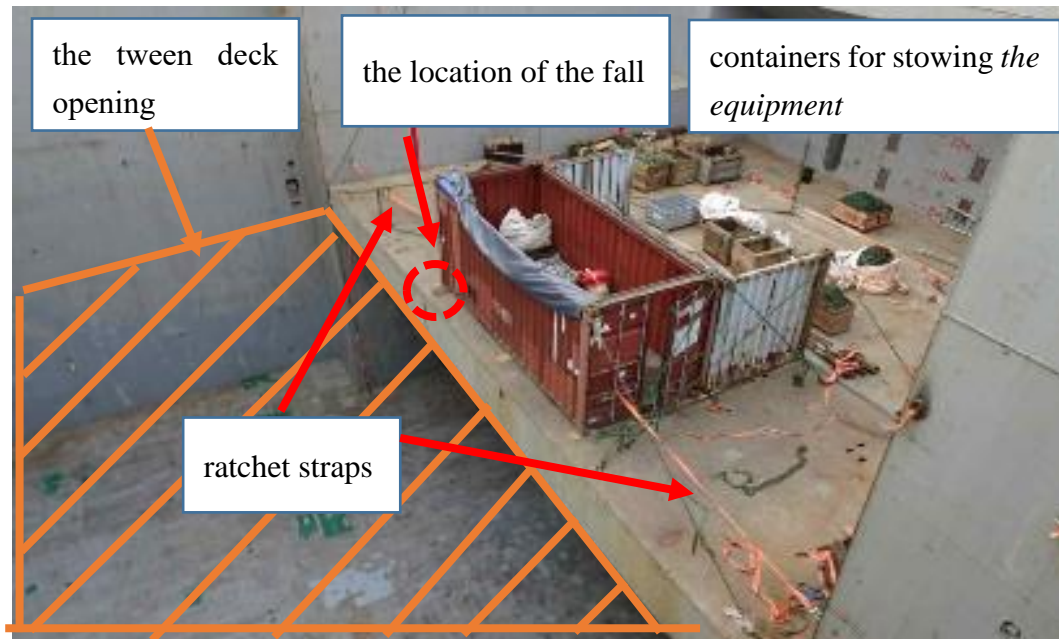
Figure 2 The No.1 cargo hold layout

- 3.4 As ordered by *the C/O*, the *3/O* holding a torchlight escorted *the representative* wearing a safety helmet, safety shoes, and a retroreflective safety vest entered *the hold*. The hatch covers of *the hold* were closed, and the space was dark. The tween deck of *the hold* was partially opened (Figure 2). *The 3/O* warned *the representative* many times not to go near the edge of the tween deck of *the hold* because of the potential danger of falling during his taking pictures and checking *the equipment* but his warning was ignored.

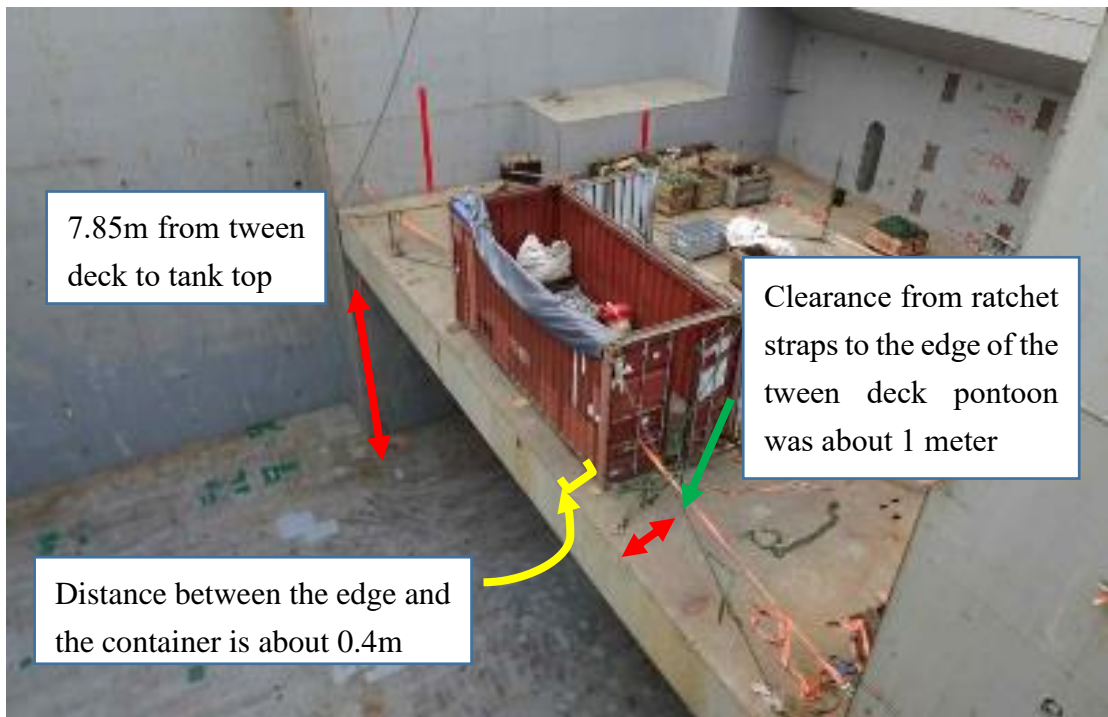
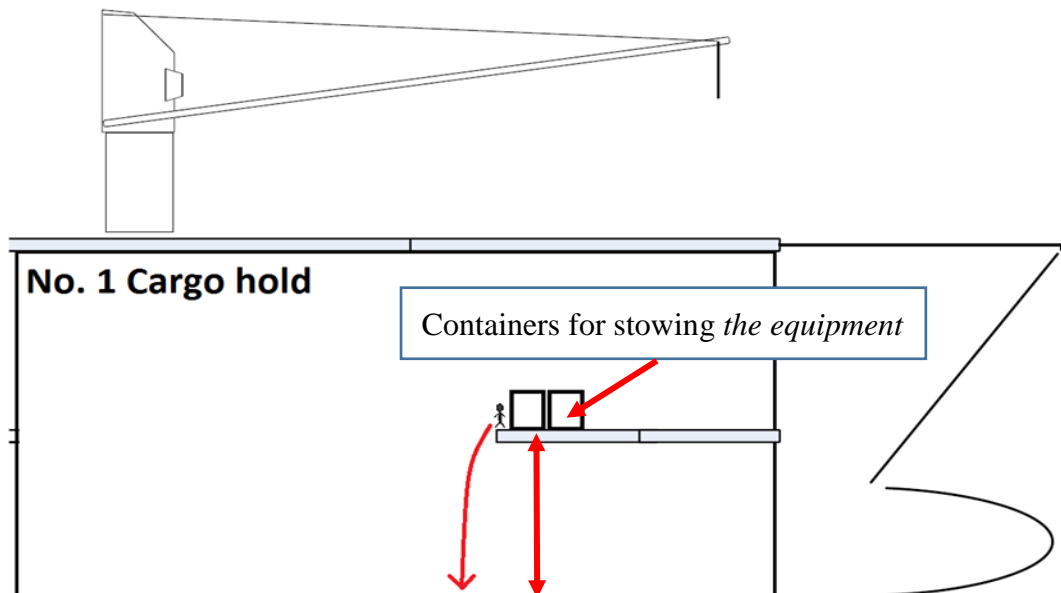
- 4.9 Chapter 11.2.4 of *the Code* stated that any opening, open hatchway, or dangerous edge into, through, or over which a person may fall should be fitted with secure guards or fencing of adequate design and construction. At the time of the accident, the tween deck of *the hold* located at the height of about 7.85 metres from the bottom was partially opened. The clearance between the outer container stowing *the equipment* and the edge of the tween deck pontoon was about 0.4 meter. The secure guard was simply provided by 2 ratchet straps of about 1 meter away from the edge of the tween deck connecting between the end sides of the outer container to the port and starboard side bulkheads (Figure 3 & 4). Such arrangement was considered a contributory factor to the accident.

- (b) the crew failed to fit the tween deck opening with secured guards or fencing of adequate design and construction to prevent the fall from the tween deck;

- (b) ensure the secure guards or fencing of adequate design and construction to be fixed on the tween deck opening for preventing the fall;
 - (c) ensure adequate illumination to be provided inside the cargo holds before entering; and
