**Report of investigation into the fatal  
accident on board the Panama  
registered container ship “MCC Tokyo”  
at Hong Kong on 28 April 2021**

The Hong Kong Special Administrative Region  
Marine Department  
Marine Accident Investigation Section

27 August 2022

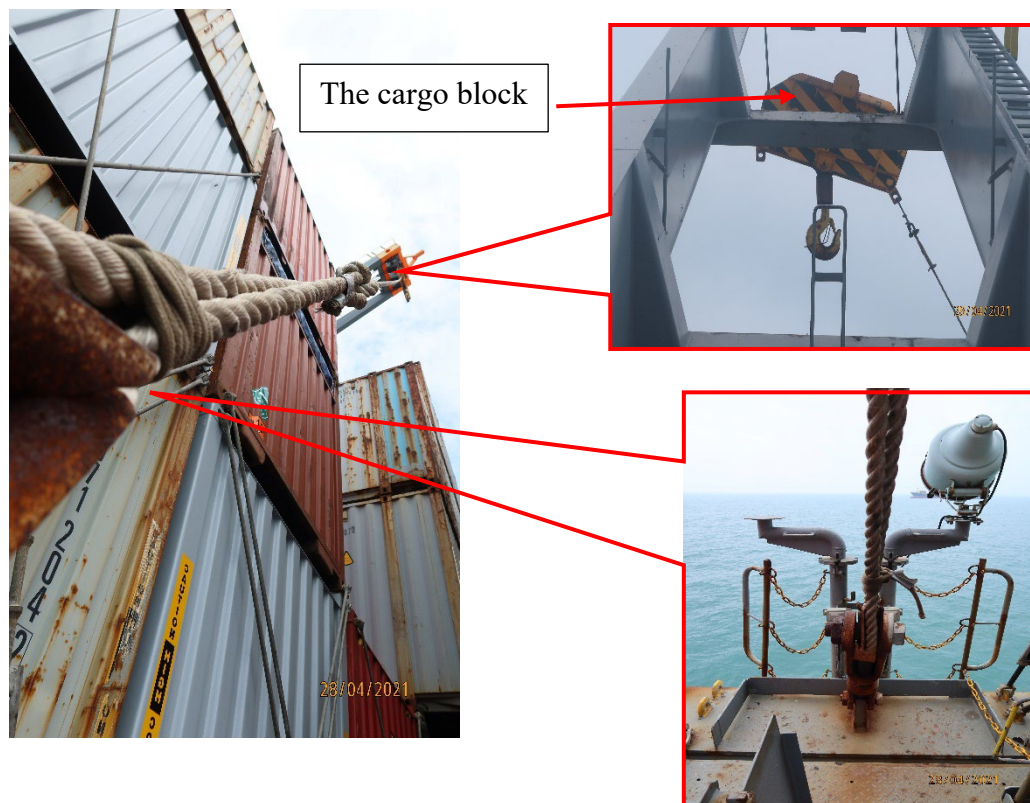
Figure 2 The port side lashing arrangement of the No.3 ship crane.

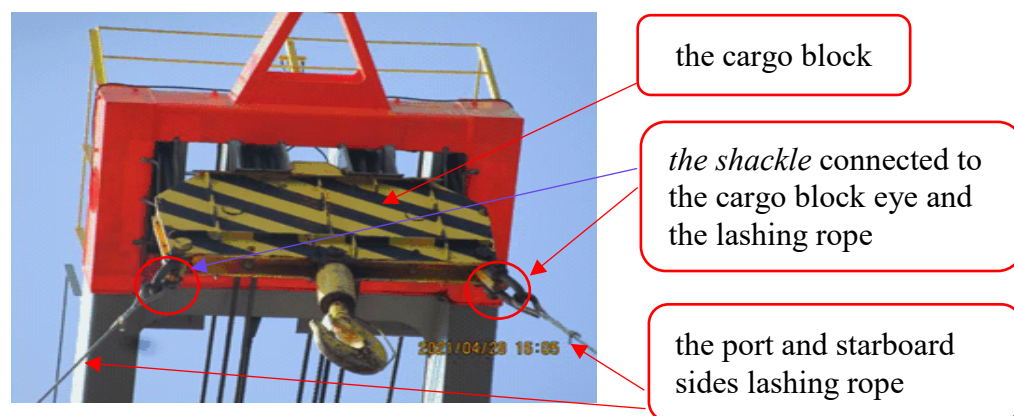
- 4.9 According to the manufacturer's manual of the ship crane (*the manufacturer's manual*), the ship crane should be secured after the finish of an operation. It should be turned to the rest direction, facing the ship forward, and lowered the jib to a rest position. The cargo block should be hoisted up until it touches the jib block. After *the cargo block* was held in position, the hoisting and luffing wire should be in tension to prevent *the cargo block* and the jib from falling. The ship crane jib of *the vessel* should be secured through fixing its cargo block by two lashing ropes affixed respectively at the port and starboard sides of the lashing bridge (Figure 3 & 4). *The manufacturer's manual* also showed that the lashing arrangement consisting of the lashing rope, rigging screw and shackle should be approved by the design section of the manufacturer (Figure 5).

Figure 3 the correct lashing arrangement for the ship crane

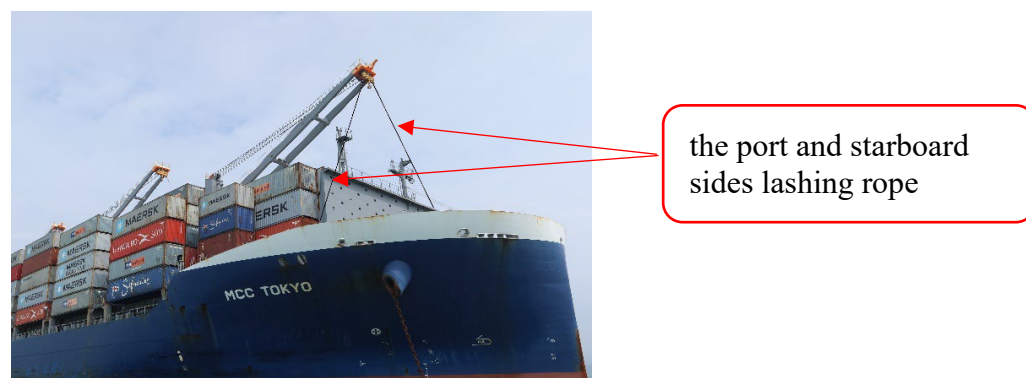
Figure 4 the lashing ropes of the ship crane

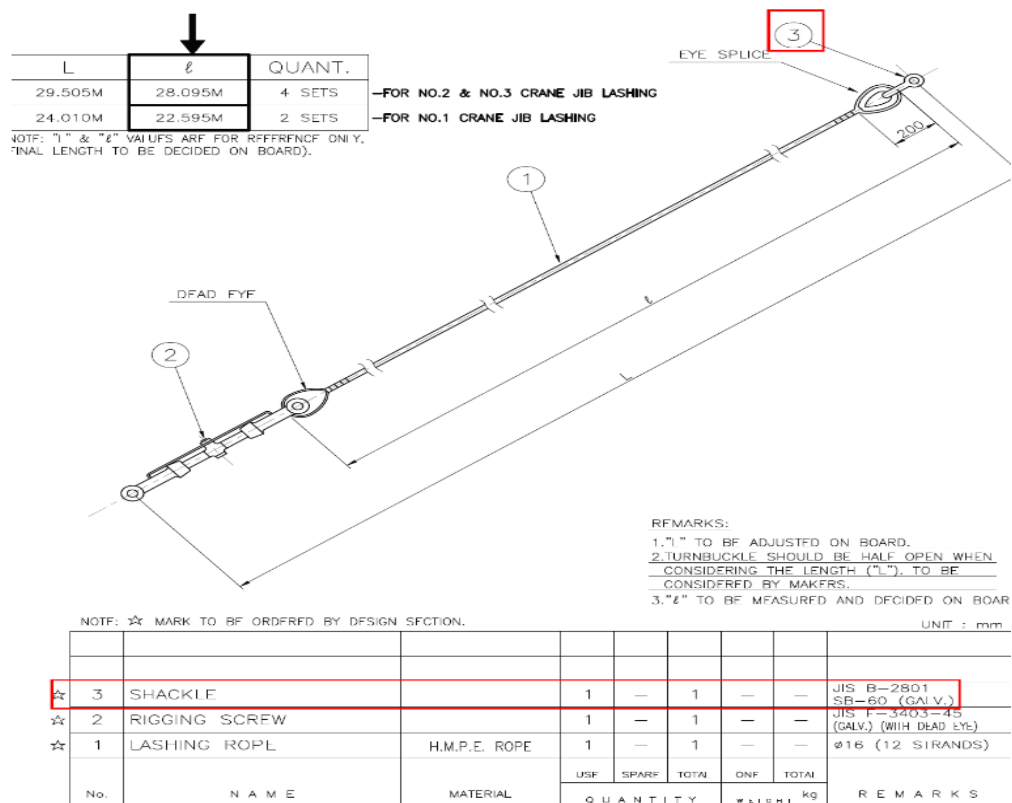
Figure 5 the requirements of the lashing arrangement

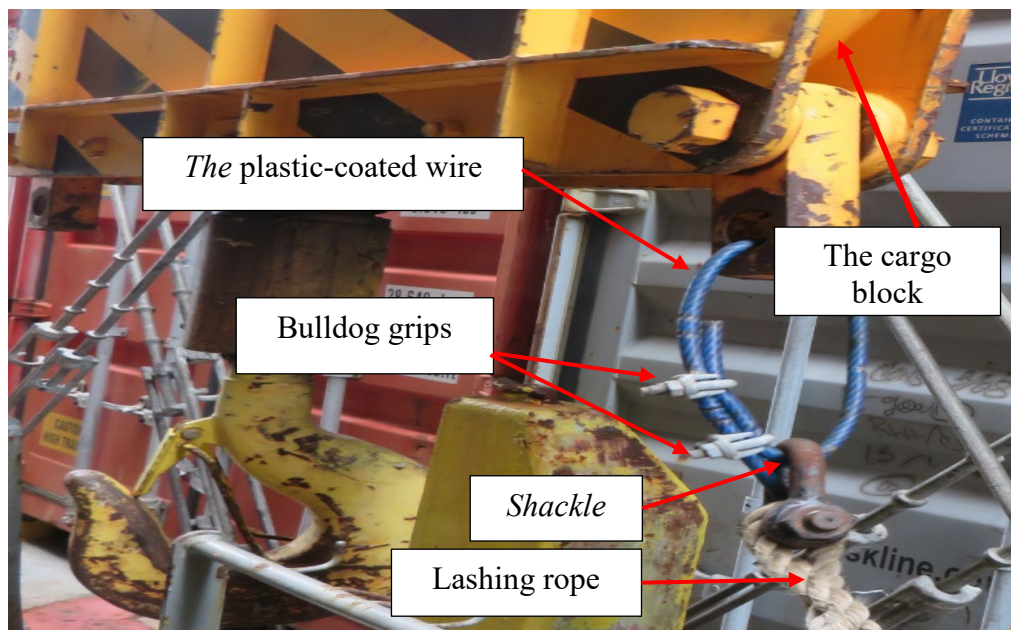
- 4.12 The shipboard port side lashing rope to *the cargo block* was similar to the starboard lashing rope. *The wire* was linked with lashing rope by *the shackle* and connected to *the cargo block* as shown in Figure 6. The requirements specified in *the manufacturer’s manual* to the lashing arrangement were not followed. The investigation also found that the use of a plastic-coated wire did not comply with the requirements of Annex 18.2 of *the Code*.

Figure 6 The lashing arrangement of the No.3 ship crane at the time of accident

- 4.15 *The wire* was subjected to loading when *the cargo block* was lifted

to the securing position. Moreover, the crew exercised an improper arrangement of using a plastic-coated wire in the lifting process. Subsequently, *the wire* slid out of the bulldog grips when the loading exerted on it during the lifting of *the cargo block*. As a result, *the wire, shackle, bulldog grips, and the lashing rope* fell from a height of about 20 meters to the lashing bridge below.

- 6.1 The management company should issue circulars informing all masters, officers, and crew members of its fleet of the findings of the investigation and lessons learnt from this accident and instruct them to:
  - (a) enhance the safety culture onboard, in particular when the ship crane is in operation; and
  - (b) enhance the training plan to ensure the crew are familiar with lifting gears and lifting operation, particularly the lashing arrangement of ship crane.
- 6.2 A copy of the investigation report should be provided to the Panama Flag Administration for information and attention on the findings of the report.
- 6.3 A Marine Department Notice is to be issued to promulgate the lessons learnt from this accident.

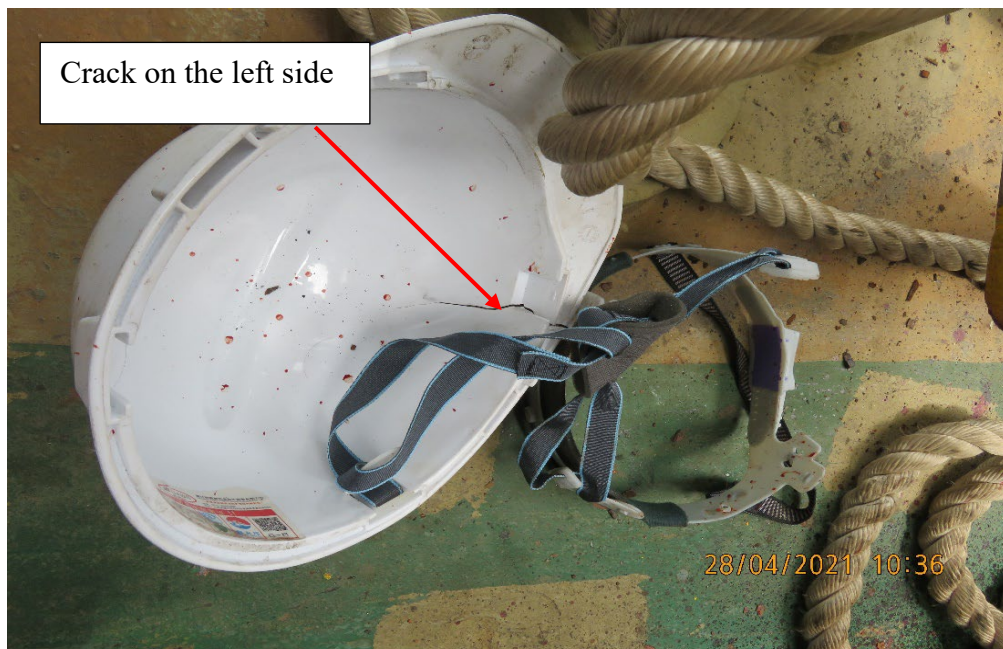
- 4.16 At the accident scene, a *shackle* linked with lashing rope and one bulldog grip were found adjacent to the OS. The safety helmet of the OS was cracked on the left side (Figure 7). It was deduced that the OS was hit by a bulldog grip and *the shackle* connected to the lashing rope, which resulted in his serious head injury leading to his death afterwards.

Figure 7 The safety helmet of the OS.
