**Report of investigation
into the fatal accident on board the
Hong Kong registered bulk carrier
“Simon Brother” at Kavieng,
Papua New Guinea on 1 May 2021**

**The Hong Kong Special Administrative Region
Marine Department
Marine Accident Investigation Section**

18 February 2022

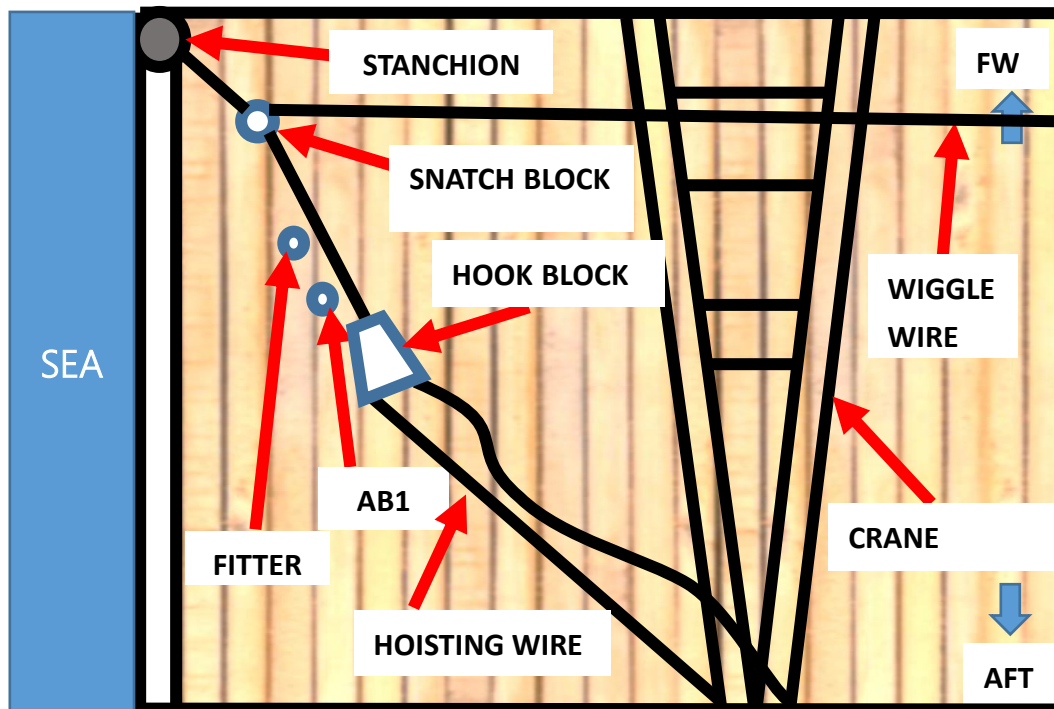
- 3.3 At around 0955 hours, a cargo securing team consisted of 8 crew members, including the AB1 and the Fitter, equipped with safety helmets, gloves, safety shoes and working clothes, finished securing the deck log cargoes (the cargoes) on top of the No.2 hatch. Afterwards, the AB1 and the Fitter observed that part of the hoisting wire was slack and jammed at the gap between the side plate and the sheave of the hook block of the No.1 crane.

- 3.4 Without informing the C/O, the AB1 and the Fitter approached the block to check when they noticed that the hoisting wire guided by the sheave on one end of the block was slack, and the other end was taut.

- 3.5 The block was shifted and rotated suddenly on the top level of the uneven cargoes during their inspection, causing the taut wiggle wire to move abruptly. The AB1 and the Fitter were struck into the sea by the released stored energy of the wiggle wire. The Fitter was conscious, and the AB1 was observed struggling to swim with his face submerged in the water for a short while.

Figure 2 Approximate configuration of the securing arrangement and position of the AB1 and the Fitter

4.19 However, at the time of the accident, one of the wiggle wires of the No.2 hatch was taken load by the hoisting block of the No.1 crane. Such wiggle wire was neither secured in position by wire rope clips nor secured to the deck fitting with a turn buckle (Figure 2), thus failing to follow the requirements of the CSM.

- (d) ensure the crew members to strictly follow the requirements of the CSM in the securing operation of the cargoes on board; and
 - (e) enhance the shipboard safe operation training for the key operations, especially when carrying out the securing operation.

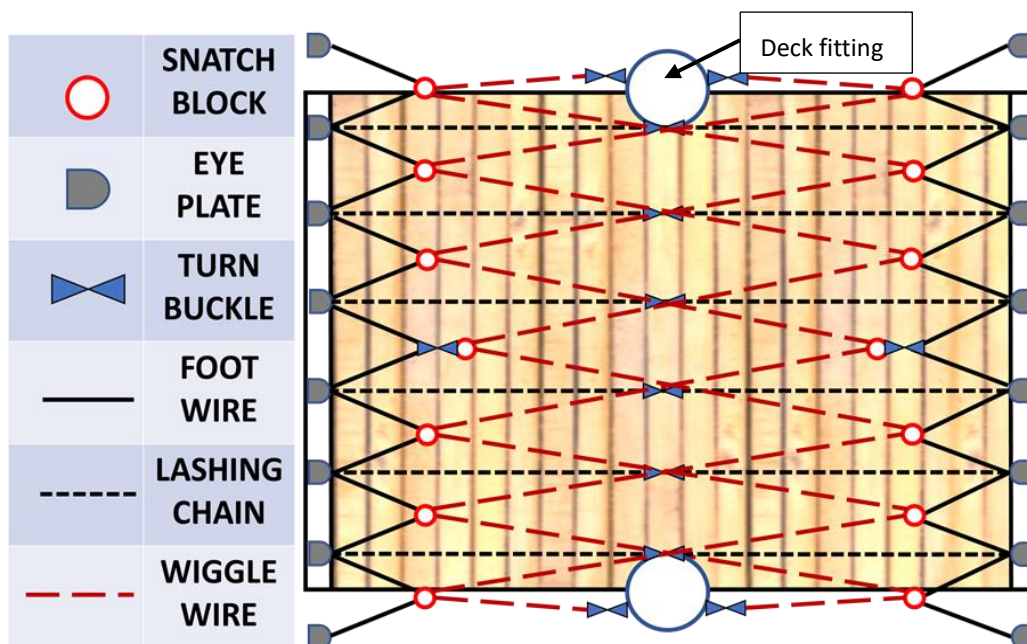
4.18 A “Lumber Loading Plan” (LLP) was included in the CSM to show the securing layout and arrangement for deck log cargoes (Figure 3). The LLP indicated that the wiggle wire lashings required a number of foot wires shackled to deck eye plates on both sides of the deck with another end attached to a snatch block to allow the wiggle wire to run through side by side above the cargoes in a zig-zag manner. Occasionally, some foot wires are required to connect to the snatch blocks by a turn buckle. Turn buckles are also required to secure both ends of the wiggle wire to a deck fitting. The wiggle wires were to be tightened by applying load onto it before the wire rope clips were used to secure the wiggle wire in position.

Figure 3 Simplified sketch of the securing layout on top of *the* deck log *cargoes* with reference to the CSM

- 4.23 Chapter 4.2.6.b.3 of the shipboard CSM states that the wiggle wire system of lashing aboard *the vessel* is not recommended because *the vessel* did not fit with independent winches between hatches for the securing operation.
