**Report of investigation
into the fire accident on board the
Panama registered General Cargo vessel
“*Affluent Ocean*” at Kellett Anchorage
No.3, Hong Kong on 2 June 2021**

The Hong Kong Special Administrative Region
Marine Department
Marine Accident Investigation Section

22 July 2022

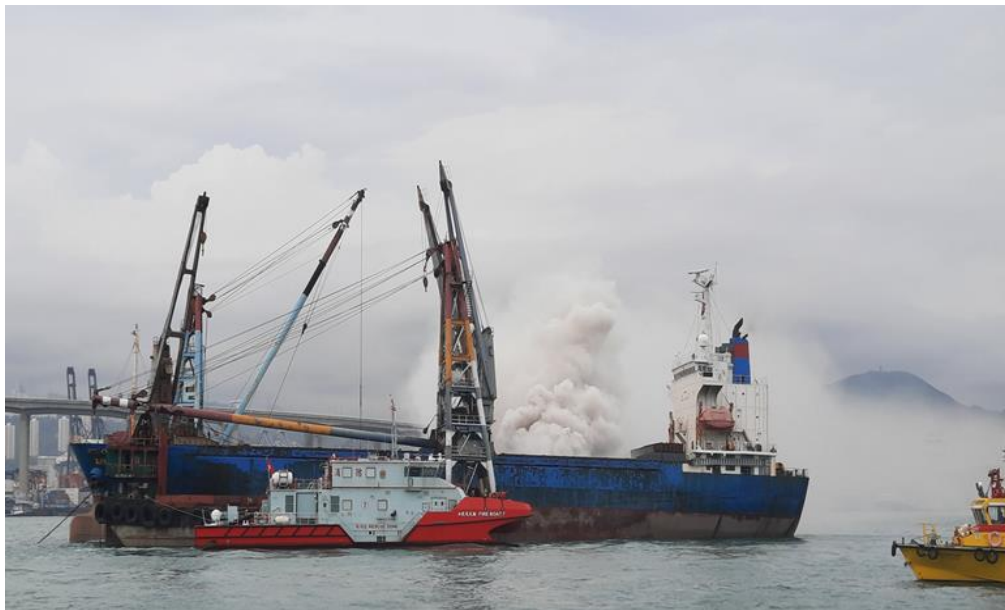
- 3.6 At about 1623 hours, all crew members mustered at the port side main deck and prepared fire hoses for firefighting. One fire hose shot water to the cargo in *the hold* when other fire hoses were for boundary cooling. At the same time, the C/O informed the port side barge to discharge the concerned cargo to find the fire source.
- 3.7 At about 1700 hours, when the cargo in *the hold* was discharged from a height of 12 metres to 10 metres, fireboats of the Fire Services Department (FSD) arrived at the scene (Figure 3). In order to make room for fireboats to fight the fire, the port side barge shifted to the forward of *the vessel*, and the discharge of the cargo had to stop. The Master then informed the C/O to request the starboard side barge to continue discharging the cargo of *the hold* to find the fire source, but the barge refused.

Figure 3: the scene of the fire when fireboats arrived

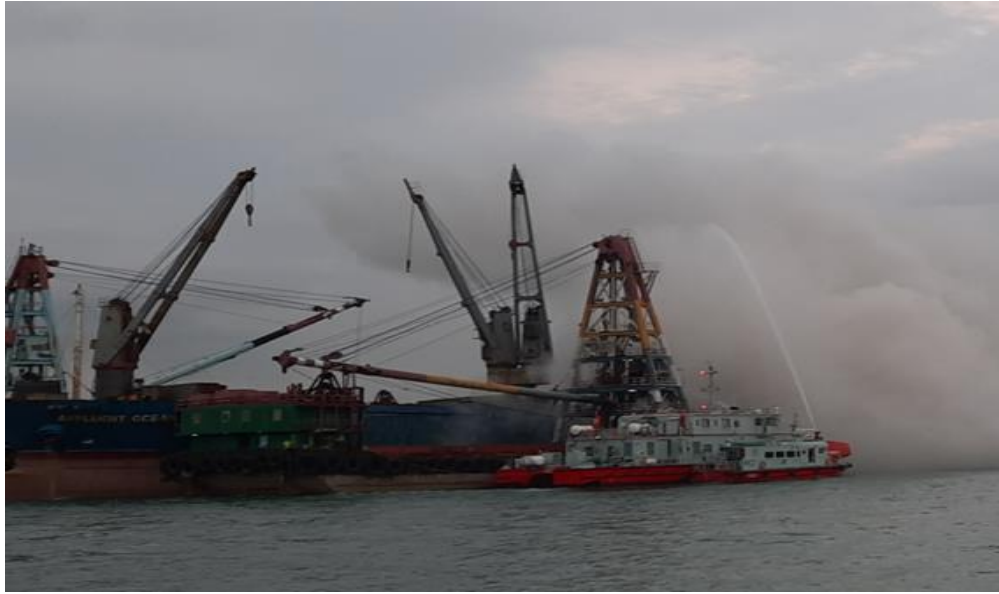
- 3.8 At about 1720¹ hours, fireboats commenced shooting water to the

No.2 cargo hold (Figure 4).

Figure 4: The fireboat was shooting water

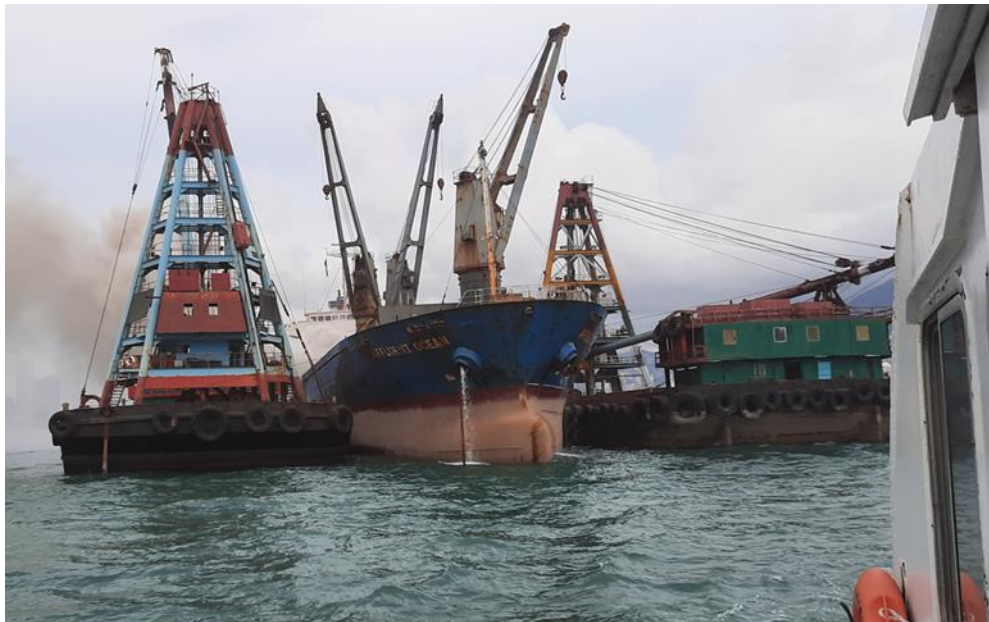
- 3.9 At about 1750 hours, a patrol boat of MD arrived at the vicinity of the scene, and the Pollution Control Unit of MD was informed to standby for combating the oil spill (Figure 5).

Figure 5: the scene when the MD patrol boat arrived

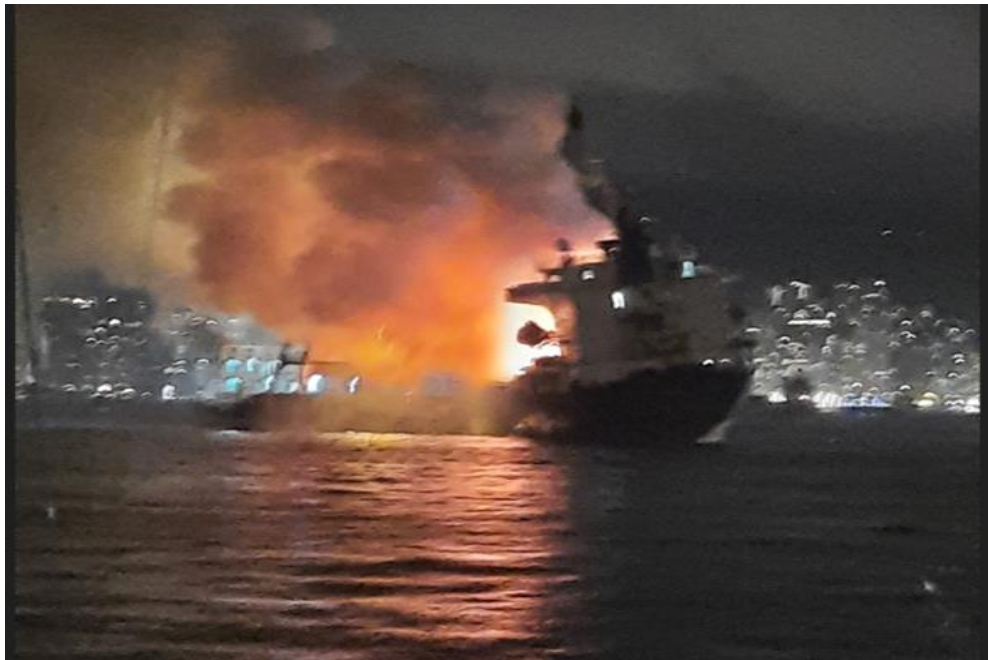
Figure 6: the scene at 2327 hours on 2 June 2021

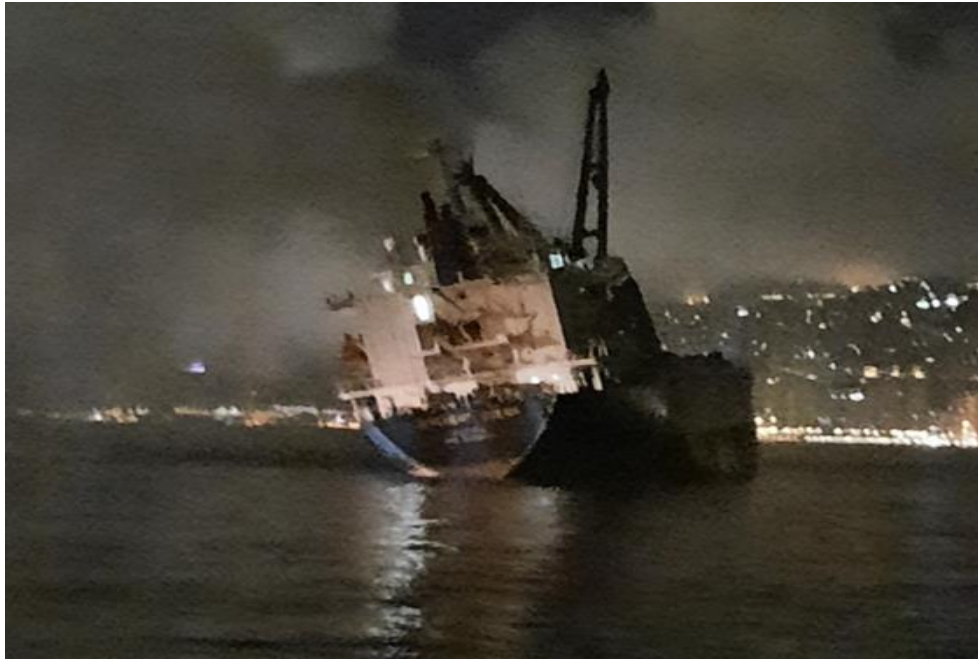
Figure 7 the fire scene at 0254 hours on 3 June 2021

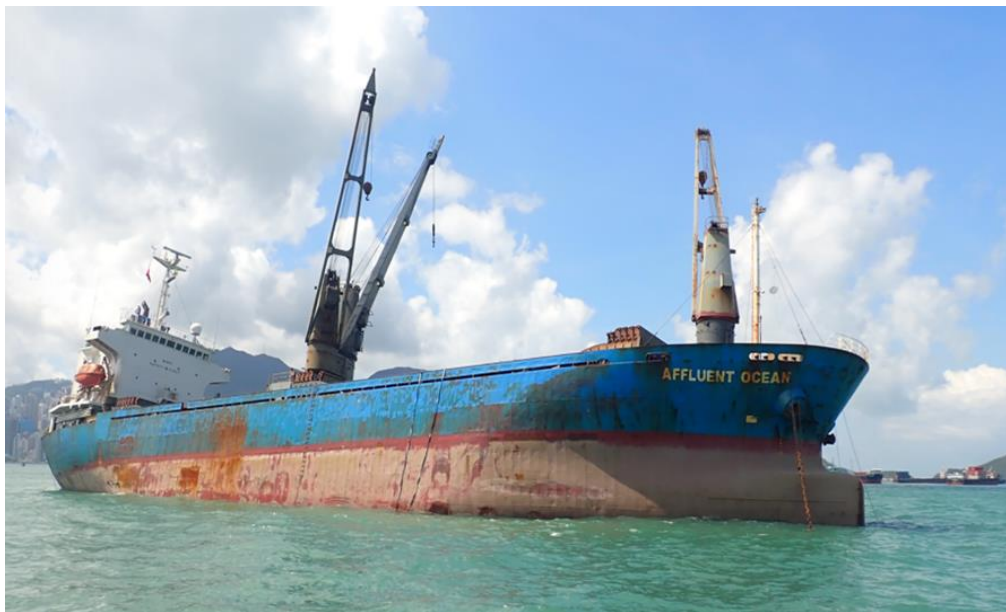
- 3.15 At about 0512 hours on 3 June 2021, the fire on *the vessel* was still not under control, and dark smoke was continued emitting from the fire scene.
- 3.16 At about 0820 hours, FSD reported that the fire on *the vessel* was extinguished. The anchoring position of *the vessel* was unchanged throughout the fire (Figure 8).

Figure 8 *the vessel* after fire was extinguished

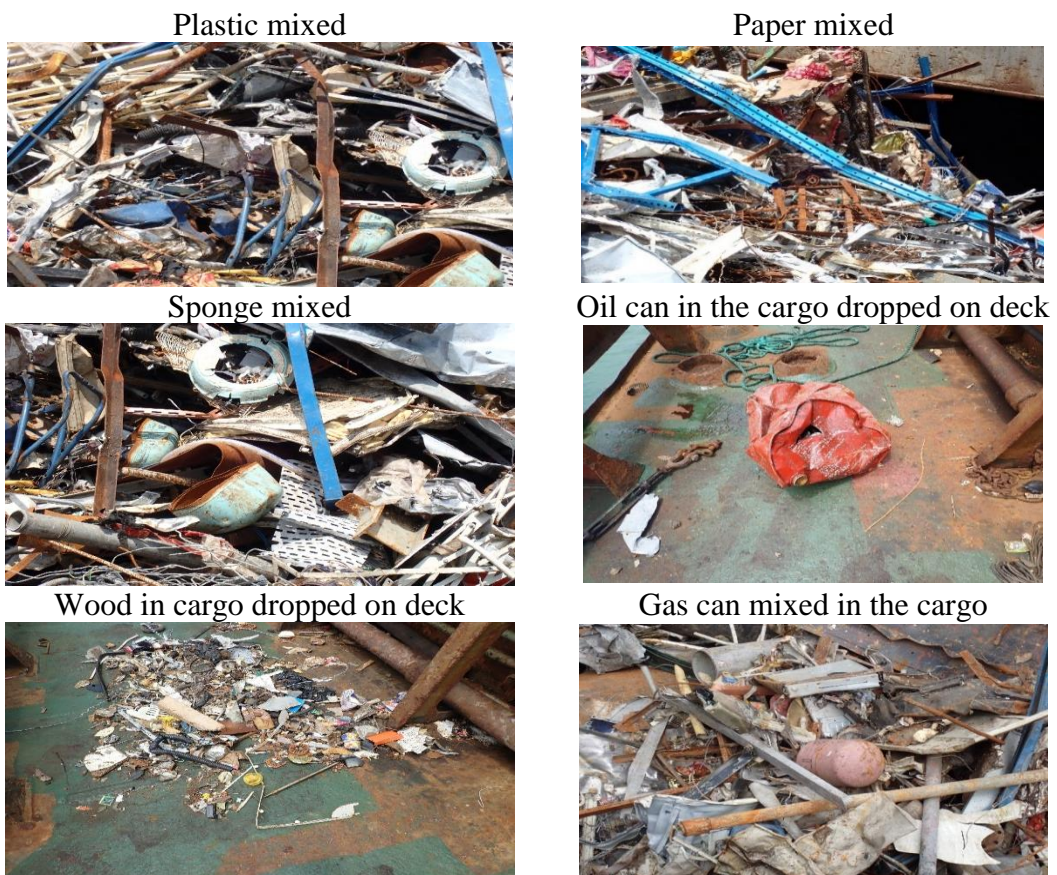
- 4.9 The investigation revealed that the cargo loaded onboard *the vessel* was mixed with other combustible substances, such as plastic, papers, sponges, oil can, woods and gas can. (Figure 9)

Figure 9 Cargo loaded onboard *the vessel*

4.10 When the duty C/O initially noticed smoke in *the hold* at 1620 hours on 2 June, the stevedores were trimming the cargo with the barge's spider grab. It might be deduced that the fire broke out when the spider grab was trimming the cargo inside the hold causing sparks generated from the metal to metal contact that ignited the combustible substances in the cargo, or possibly as a result of spontaneous combustion.

4.11 According to *the instruction*, it was identified that the scrap metal loaded in Hong Kong could be liable to spontaneous combustion easily and might cause fire, in particular, when shipping steel scrap, the property of which was slightly different from the scrap metal as defined in the IMSBC Code.

4.13 *The instruction* established a procedure as “*sprinkle water on top of steel scrap about 10 minutes*” after completion of loading and survey at the loading port. However, the investigation revealed that the Master underestimated the risk of loading scrap metal that might combust spontaneously, and the Master did not follow the shipboard SMS to carry out a risk assessment properly and establish a contingency plan to respond to the potential fire risk when loading scrap metal in Hong Kong, especially when trimming the cargo by using the grab.

- (a) enhance safety awareness of the risk of loading scrap metal that might spontaneously combust;
 - (b) ensure a risk assessment before loading scrap metal cargo in bulk according to the shipboard SMS to establish procedures to respond to the hazards identified;
