**Report of investigation  
into the fatal accident on board the  
Hong Kong registered bulk carrier  
“Hebei Universe” at Qingdao  
anchorage, China on 17 December 2021**

**The Hong Kong Special Administrative Region  
Marine Department  
Marine Accident Investigation Section**

30 September 2022

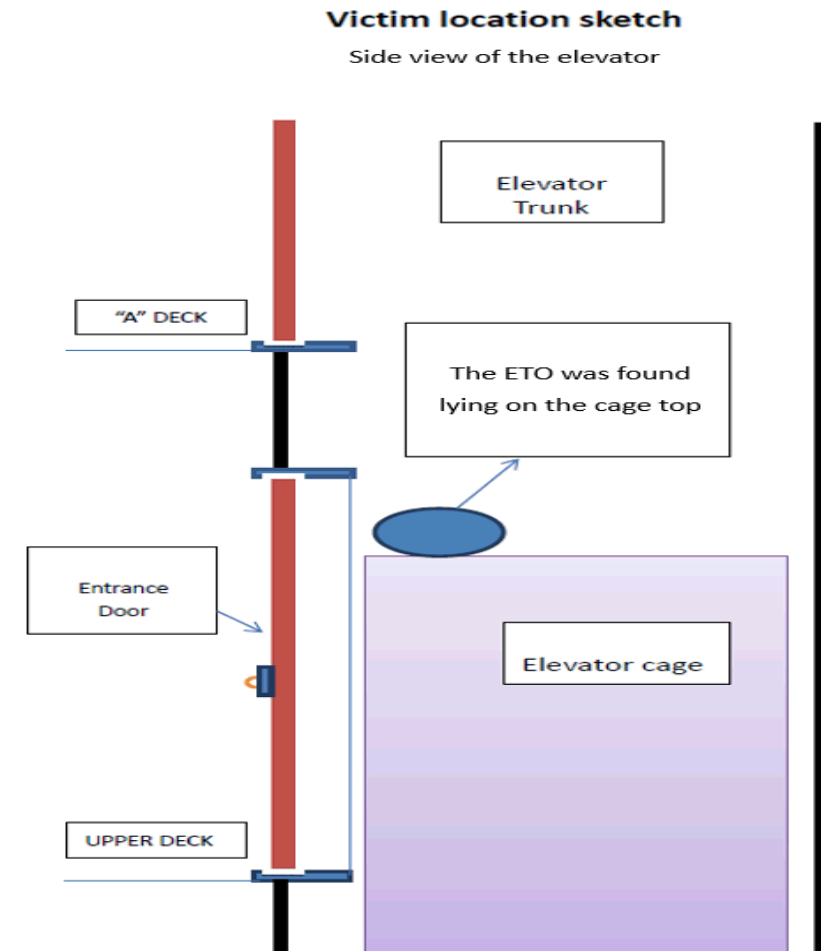
Figure 2 Victim's location inside the elevator trunk

- 3.6 *The 3/E and the Second Engineer (the 2/E) attempted to manually open the entrance door on the upper deck without success. Later, the engine room crew removed the entrance door on the upper deck and found the ETO was unconscious, curling on the top of the elevator cage (Figure 2), bleeding from his nose and mouth, head tilting downward, and facing the entrance door.*

- 4.12 When *the ETO* was found lying on the cage top of *the elevator*, he was bleeding from his nose and mouth with his face turned into purple. But no trauma was found on his body after being examined by the crew members.

- 4.13 The death certificate of *the ETO* issued by the hospital in Qingdao stated that the external compressive force of machinery might have caused his death. The police report stated that there was no trauma found on the body of *the ETO* thus ruling out the factor of homicide. It could be deduced that *the ETO* might have been crushed by the moving elevator while repairing *the elevator* on the cage top, resulting in his death.

- 4.19 The investigation revealed that during the repair of *the elevator*, the operating panel on the cage top was set in “auto” mode and the emergency stop switch was not in the “trip” position. *The ETO* was found working alone on the cage top without displaying any *safety signs*. He was exposed to serious safety hazards while carrying out the repair work on *the elevator* alone. He did not follow the requirements of the *operation manual* and *the Code*, resulting in his trapping between the cage top and upper edge of the upper deck entrance door.

- (a) strictly follow the shipboard *operation manual* and *the Code* requirements when carrying out the work on the elevator in a safe manner on board;

- (b) ensure that the risk assessment and the permit-to-work system are followed before commencing the work on the elevator; and
  - (c) enhance safety awareness and safety culture on board in order to ensure that the crew members have sufficient safety awareness in the work on the elevator.

- 6.2 The management company should revise the shipboard *SMS* to identify work on elevator, including work requiring access to its trunk, as one of the main risks onboard and conduct an internal audit on *the vessel* to ensure that the crew members strictly follow the safety requirements when carrying out work on *the elevator*.

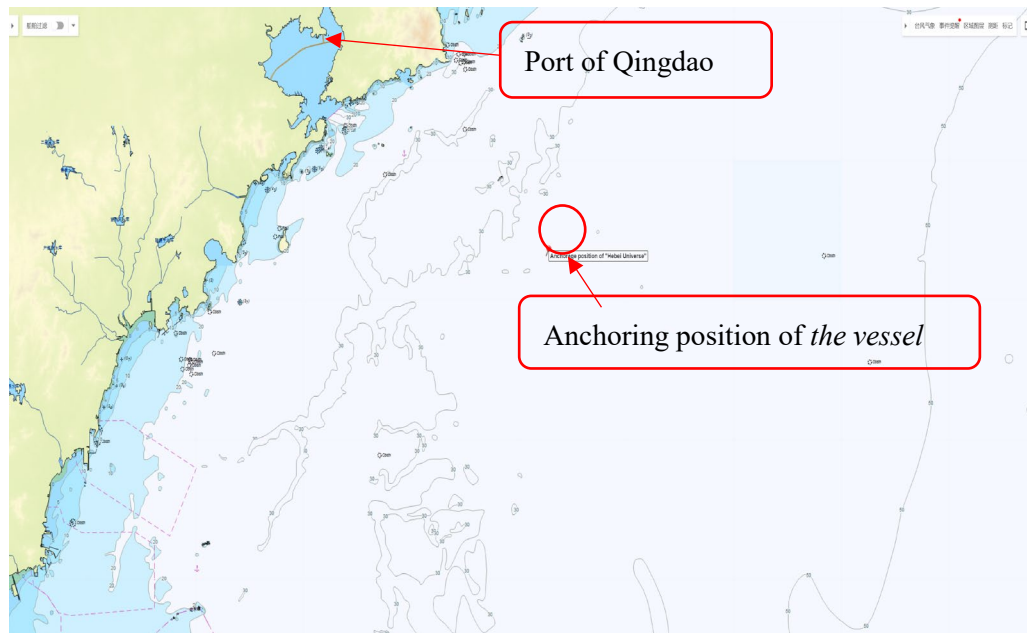
Figure 3: The anchoring position of *the vessel* at the time of the accident

- 4.6 At the time of the accident, the weather was cloudy with northwesterly wind of Beaufort Wind Scale force between 5 and 7. The sea was moderate to rough and the visibility was good. According to the

crew statement, *the vessel* was quite steady on the day of the accident though the weather outside was unpleasant as *the vessel* was in full loading condition. It was deduced that the weather should not be a contributory factor to the accident.

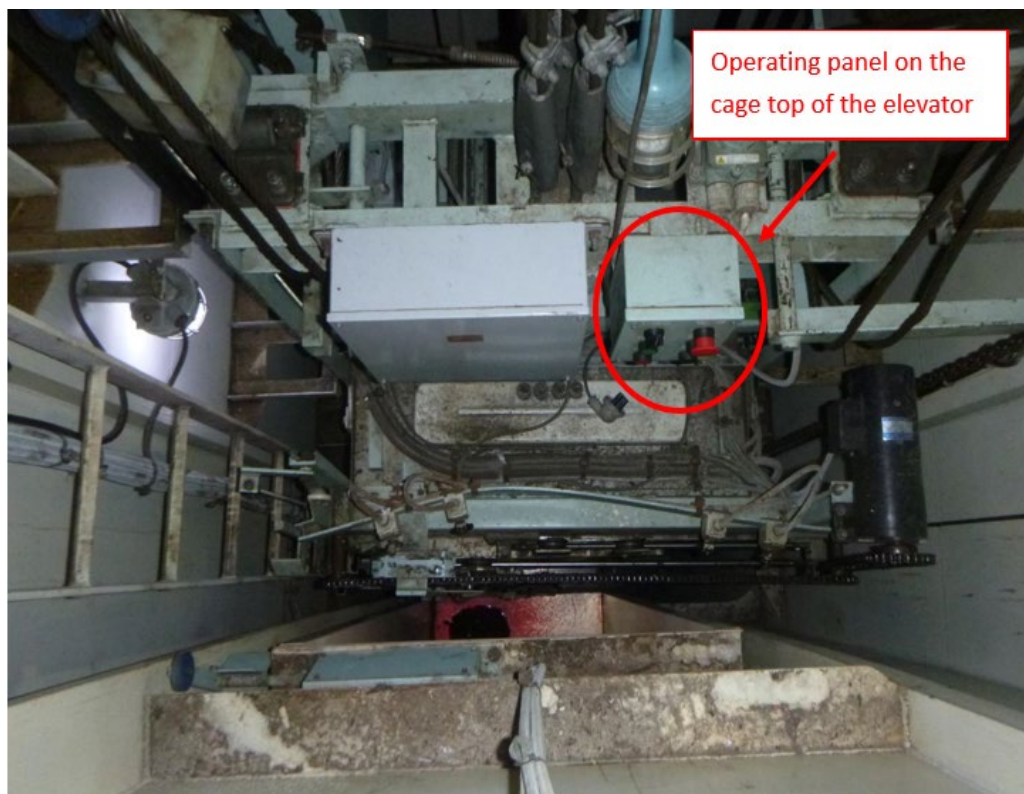
Figure 3 Operating panel on the cage top of *the elevator*

4.16 *The elevator* can be operated in “auto”<sup>2</sup> mode, “manual”<sup>3</sup> mode (Figure 3), and mechanical<sup>4</sup> mode. An emergency stop switch is provided on the operating panel of the *elevator* located at the top of the cage. A call button is installed at the side of entrance door on *each deck* and inside *the elevator* cage.

- 4.18 *The operation manual* stated that a post of “Out of service” or “Don’t use” (*safety sign*) should be displayed on the entrance door of each deck and more than two engineers with effective communications should attend the work on *the elevator*. *The operation manual* also stated that the operation mode of *the elevator* should be switched to the “manual” mode, and that the emergency stop switch should be changed to the “trip” position while working on the cage top of *the elevator*.
