**Report of investigation  
into the fatal accident on board the  
Hong Kong registered bulk carrier  
“*Clearwater Bay*” at sea on 1 January  
2022**

The Hong Kong Special Administrative Region  
Marine Department  
Marine Accident Investigation Section

7 October 2022

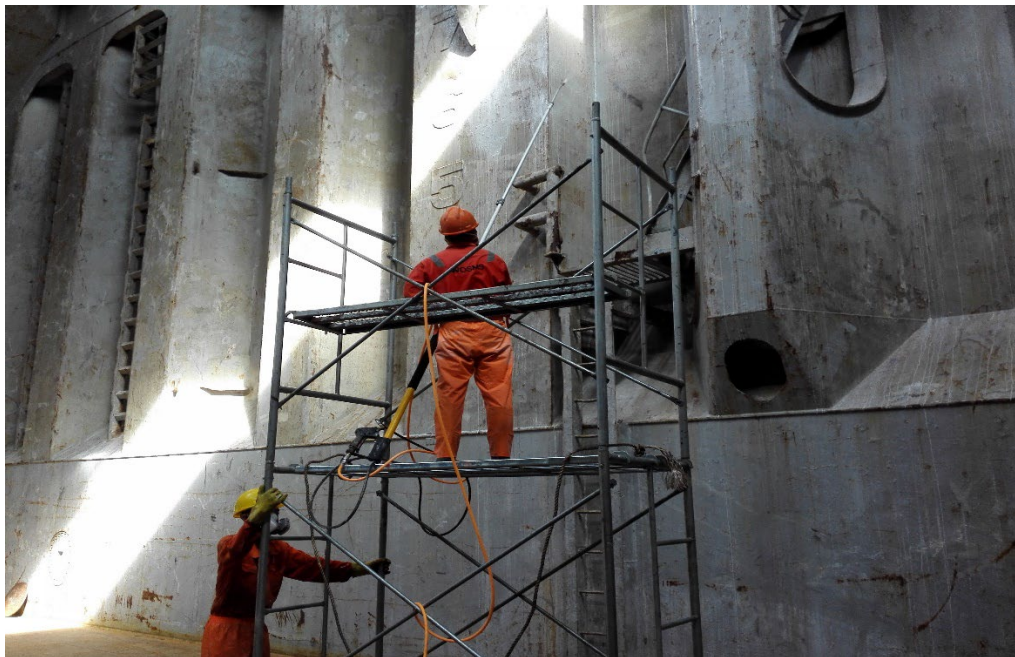
Figure 2: lime-coating operation in *the cargo hold*

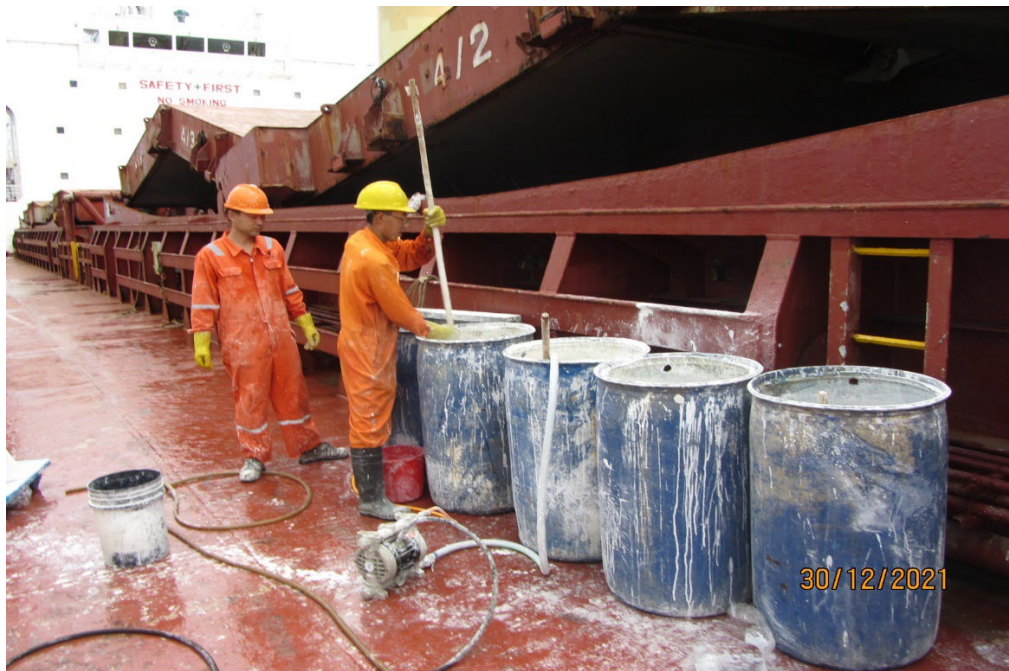
Figure 3: Cleaning the lime residues on the main deck

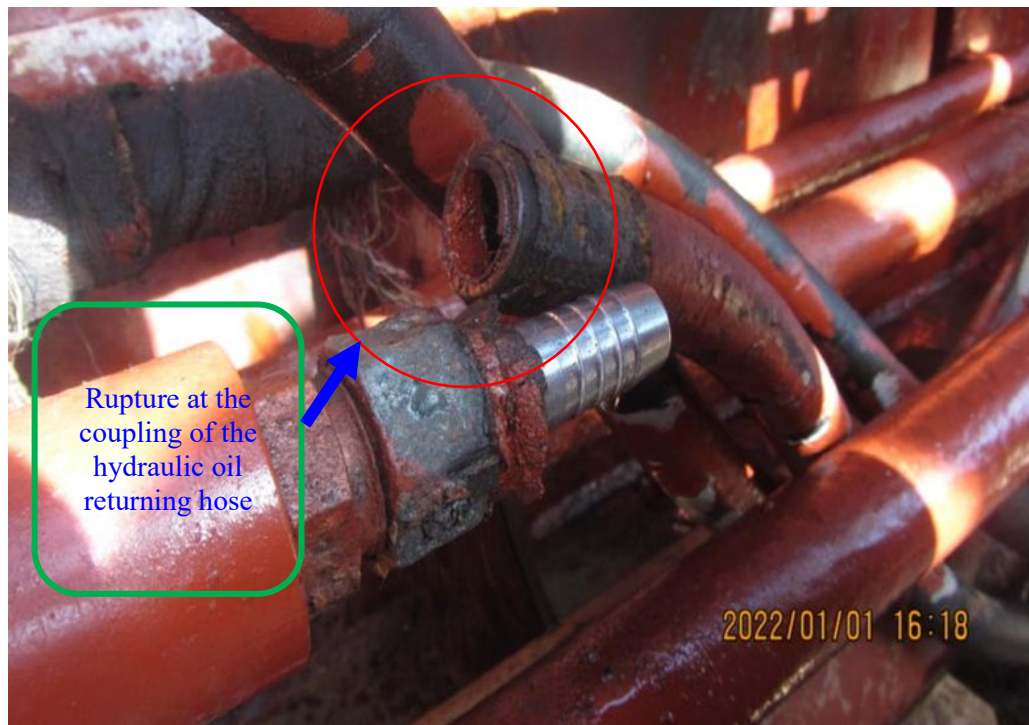
- 3.7 The AB found that the oil return hydraulic hose ruptured at the coupling between the oil pipe and the hose of *the operating system*, and the leaked hydraulic oil was found underneath the control box. The upper body of the C/O was crushed under the hatch cover when he was checking *the cargo hold* condition at the time of the accident (Figures 4 & 5).

Figure 4: Rupture of the hydraulic oil returning hose

- 4.24 The accident was caused by the rupture of the hydraulic pipe, which led to the loss of the hydraulic pressure of *the operating system* resulting in the hatch cover being closed suddenly by its weight. The C/O could not escape when he leaned over the hatch coaming under the hatch cover to check the condition of *the cargo hold*. The accident resulted in the upper body of the C/O being crushed by *the hatch cover*.
- 4.25 According to the Death Certificate issued by Registrar of Births, Deaths and Marriages, Western Australia, the cause of death was injured when a malfunctioning hydraulic hatch cover crushed him.

- (b) strictly follow the requirements of *the manual* to carry out the maintenance of the hydraulic operating system of the hatch cover; and
  - (c) strictly follow the requirements of *the Code* and *the manual* to operate the hatch cover.

- 6.2 The management company should consider revising the shipboard SMS to ensure the hydraulic operating system of the hatch cover is included in the shipboard maintenance manual and conduct an internal audit on *the vessel* to ensure that the crew members strictly follow the requirements of *the manual* to carry out maintenance onboard.

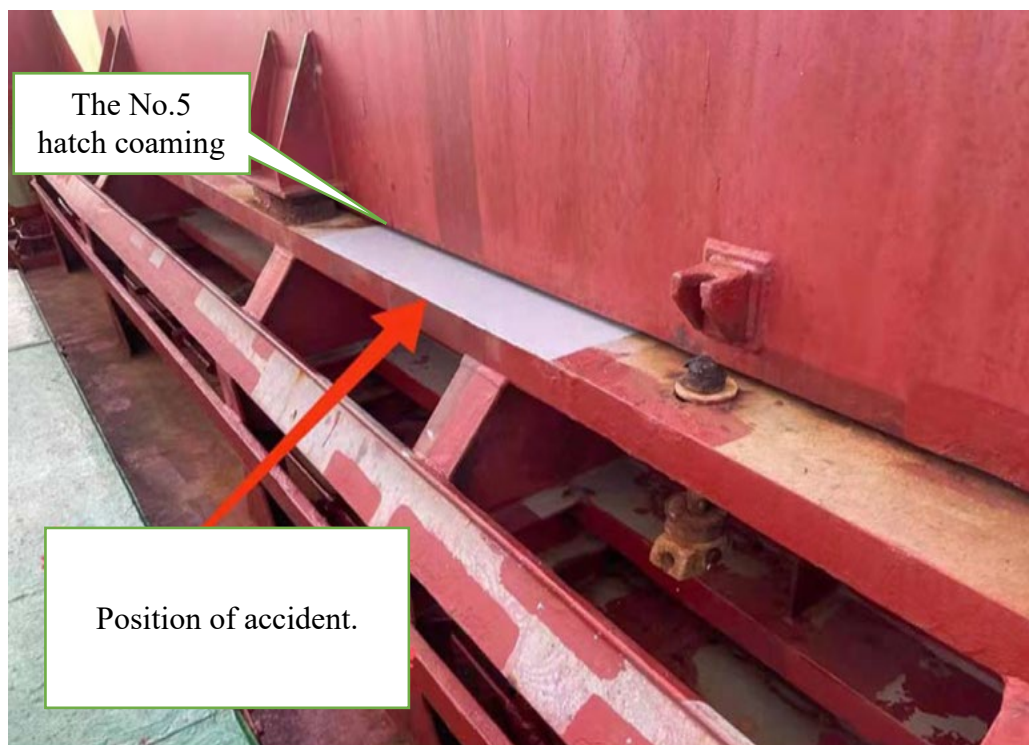
Figure 5: The No. 5 hatch coaming where the accident occurred

- 4.21 At the time of the accident, the hatch cover was partially opened. The C/O leaned over the hatch coaming under the partially opened hatch cover, which was merely held by the hydraulic pressure, to check the condition of *the cargo hold* and take photos. It was deduced that the C/O did not realize that he was in a dangerous working condition when carrying out the above work.

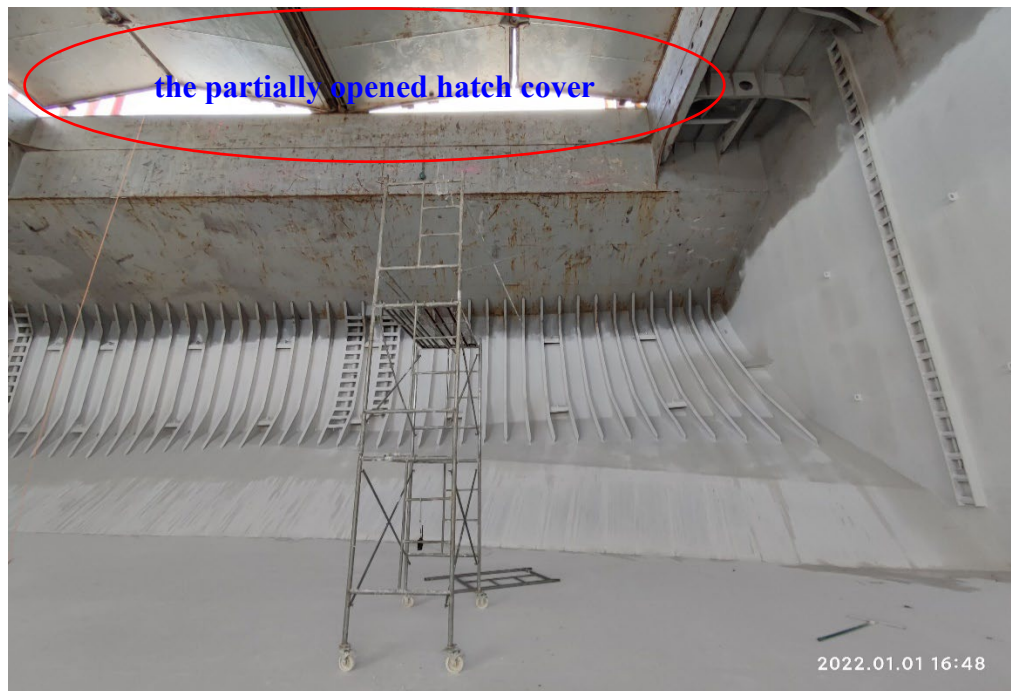
- 4.13 *The hatch cover* was partially opened under the condition that *the vessel* was rolling at about 5 degrees when it was underway. The investigation revealed that the hatch operating condition did not follow the instructions of *the manual* as it should not be operated while underway.

- 4.15 However, *the hatch cover* was partially opened when the crew members carried out the lime-coating operation in *the cargo hold* (Figure 6). It did not follow the requirements of *the Code* and *the*

Figure 6: the partially opened hatch cover
