**Report of investigation  
into the man overboard accident on  
board the Hong Kong registered bulk  
carrier “*JIA MAO SHAN*” at sea on 12  
March 2022**

The Hong Kong Special Administrative Region  
Marine Department  
Marine Accident Investigation Section

19 December 2022

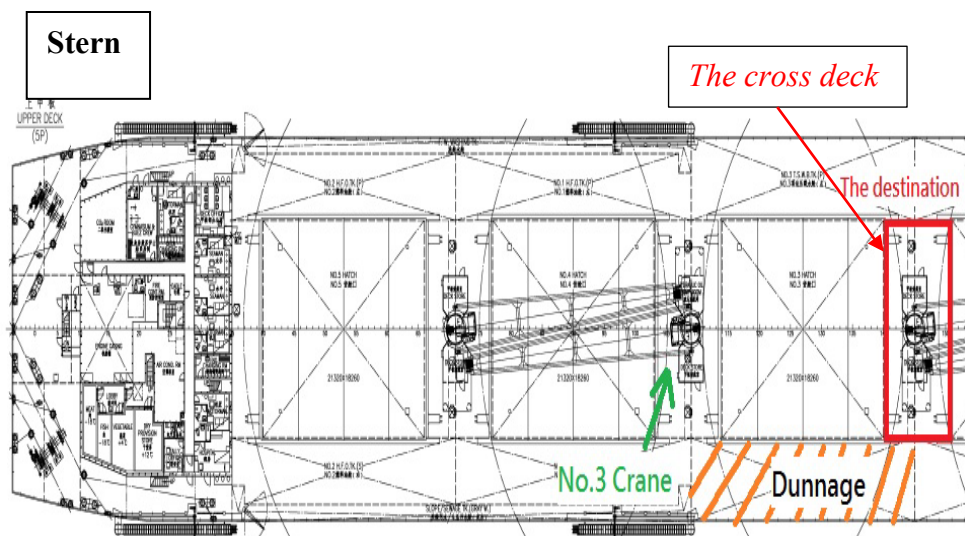
Figure 2 Location of *the work* (from Starboard Main Deck to the Cross Deck)

- 3.7 At 1100 hours, *the work* on the port side main deck was completed and commenced on the starboard side main deck near the No.3 cargo hold (*the hold*).
- 3.8 According to the working arrangement in the toolbox meeting, the packed dunnage stowed on the starboard side main deck would be transferred to *the cross deck* (Figure 2).
- 3.9 *The work* was carried out by using *the crane* with its rigging arrangement (Figure 3) (i.e. a steel wire rope was connected to the crank hook; a nylon rope was connected to the steel wire rope by a shackle; the packed dunnage was tied with another hoisting sling and connected to the nylon rope; and three independent tug lines<sup>4</sup> in the directions of bow, stern and side were connected to the crane hook and controlled by hand through the deck ring (Figure 4)) aiming to restraint the movement of the hook.

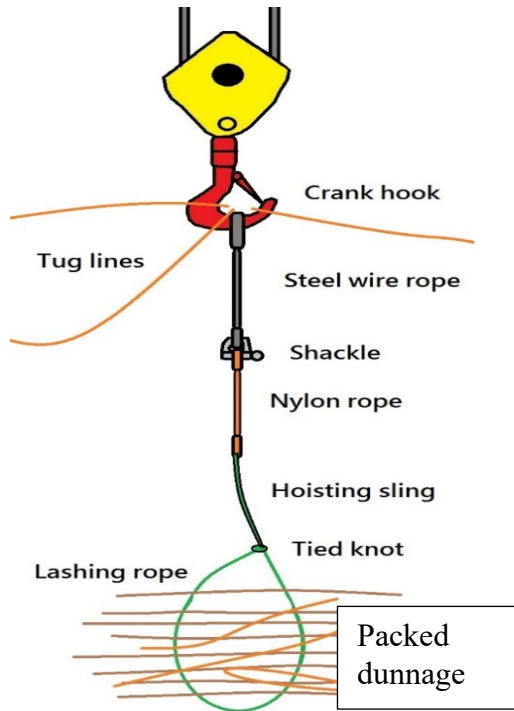
Figure 3 diagram of rigging arrangement

- 4.14 Paragraph 3.2 of the lifting operation procedure (Document No. OHSAS13) of the shipboard SMS manual stated that the enhanced protective measure of at least two tug lines should be attached to the lifting object when the vessel was in rolling condition during lifting operation. The investigation found that 3 tug lines were attached to the crane hook, but not to the packed dunnage, to prevent its swing during the lifting operation. It did not follow the “lifting operation procedure” requirements of the shipboard SMS manual. If the crew had followed the requirements of the lifting operation procedure, the tug lines might not have been entangled with the hoisting slings, and the accident would have been avoided.

- (c) strictly follow the requirements of the shipboard SMS when using tug lines during lifting operation;
  - (d) ensure to effectively carry out the shipboard toolbox meeting and its risk assessment including identifying the preventive safety measures to risks for lifting operation; and

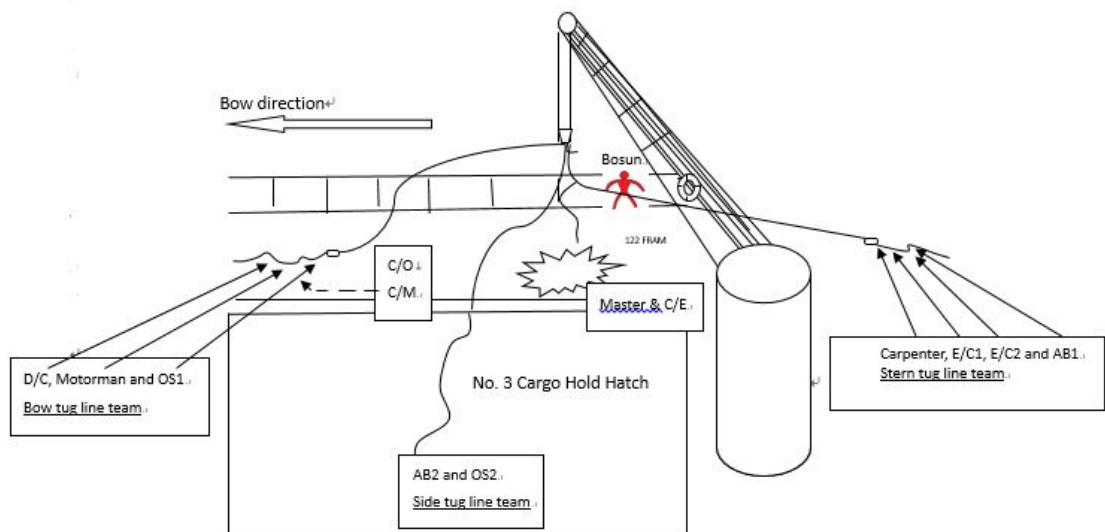
Figure 5 Sketch of the position of the crew on deck during *the work*

3.10 The bow tug line was controlled by the D/C, the Motorman1 and the OS1. The AB2 and the OS2 on *the hold* hatch controlled the side tug line. The stern tug line was controlled by the AB1, the E/C1, the E/C2 and the Carpenter (Figure 5).

- 3.13 The stern tug line team did not retract the tug line while lowering the crane hook for unknown reason. As such, the stern tug line became slack. The motion of the hook brought the slack stern tug line into tension. The tensioned stern tug line hit the bosun who was standing in the way of the motion of the tug line and the hook (Figure 5), resulting in the bosun being brought over the handrail of *the vessel* and fallen overboard into the sea.

- 4.20 The investigation also found that the bosun stood close to the ship side near the handrail of *the vessel* and within the range of the movement of the stern tug line (Figure 5). The bosun lacked safety awareness that the taut stern tug line might hit and injure him.

- (e) enhance the safety awareness on the risk of unexpected taut stern tug line during the lifting operation and the significance of effective communications when executing their duties between the deck and engine departments onboard.
