**Report of investigation
into the oil spill accident on board
Taiwan registered container ship “TS
TAICHUNG” at Kwai Chung Container
Terminals, Hong Kong on 1 April 2022**

**The Hong Kong Special Administrative Region
Marine Department
Marine Accident Investigation Section**

21 February 2023

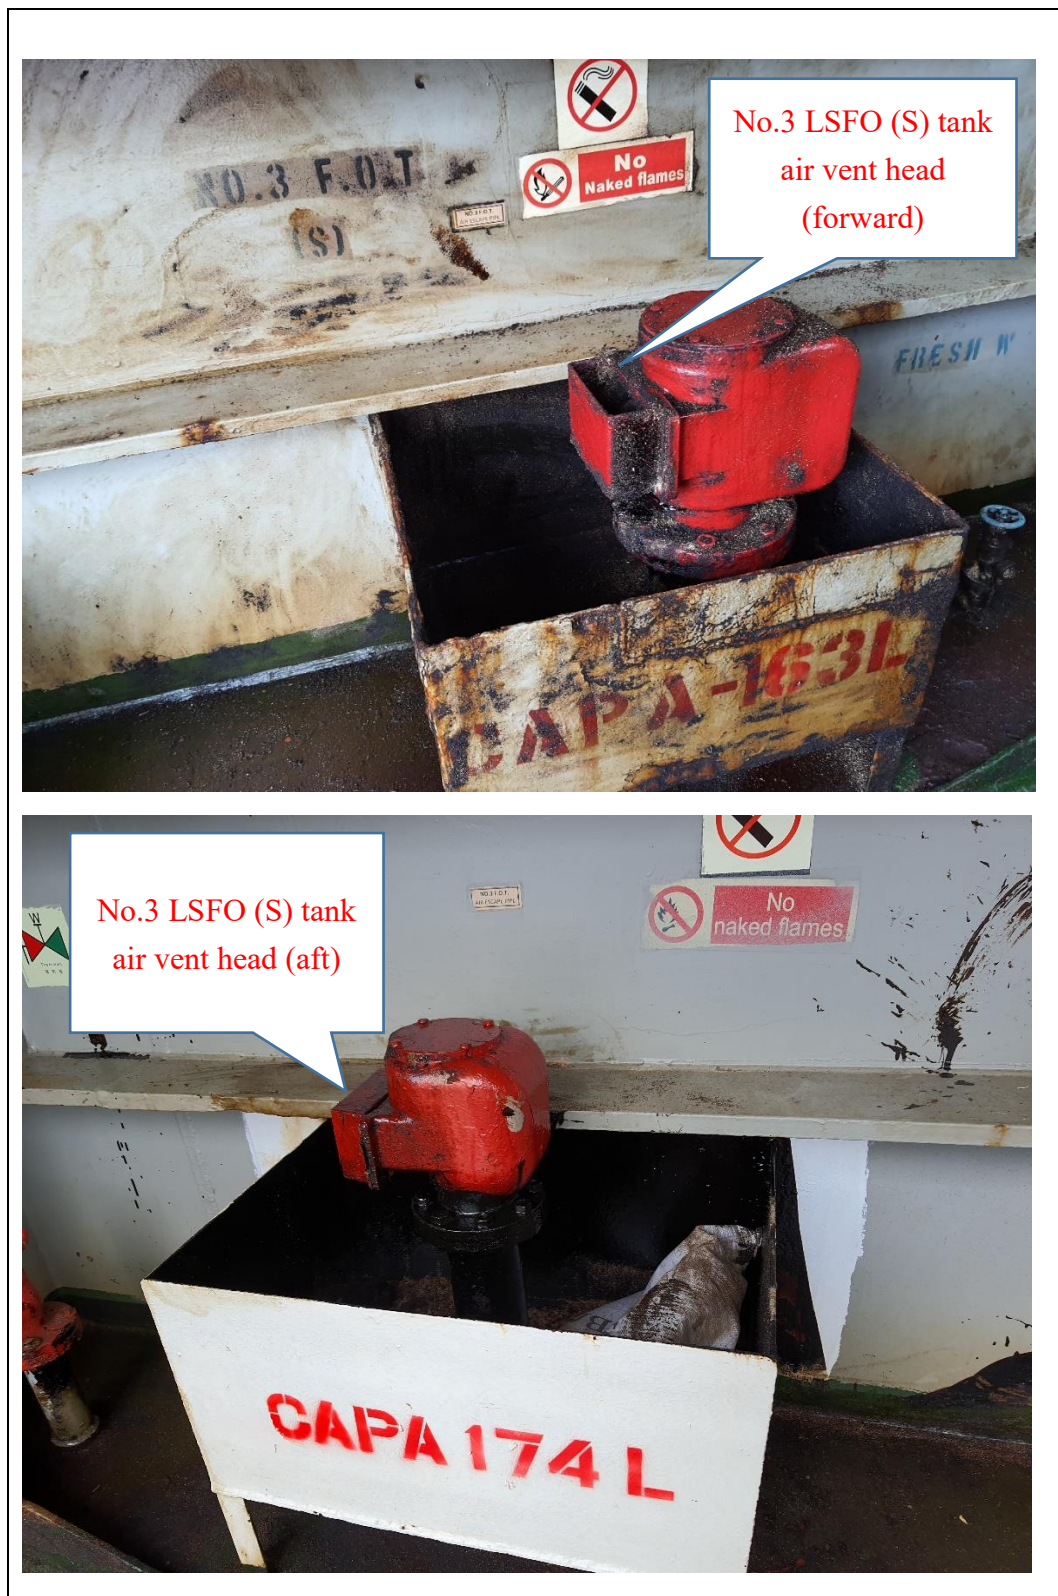
- 3.11 At 1514 hours, *the 4/E-1* reported to *the C/E* through a walkie-talkie that fuel oil spilled out from the air vent heads of No.3 (S) LSFO tank on the starboard side upper deck of *the vessel* (Figure 3) and immediately ran to the port side bunker station to inform *the barge* to

Figure 3 Oil spilled from the air vent heads of No.3 (S) LSFO tank

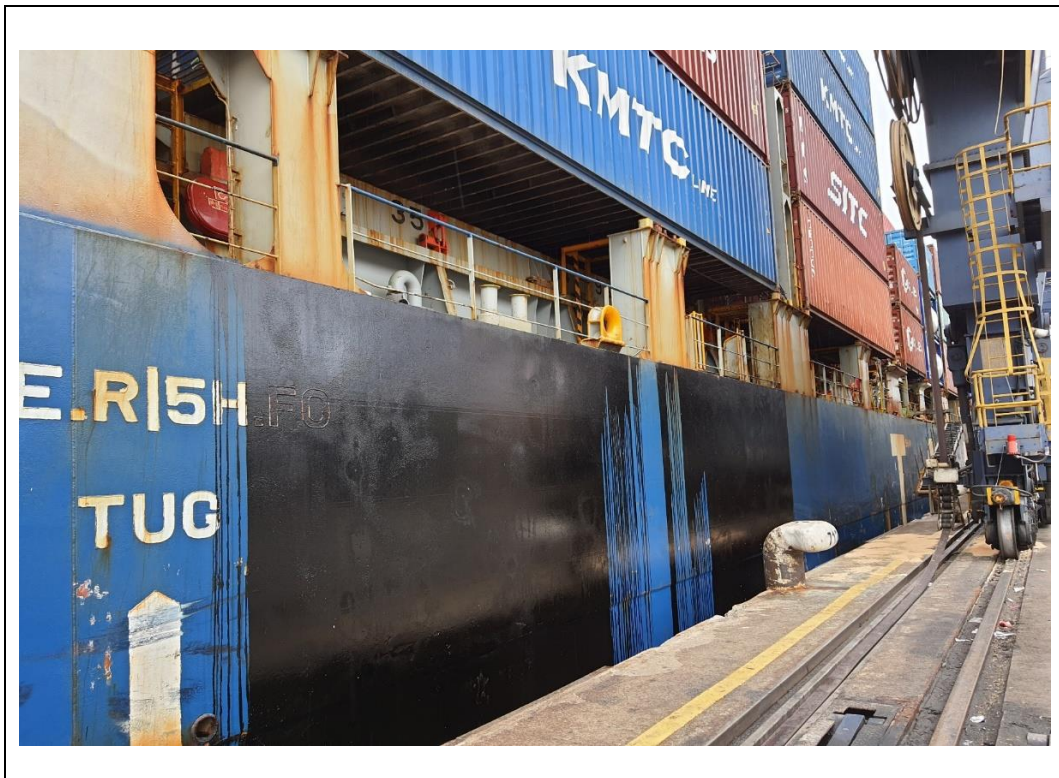
- 3.12 At 1518 hours, the master of *the vessel (the Master)* called the local agent for assistance and reported the oil spill incident to Marine Department via the agent.
- 3.13 *The vessel* crew cleaned up the overflowed fuel oil on the starboard side upper deck. As the scuppers on the upper deck were plugged, some overflowed fuel oil accumulated on the deck and spilled into the sea over the deck side gutter bar near Bay 34 and Bay 35 (Figure 4).

Figure 4 Oil flowed into the sea near Bay 34 and Bay 35

- 3.14 At 1620 hours, *the C/E* confirmed that the oil quantity in the No.3 (S) LSFO tank was about 372 m³. He also estimated that the overflowed fuel oil was about 1000 liters, of which 800 liters were collected on board and 200 liters were spilled into the sea.

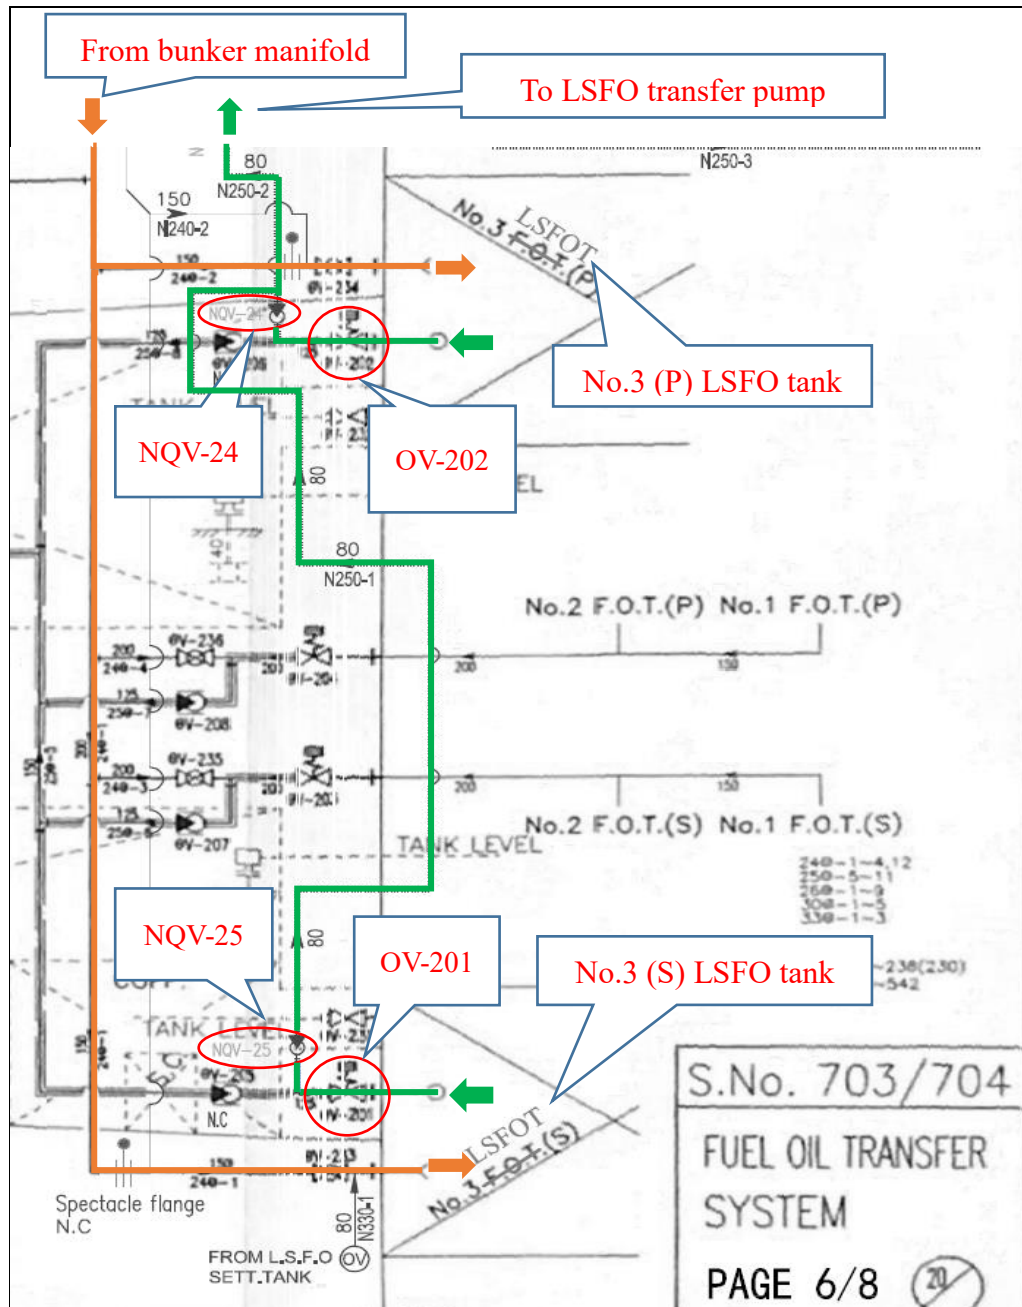
Figure 6 LSFO transfer system

- 4.19 *The vessel* modified the existing fuel oil transfer system. It retrofitted a newly installed LSFO transfer line connecting to both No.3 (P & S) LSFO tanks and the inlet of the LSFO transfer pump (*the LSFO line*) in a shipyard in July 2020. The relevant drawings of the amended fuel oil transfer system were approved by the CR Classification Society on 5 August 2020.
- 4.20 According to the approved drawing of the fuel oil transfer system (Figure 6), *the LSFO line* should have quick closing outlet valves (OV-201 and OV-202) installed on both No.3 (P & S) LSFO tanks. Additionally, two stop-check valves³ (NQV-24 and NQV-25) should have installed on *the LSFO line* just after both quick closing outlet valves.

- 4.21 As *the vessel* was using LSFO for the main and auxiliary engines during her stay in Hong Kong, the quick closing outlet valve (OV-202) and the stop check valve (NQV-24) of the No.3 (P) LSFO tank to the LSFO fuel oil transfer pump were kept open.

- 4.22 The post-investigation estimated that about 90 m³ of fuel oil deficiency in the No.3 (P) LSFO tank was lost. It also found that the quick closing outlet valve (OV-201) of the No.3 (S) LSFO tank was kept open⁴, and the stop check valve (NQV-25) (*the valve*) was not fully closed during the fuel changeover. The preliminary finding showed that the oil loss might flow into the No.3 (S) LSFO tank by gravity before the bunkering operation. The non-return function of *the valve* was suspected to be defective. It was also found that the crew failed to isolate *the LSFO line* of the No.3 (S) LSFO tank before bunkering operation, resulting in about 90m³ of LSFO being flowed from the No.3 (P) LSFO tank into the No.3 (S) LSFO tank which was not discovered by *duty bunkering crew* until oil spill accident happened.

- (a) isolate fuel oil transfer system connecting to respective fuel tanks when they are not in use before bunkering operation.
 - (b) strictly follow the requirements of the Classification Society approved drawings to fit the stop-check valve while retrofitting the fuel oil transfer system; and

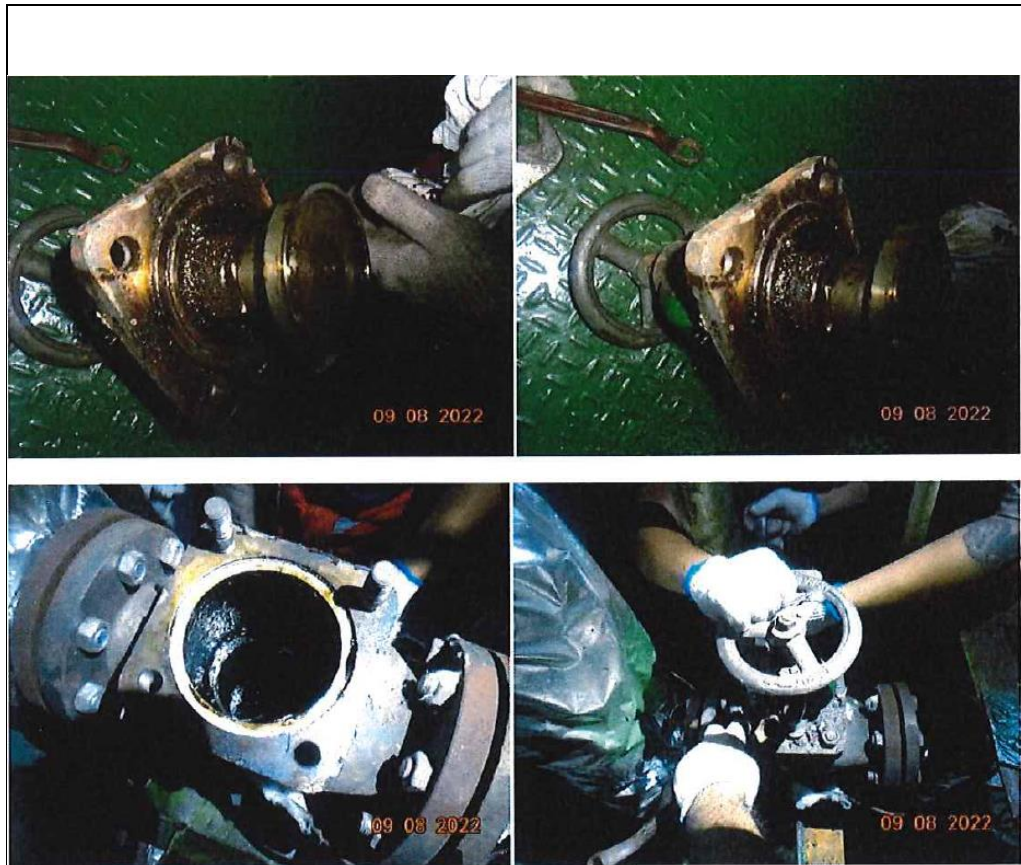
- 4.23 On 9 August 2022, *the valve* was dismantled for inspection while *the vessel* underwent a special survey in the dry dock. The attended surveyor of the Classification Society found that *the valve* was not a stop check valve as required under the approved drawing but a globe valve without a non-return function which could not prevent the backflow of liquid (Figure 7). It indicated from the post-investigation that the fuel oil transfer system was fitted with an incorrect type of valve and did not follow the approved drawings by the Classification Society in installing the stop-check valve with a non-return function during its retrofitting.

Figure 7 Inspection of *the valve* (NQV-25) showed that the type of *the valve* was not according to the approved drawing

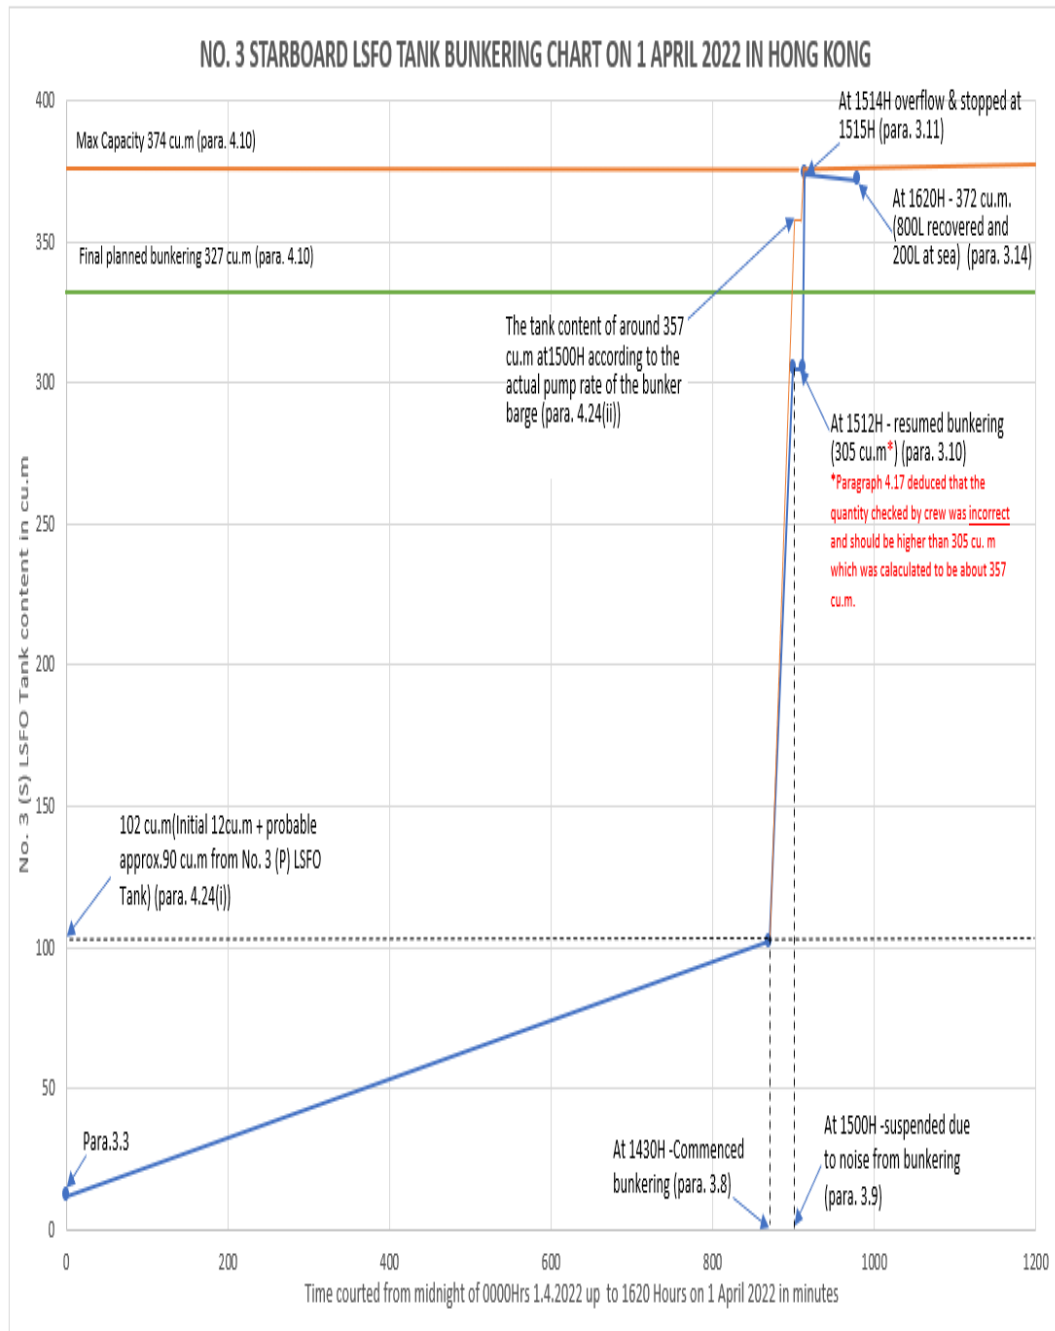
Figure 8 Bunkering Chart on 1.4.2022

4.24 The discovery of the incorrect globe valve fitted, as mentioned in paragraph 4.23 above, can help to support the preliminary finding in paragraph 4.22 and explain the spillage scenario⁵ with details as follows:- (Figure 8)

- (i) Before the commencement of the bunkering at 1430 hours, the content of the No. 3 (S) LSFO tank had gradually increased from its initial content of 12 m³ to approximately 102 m³ due to about 90 m³ of fuel oil flowed from the No. 3 (P) LSFO tank by gravity.
- (ii) Since it was reported that the fuel oil started spilling at 1514 hours, when the tank content was up to its maximum of 374 m³, the total amount of bunker loaded would be 272 m³ (the max.). As this happened in a total of 32 minutes, the average bunker pumping rate of the barge would be 510 m³ per hour. Hence, when the bunkering was suspended at 1500 hours due to the abnormal noise, the bunker loaded was estimated to be 255 m³

as per the bunkering delivery note (Table 2) and the tank content at that time might be 357 m³ as calculated.

- (iii) Assuming the bunker pump of *the barge* could achieve the pumping rate of 510 m³ per hour upon starting, an amount of 17 m³ should have been pumped into the tank in only 2 minutes leading to the overflow at the time of 1514 hours.
- (iv) At 1620 hours, the final content of the No. 3 (S) LSFO was measured to be 372 m³ probably the fuel oil inside the tank had been settled down as from 1515 hours.
