**Report of investigation
into a fatal accident on board the Hong
Kong registered oil tanker “*Wisdom
Venture*” at Jawaharlal Nehru Port,
India on 19 April 2022**

The Hong Kong Special Administrative Region
Marine Department
Marine Accident Investigation Section

28 February 2023

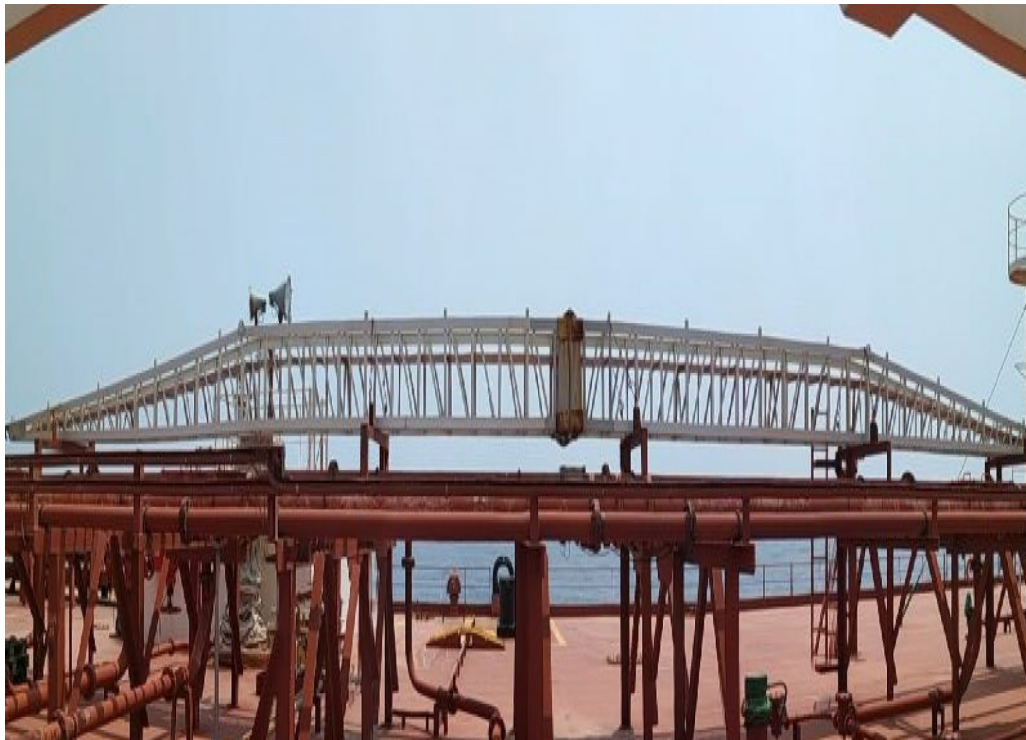
- 3.1 At 2048 hours on 18 April 2022, *the vessel* berthed at No. LB-01 terminal of *the discharging port* by starboard side to discharge *the cargo*.
- 3.2 After berthing at *the discharging port*, *the portable gangway* (Figure 2), 20 meters in length with weight of 772 kilograms, was rigged between the jetty and the middle of *the vessel* as an access. One end of *the portable gangway* rested on *the vessel's* deck rail and the other end rested on the jetty.

Figure 2: *the portable gangway* secured on the deck

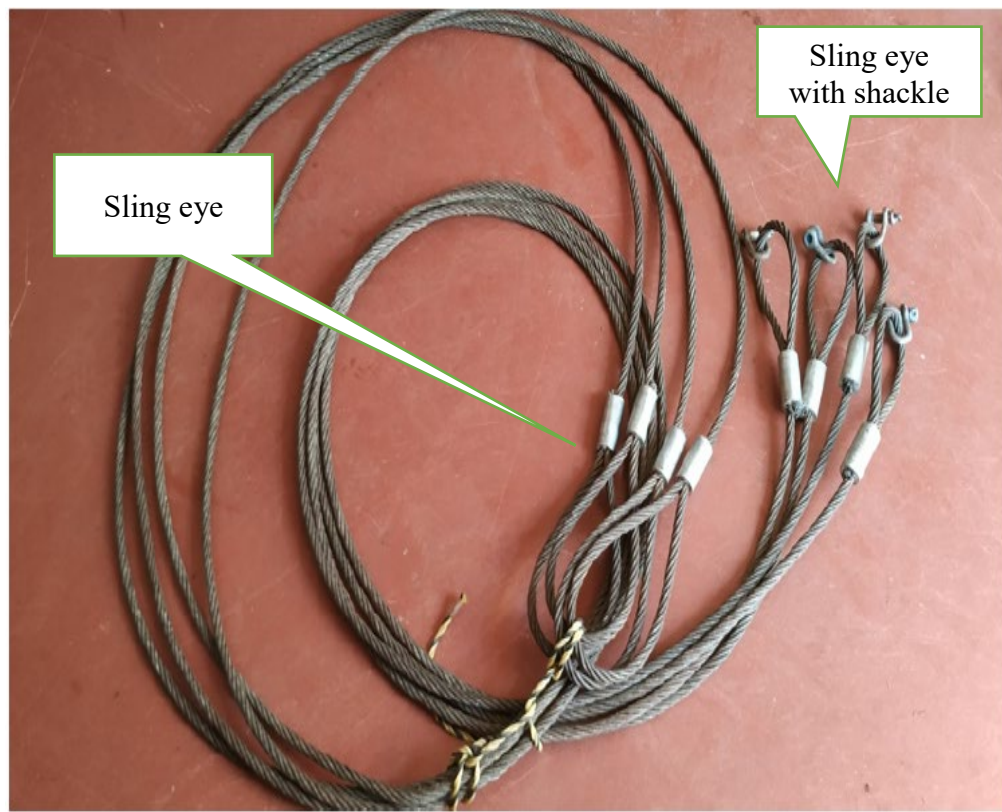
- 3.6 *The portable gangway* was lifted by the crane of *the vessel* through four wire rope slings of seven meters each connected between the crane hook and the pad eye of *the portable gangway*. One end of the sling eye was directly connected to the crane hook, and another end of the sling eye was connected to the pad eye of *the portable gangway* by using a shackle. (Figures 3, 4 and 5 refer).
- 3.7 The safe working load of the crane was 15 metric tons and maximum working radius was 29 meters, i.e. the crane hook could reach seven meters outside ship's hull (22 meters from crane post to ship hull).

Figure 3: four wire rope slings with shackles

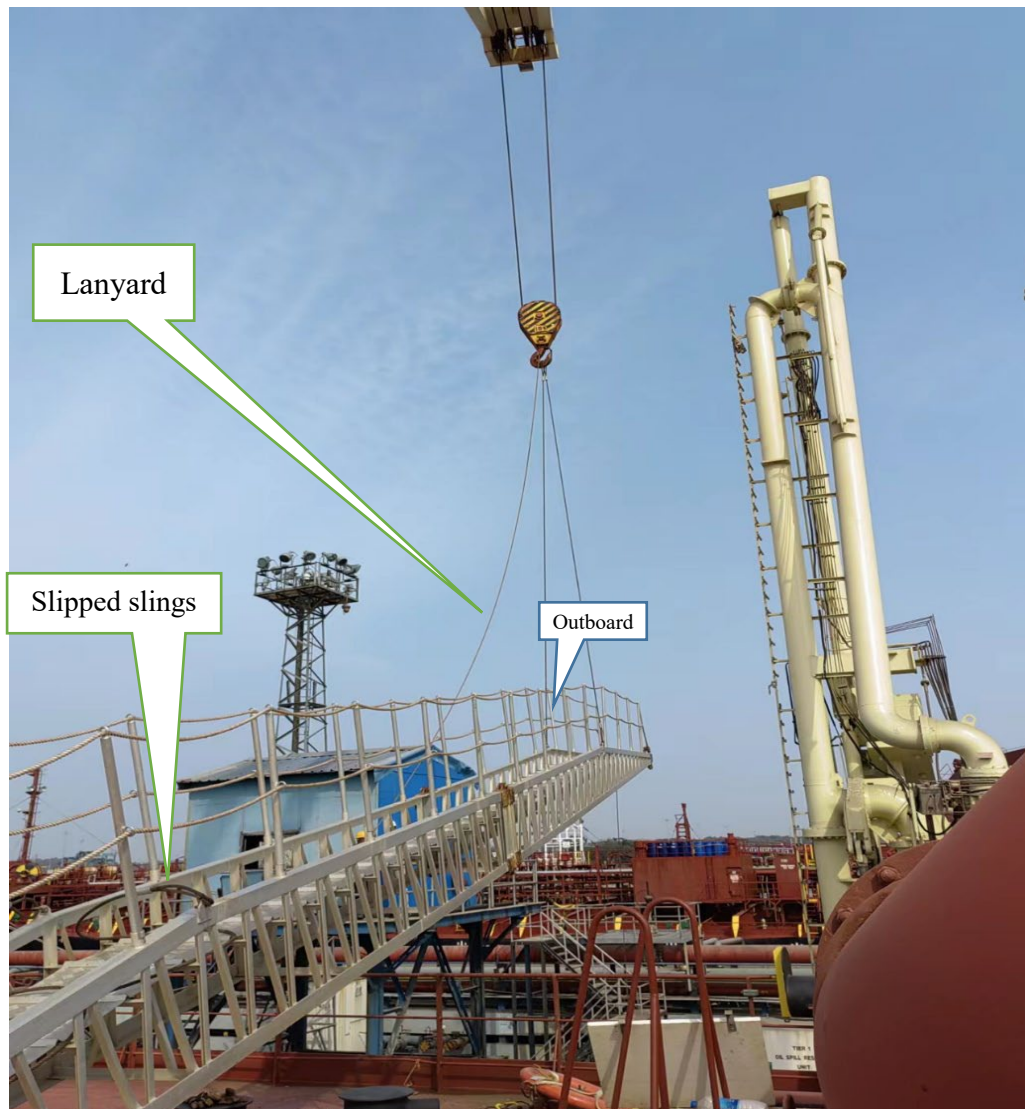
- 3.9 At about 1610 hours, *the sling wires* were slipped out suddenly from the crane hook, resulting in the falling of *the portable gangway* onto the main deck. Unfortunately, AB3's leg was hit heavily by the falling gangway and he was lying on the main deck unconsciously with blood in his mouth (Figure 8 & 9).

Figure 8: The scene of the accident

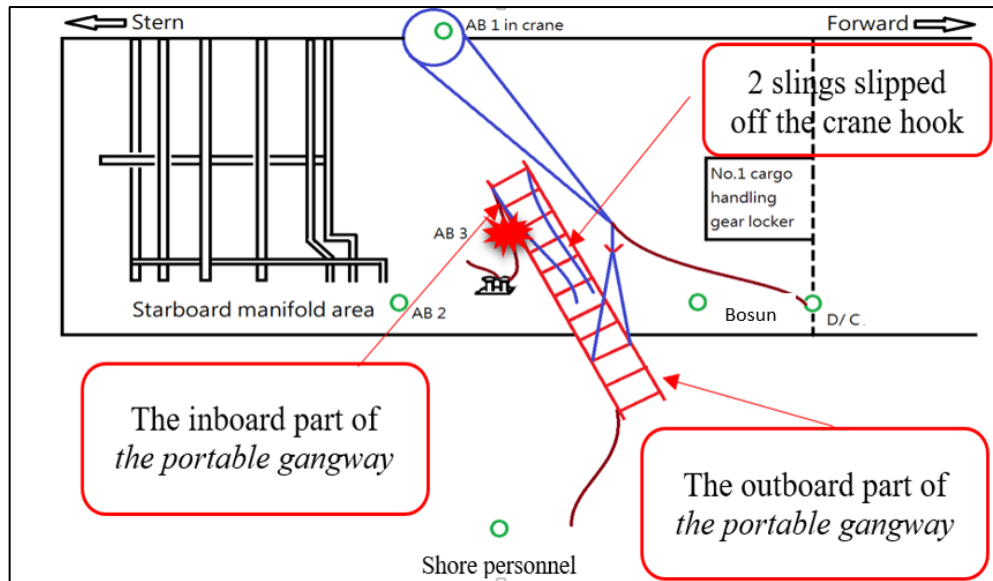
Figure 9: Schematic diagram after *the sling wires* slipped off from the crane hook

- 5.3 As the outboard end of *the portable gangway* was at the jetty and the inboard end was at the deck rail, with seven meters each in length of the wire rope slings connected to their respective pad eyes on the gangway, the outboard slings were in tension whereas the inboard slings (*the sling wires*) were slack when commencing the lifting operation. As outboard end of *the portable gangway* was lifted slightly above the deck rail, all of a sudden, the tension of the slings at the outboard end forced *the portable gangway* to swing inboard causing *the sling wires* slipped out from the crane hook, resulting in the falling of *the portable gangway* onto the main deck. Unfortunately, AB3 was hit heavily by the falling gangway, lying unconsciously on the main deck with blood in his mouth. The Master immediately organized emergency medical team to apply first aid to AB3, including Cardiopulmonary Resuscitation (CPR), and sought emergency medical assistance from the local authority. At 1640 hours, AB3 was sent to a local hospital by ambulance for medical treatment, but he was declared dead later.

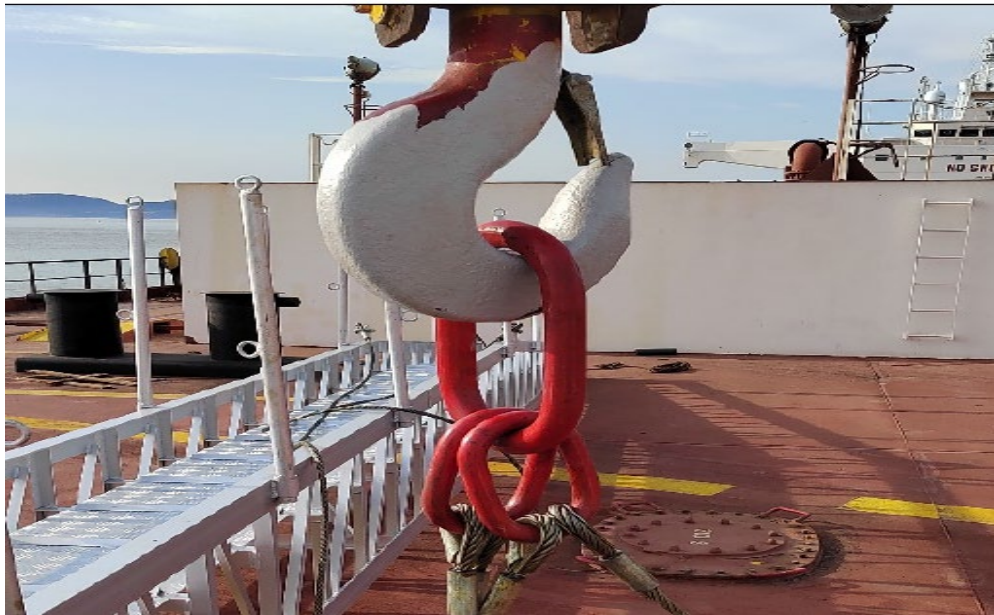
- 4.15 Section 5.2.3 of the “Health, Safety and Environment Manual” (*the HSE manual*) of the shipboard SMS states that a lifting operation should be carried out in a safe manner, the lifting appliances operator should be guided by *the Code* and Section 19.2.7 of *the Code* states that the configuration of slinging should be taken into account when selecting accessories for lifting.
- 4.16 According to the investigation report of *the Company*, the lifting operation of *the portable gangway* as required by its manufacturer was to be carried out by a composite lifting unit which had a master link connecting with the four wire rope slings and the crane hook (figure 10). However, at the time of the accident, the four sling eyes were directly connected to the crane hook (Figure 11). It was

Figure 10: the manufacturer-qualified composite lifting unit of *the portable gangway*

- (a) strictly follow the requirements of shipboard SMS, the manufacturer and *the Code* to lift *the portable gangway* in a safe manner;
 - (b) strictly follow the requirements of *the Code* to hold toolbox meeting before commencing work;

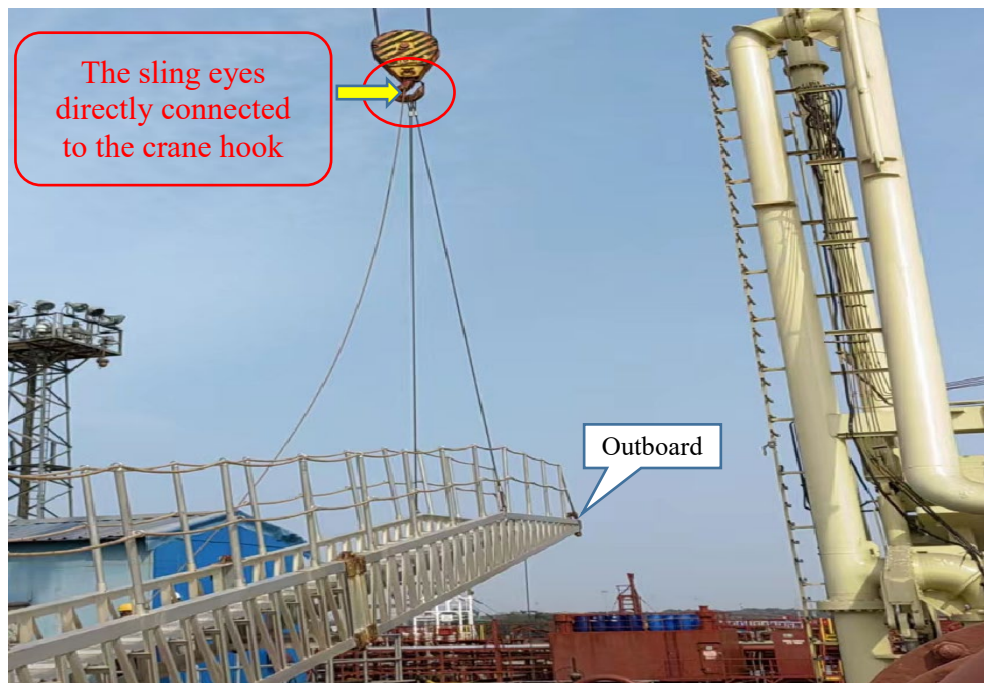
found that *the deck crew* did not follow the shipboard SMS and *the Code* requirements to lift *the portable gangway* in a safe manner by using the manufacturer-qualified lifting accessories.

Figure 11: the slings connected to the crane hook at the time of the accident
