**Report of investigation
into the fatal accident on board the
Hong Kong registered bulk carrier
“*Great Century*” at sea on 22 April 2022**

The Hong Kong Special Administrative Region
Marine Department
Marine Accident Investigation Section

17 November 2022

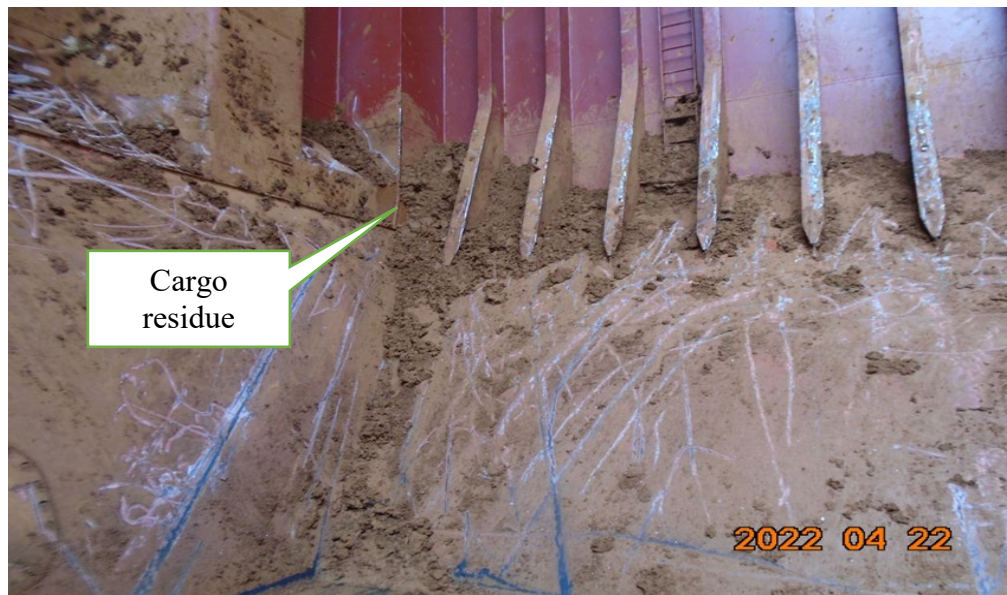
Figure 2: Cargo residue in *the hold*

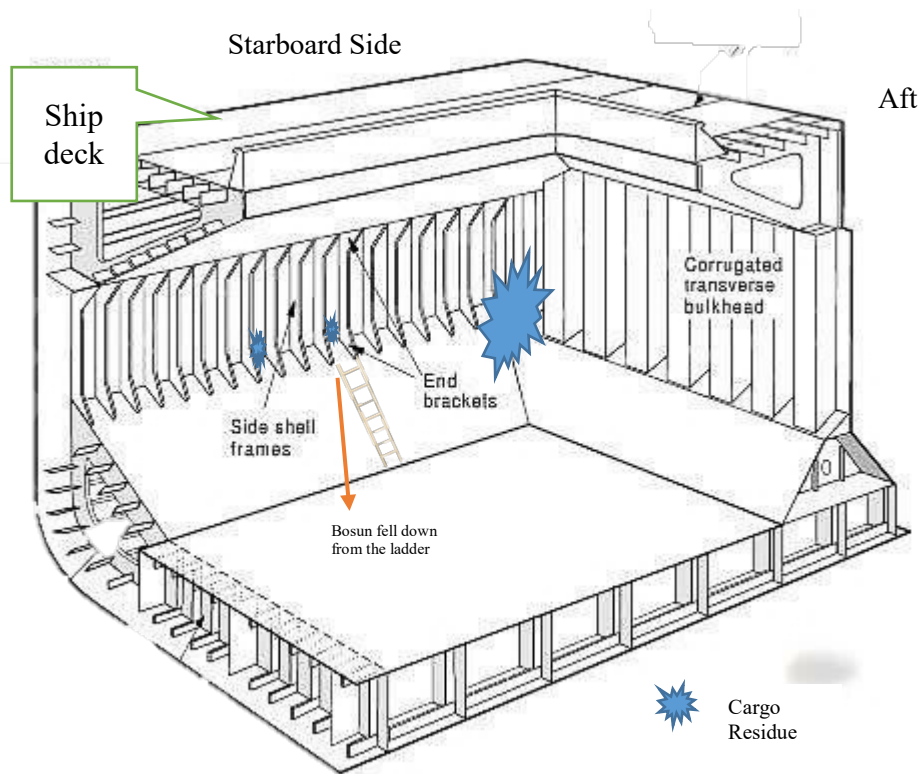
Figure 3: Schematic diagram of the No. 1 cargo hold

- 4.12 According to the information provided by *the Company*, the bosun fell to the tank top of *the hold* when he climbed *the ladder* to remove the cargo residue left on the upper part bulkhead of *the hold* (Figure 3). His head struck the tank top of *the hold* while falling from *the ladder*, resulting in vague redness, swelling at the back of his head, and gradual loss of consciousness.
- 4.13 The death certificate of the bosun issued by the hospital in *the discharging port* stated that the cause of death was respiratory and cardiac arrest.

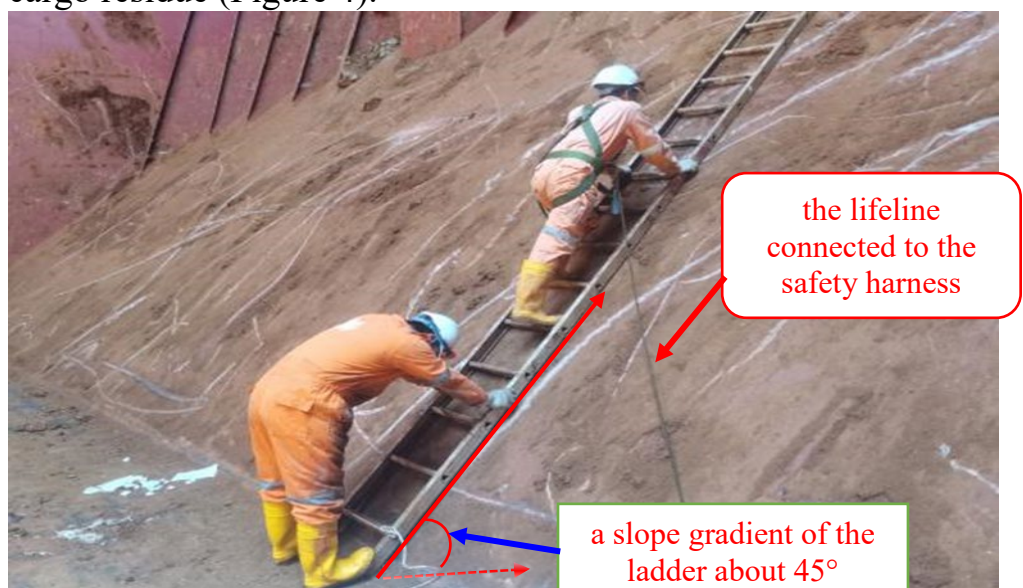
- 3.5 At about 1440 hours, *the D/C* and the bosun shifted *the ladder* to the position between frame No. 200 and No. 201 with a slope gradient of about 45° . The bosun climbed up *the ladder* to clean the upper part of *the hold* with *the ladder* being held by *the D/C* who was facing downwards to the tank top to protect his eyes from the falling cargo residue (Figure 4).

Figure 4: Simulated scenario of climbing ladder

- 4.20 However, the investigation revealed that the lifeline of the harness was not secured to a strong point while the bosun was climbing *the ladder in the hold* (Figure 4), and that the C/O, as a supervisor, did not supervise *the hold cleaning* on-site. It was deduced that the approval of a permit to work at height for the cargo holds cleaning onboard was only for the formality without executing the permit in a professional and responsible manner.

- (c) strictly follow the requirements of *the Code* on using the portable ladder and proper securing of the lifeline connected to the safety harness when working at height.

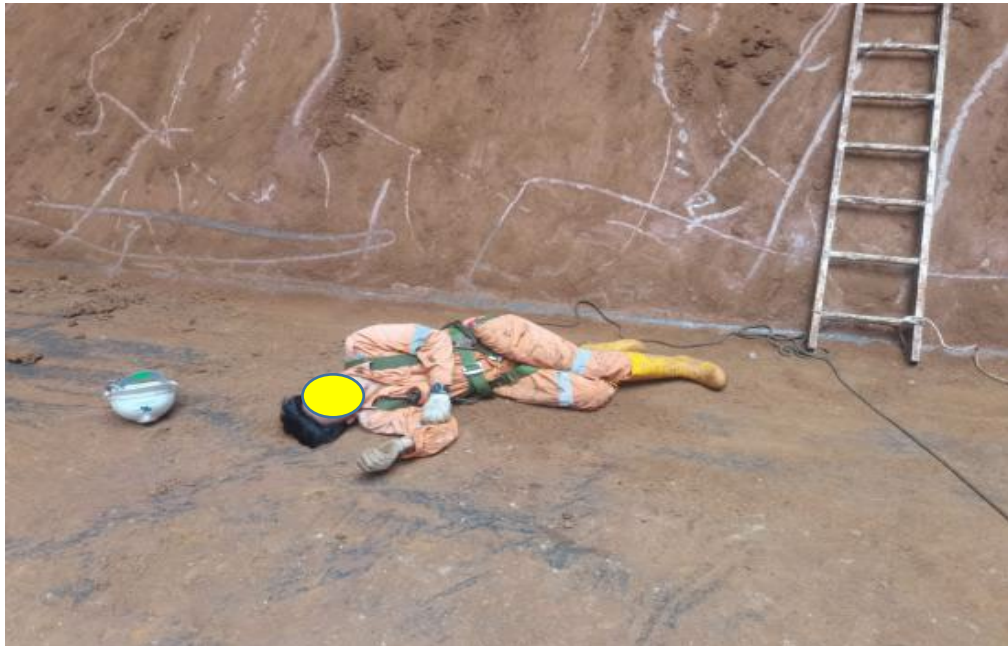
- 3.6 Whilst holding the ladder, *the D/C* suddenly felt *the ladder* shaking abnormally and heard a sound. He then saw the bosun lying on the tank top, bleeding from his ears but still having normal respiratory and heart rates. His safety helmet was damaged and was away from his head about 0.2 to 0.5 meters (Figure 5 & 6).
- 3.7 The deputy bosun in *the hold* reported the accident to the Master by portable walkie-talkie via the duty second officer on the bridge. After receiving the report, the Master immediately organized the crew to apply the emergency medical treatments to the bosun and contacted the nearby Vessel Traffic Services for emergency assistance. The Master steered *the vessel* back to *the discharging port* and contacted the local agent for emergency medical treatment for the bosun.

Figure 5: Spot of the accident

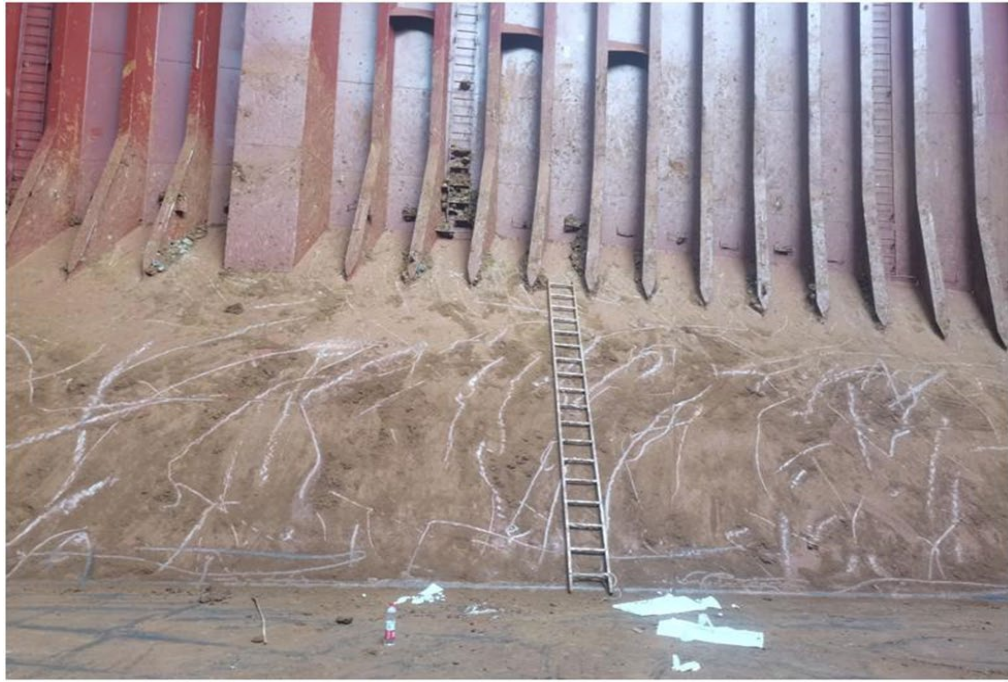
Figure 6: Placement of *the ladder* at the time of the accident

- 4.25 Chapter 17.3.1 of *the Code* stated that working from portable ladder should be avoided as far as possible but, where necessary, personnel should use a safety harness with a lifeline secured above the work position where practicable.
- 4.26 *The ladder* used in *the hold* for *the hold cleaning* was pitched at about 45° from the horizontal (Figure 4) with no clearance behind the rungs. The bosun did not properly secure the lifeline connected to his safety harness while he was climbing *the ladder* during *the hold cleaning* (Figure 3), which did not comply with the requirements of *the Code*.

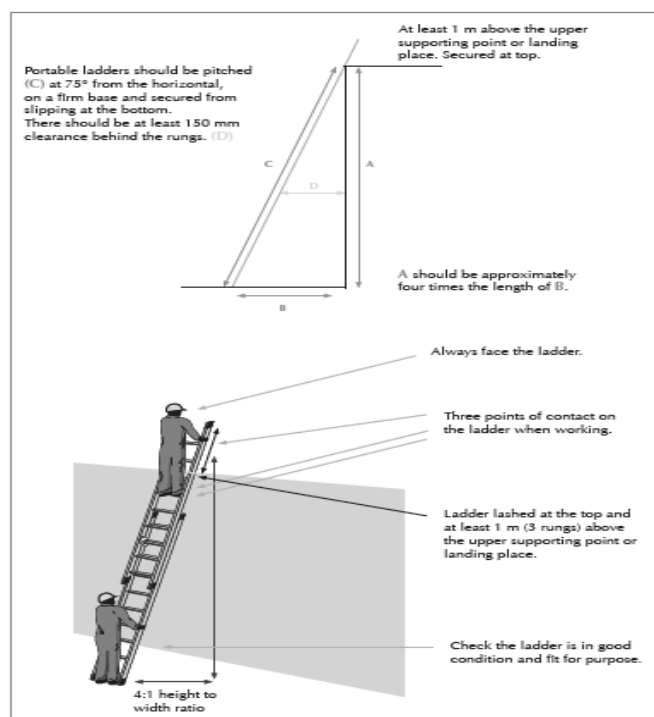
- 4.24 Chapter 17.3.4 of *the Code* required that portable ladder when in use be pitched at 75° from the horizontal (Figure 7), be secured from slipping at the bottom, and have at least 150 millimeters of clearance behind the rungs.

Figure 7: Requirements of using portable ladder
