**Report of investigation  
into the fatal accident on board the Hong Kong  
registered bulk carrier “*Wei He*” at Karachi,  
Pakistan on 9 May 2022**

The Hong Kong Special Administrative Region  
Marine Department  
Marine Accident Investigation Section

13 December 2022

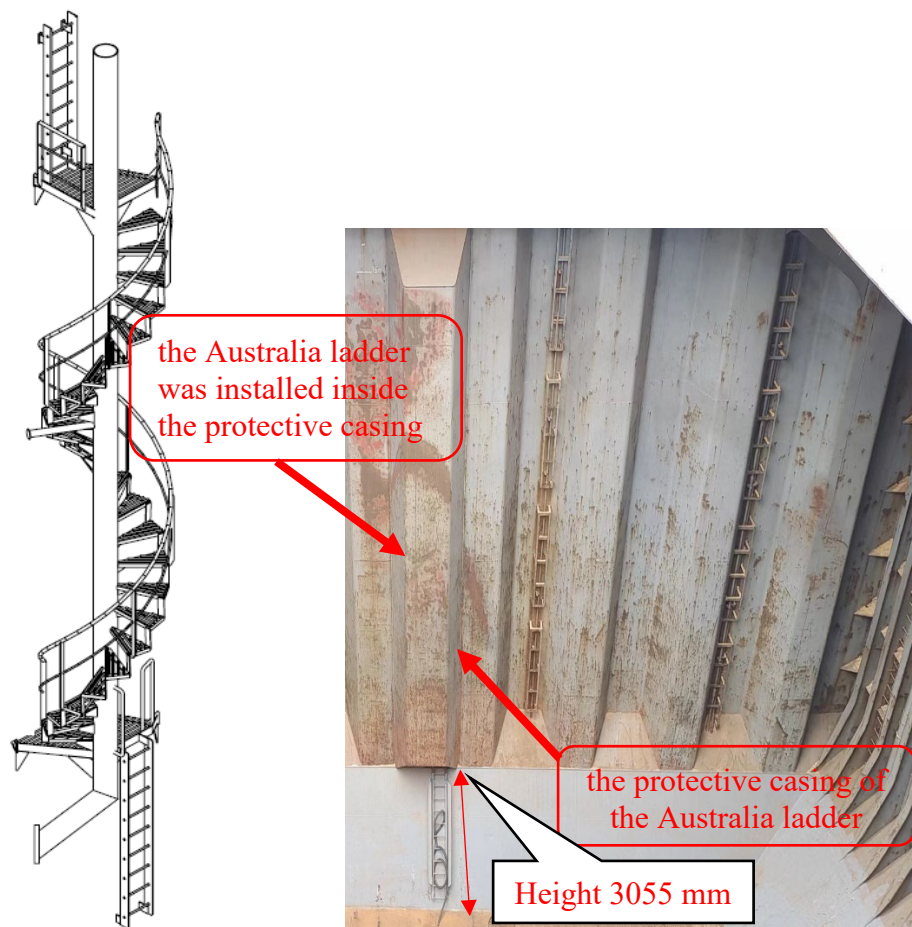
Figure 4: the Australia ladder with the protective casing of *the hold*

- 4.11 At the time of the accident, the lower exposed part of the Australia ladder of *the hold* was submerged by *the cargo* (Figure 7). With the cover of its aft hold entrance kept close (Figure 8), *the ladder space* became an enclosed space. The enclosed *ladder space* was possibly lack of oxygen due to the oxygen depleting nature of the grain and having residue poisonous gases from the post-fumigation.

- 4.30 The two stevedores entered the aft entrance of *the hold* to *the ladder space* for unknown reasons. Paragraph 4.11 mentioned that *the ladder space* might lack oxygen and have poisonous gas from the post-fumigation. Because no autopsy report was available to ascertain the cause of death, the investigation could only deduce that the cause of death of the two stevedores was lacking oxygen or possibly breathing in poisonous fumigant gas within *the ladder space*.

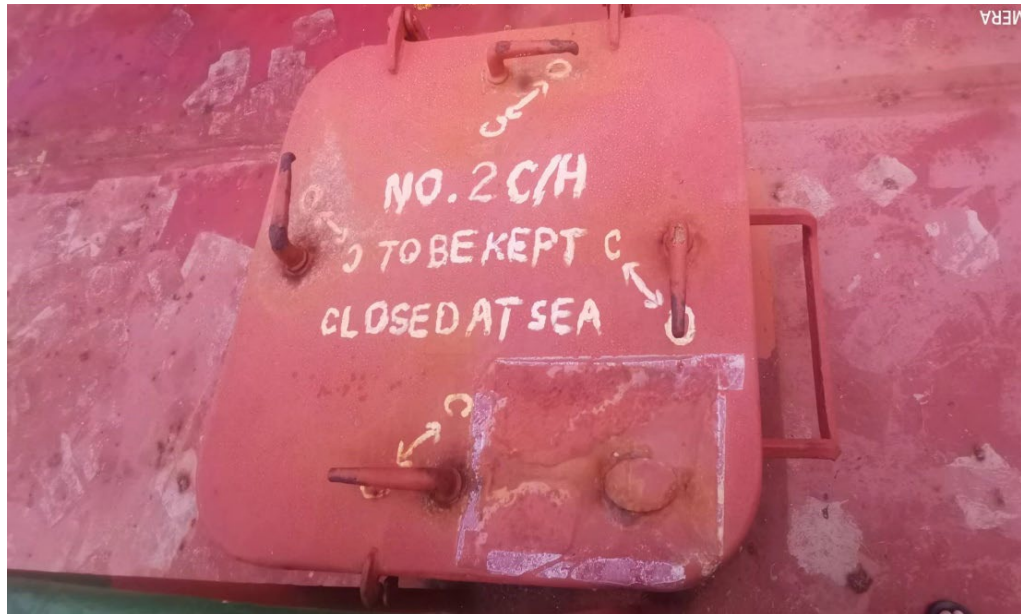
Figure 8: the cover of the aft hold entrance of *the hold*

- 4.14 The investigation found that if the cover of the aft hold entrance to *the ladder space* had been locked, secured or marked properly, the foreman and the two stevedores might realize that it was not permitted to enter *the hold* through the aft hold entrance. As such, the crew failed to follow the requirements of *the Code* to mark the entrance to *the ladder space* as a dangerous space and locked or secured against entry accordingly, which was considered as one of

- 5.3 The investigation revealed that the main contributory factors leading to the accident were as follows:
- (a) the crew failed to follow the requirements of *the Code* to mark *the ladder space* as the entrance to a dangerous space and lock or secure it properly against unauthorized entry;

- (a) strictly follow the requirements of *the Code* to mark the space as the entrance to a dangerous space and lock or secure it properly against unauthorized entry;
