**Report of investigation  
into a serious injury accident on board  
the Hong Kong registered bulk carrier  
“*Grand Demeter*” at sea on 22 May 2022**

The Hong Kong Special Administrative Region  
Marine Department  
Marine Accident Investigation Section

15 December 2022

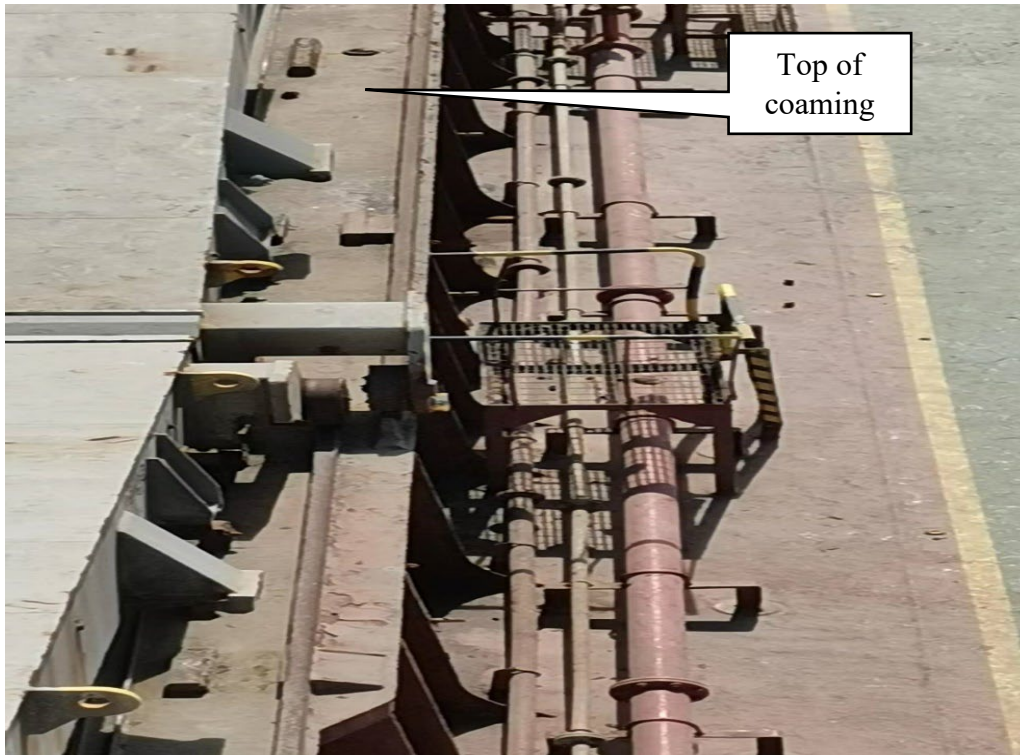
- 3.6 In order to clean the cargo residue piled up on top of *the hatch coaming*, the AB1 planned to position himself there with the folding type hatch cover partially open (Figure 2). At 1756 hours, the AB1 fell from the handrail, which was part of the structure of the platform connected to *the hatch coaming*, onto the main deck (position 3 of Figure 3) while he was climbing up to the top of *the hatch coaming* (position 1 of Figure 3) from the platform for cleaning there. As a result of the falling, AB1's crotch hit against the fire main (position 2 of Figure 3) followed by banging his head on the main deck causing him unconscious with bloodshot eyes.

Figure 2: overlook the main deck and hatch coaming

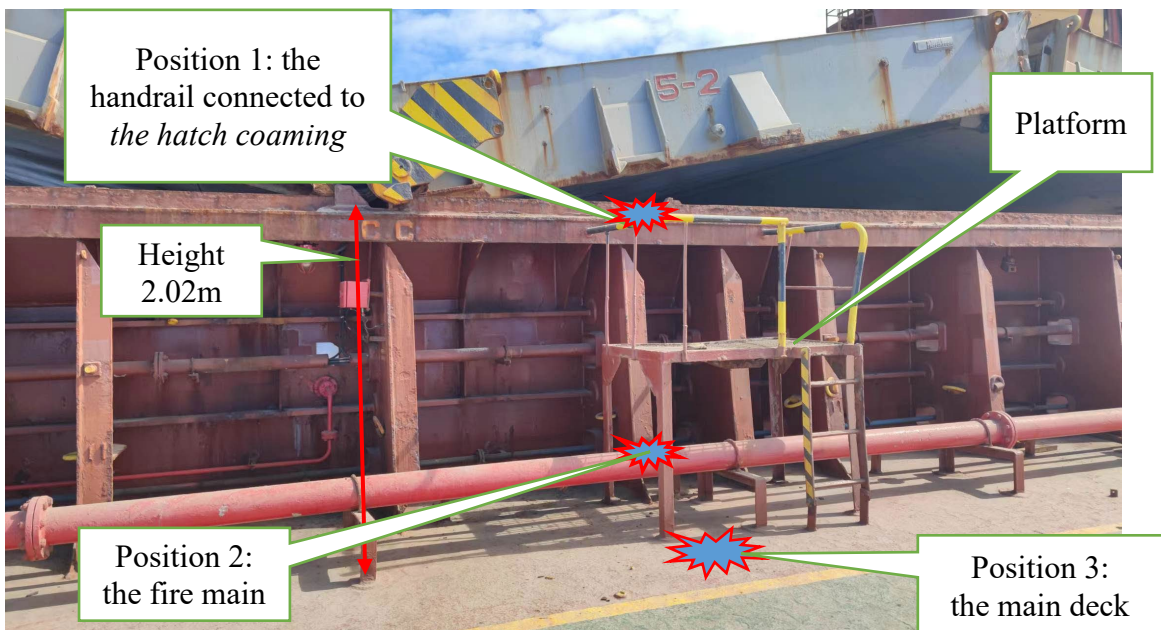
Figure 3: the falling accident site

- 4.16 Paragraph 3.6 mentioned that the AB1 fell from the handrail of the platform while he was climbing up to the top of *the hatch coaming* to clean the cargo residue there. The investigation found that the AB1 lost balance due to a missing step or slippery at the top of *the hatch coaming* while he was holding the fire hose with him, resulting in the falling and injury.

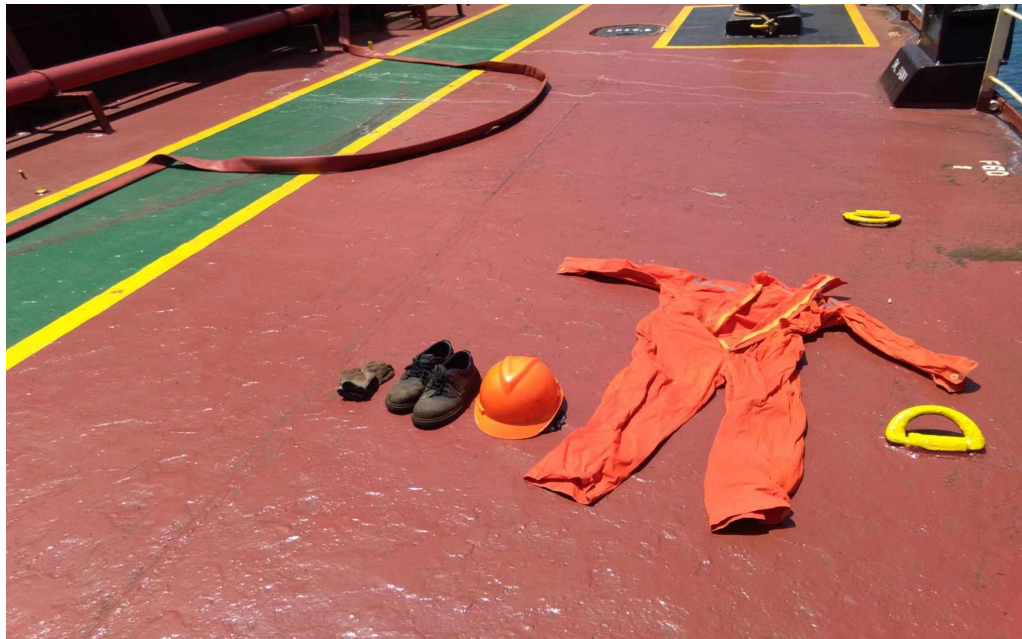
- 4.17 Section 1 of the “Precautions for working aloft” (i.e., HMC-SBM-018) of the shipboard *SMS* defines working at height as work at the height of 2 meters or more. It also states that personnel working at height should wear proper safety equipment, such as a safety harness, skid-proof shoes, a safety belt, a portable ladder, or other arresting devices.

- 4.18 According to the information provided by *the Company*, the height of *the hatch coaming* is 2.02 meters from the main deck of *the vessel*. As mentioned in above paragraph 4.17, the cleaning of *the hatch coaming* was identified as working at height. At the time of the accident, *the* AB1 did not wear safety harness, and no other arresting device (Figure 4) was used during the cleaning of *the hatch coaming*.

Figure 4: Personnel protective equipment of *the AB1* for cleaning *the hatch coaming*

- (a) strictly follow the requirements of shipboard SMS to wear proper safety equipment when cleaning the hatch coaming onboard;
  - (b) strictly follow the requirements of *the Code* to obtain a permit to work in a location where there is a risk of falling, such as at the top of the hatch coaming, before conducting the cleaning work there;
