**Report of investigation  
into a fatal electrocution accident  
onboard the Hong Kong registered bulk  
carrier “*COSCO WUYISHAN*” at sea on  
15 August 2022**

The Hong Kong Special Administrative Region  
Marine Department  
Marine Accident Investigation Section

28 February 2023

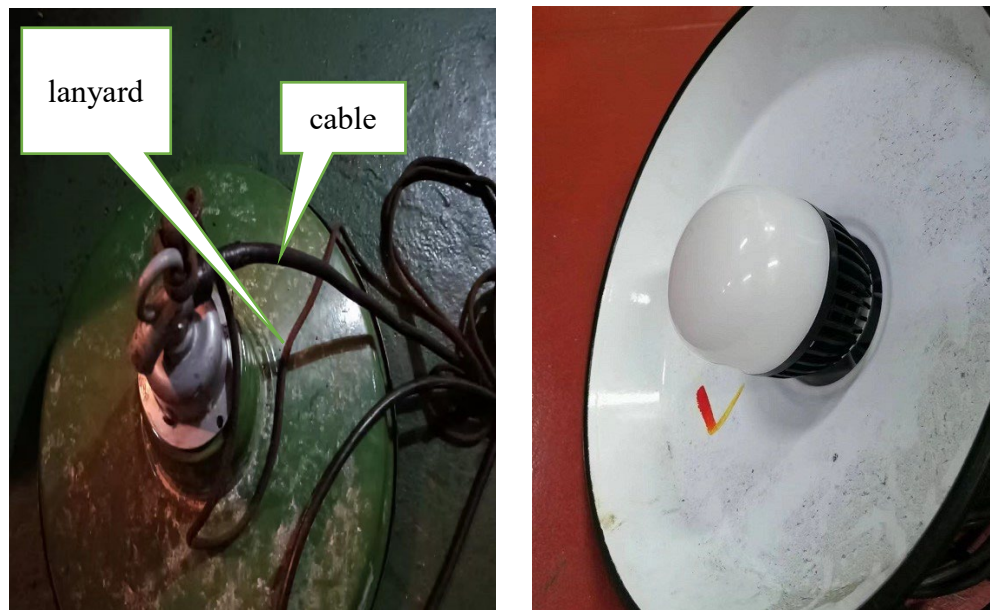
Figure 3: *The light used in the hold*

- 3.4 At 1952 hours, the sky was getting dark. The bosun requested the crew on the main deck to prepare a portable cargo light to illuminate *the hold*. Another able seaman (the AB2) visually checked the condition of *the light* and lowered it from the main deck by a lanyard to a height of about one and a half meters above the tank top of *the hold*. *The light* was powered by the ship's main of 220 volts (Figure 3).

- 4.14 Section 11.5.8 of *the Code* states that a portable lamp used in damp or humid conditions should be of low voltage, preferably 12 volts, or other suitable precautions to avoid risks of electric shock from mains voltage.
- 4.15 The investigation found that *the light* was being supplied with 220 volts, and its ingress protection (IP) rating of *the light* was IP20<sup>4</sup> which did not protect against water; *the hold* was wet and humid after being cleaned by water, and some water accumulated on the aft part of the tank top (Figure 2). No additional suitable precautions were taken to avoid the risks of electric shock. It revealed that the crew of *the vessel* did not follow the relevant

requirements of *the Code* to avoid electric shock under damp or humid conditions when using a portable lamp.

- 4.22 As paragraph 3.7 mentioned, the AB held *the light* by hand to illuminate *the bilge well* after he completed the cleaning work. He did not realize that the nearly bare metal tank top of *the hold* was wet; *the hold* was damp, humid, and had large conductive surfaces; the rubber gloves used were in poor insulation as he had just completed cleaning residue in *the bilge well*; *the light* was working under the power of 220 volts without protection against water etc., which were the causes for the electric shock. Therefore, it was deduced that the AB lacked safety awareness of the danger of electric shock.

- (a) strictly follow the relevant requirements of *the Code* to use a portable lamp with low voltage or take suitable precautions to avoid electric shock in damp or humid conditions;
