**Report of investigation
into the fatal accident happened on
board Hong Kong registered bulk carrier
“*Great Century*” during shifting
operation at the port of Pascagoula,
USA, on 20 November 2022**

The Hong Kong Special Administrative Region
Marine Department
Marine Accident Investigation Section

19 June 2023

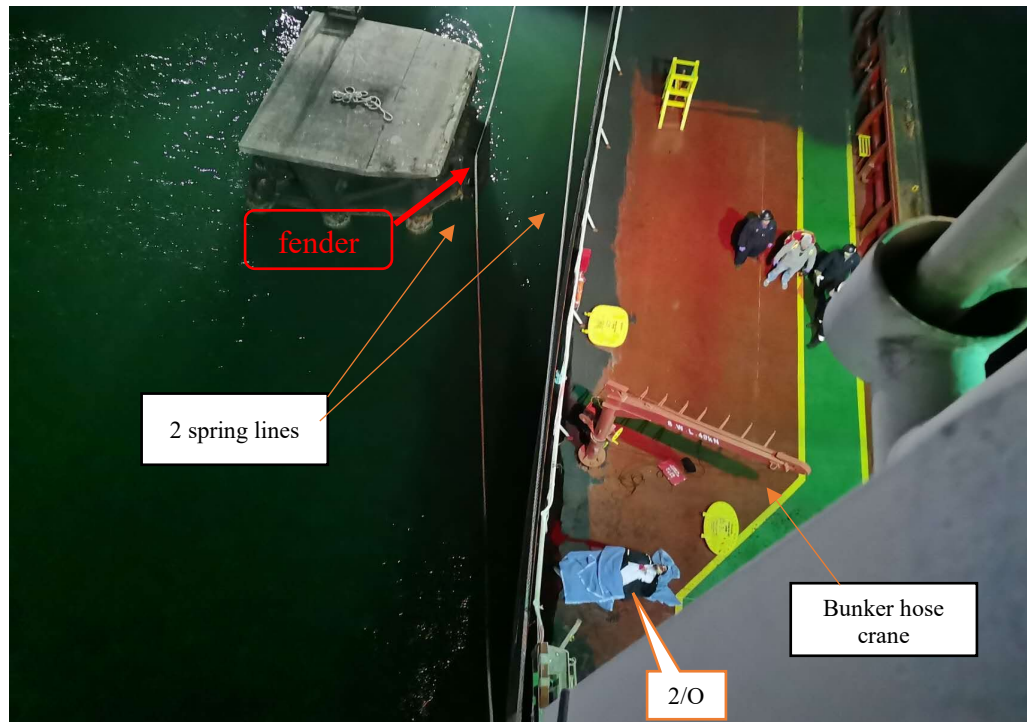
Figure 6: *the accident site*

- 3.9 The Master ordered C/O immediately to go to the spot with 3/O to assess the condition of 2/O and provide first aid to him. The C/O checked the vital signs of 2/O after arriving at *the accident site* and found 2/O had no breathing, no heart beating, blood in his mouth and nose, and bloody stain on deck around him (Figure 6). Meanwhile, the Master immediately contacted the local agent to seek emergency medical treatment for 2/O.

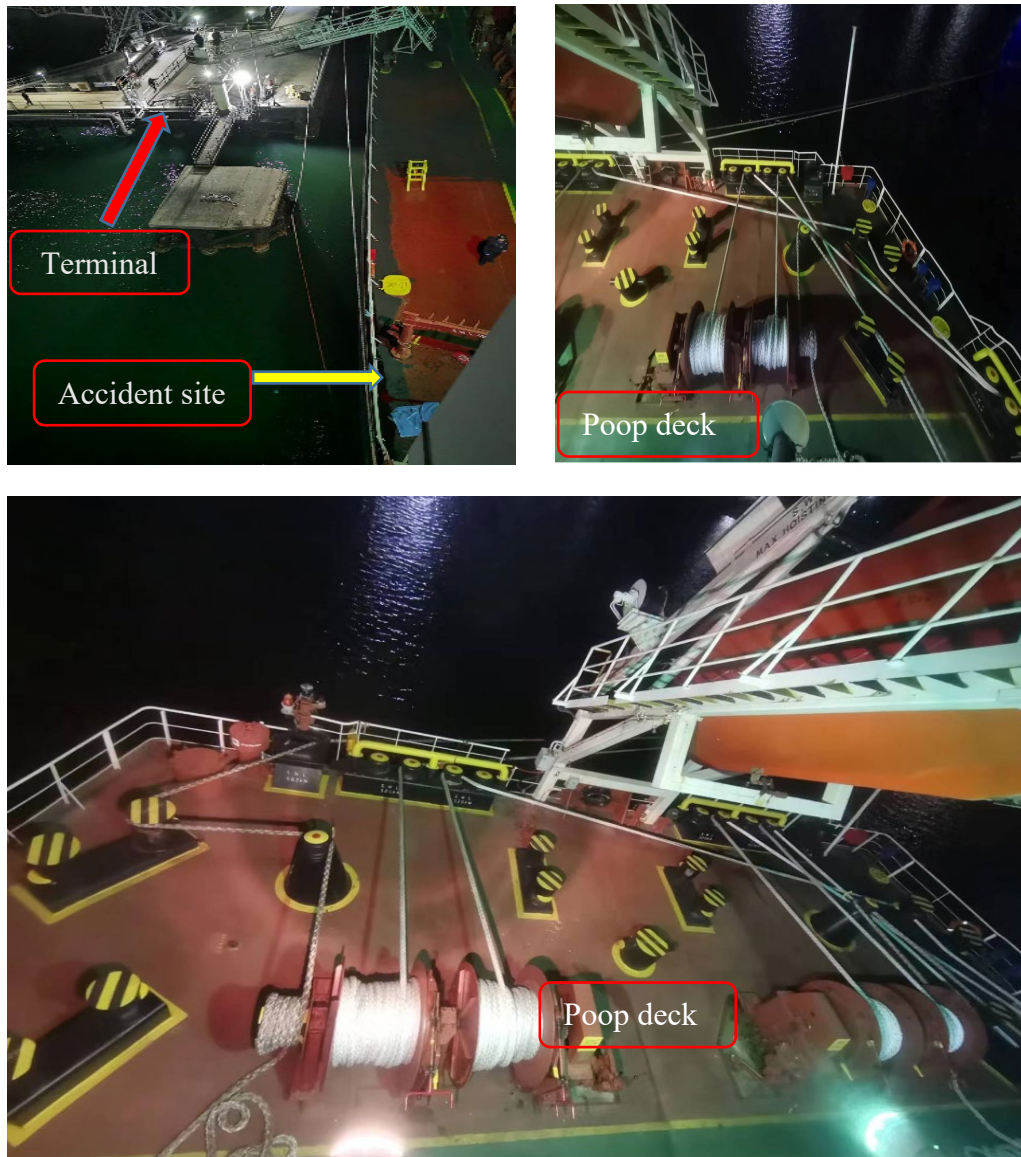
Figure 7: illumination of *the accident site*, terminal and poop deck

- 4.15 Chapter 11.2.2 of *the Code* stated that adequate lighting should be provided in areas for transit, loading or unloading of cargo or other work processes. According to the photos of *the accident site* and poop deck provided by *the Company* (Figure 7), the illumination on *the terminal* and *the vessel* was sufficient for *the shifting operation* except for the area near the fender where the aft spring line was entangled as reported by the Master. The illumination might be considered to be one of the contributory factors to the accident.

- (a) strictly follow the requirement of *the Code* to remain in safe position and its recommendation to identify dangerous areas by using a bird's eye view of the mooring deck arrangement during operation of shifting vessel including the provision of illumination around the fender area which is far from the vessel;

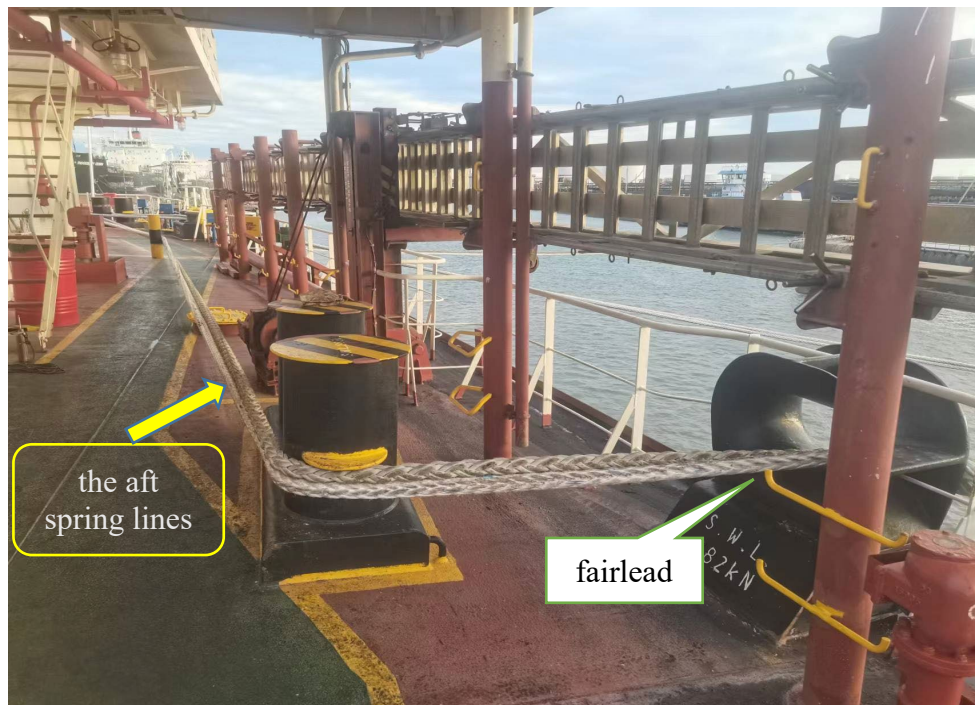
Figure 8: the layout of two aft spring lines on aft main deck

- 4.16 The aft spring lines were found slack when the vessel was in position during *the shifting operation*. The 2/O ordered AB1 to heave the slack aft spring lines and checked their condition simultaneously at *the accident site*. The investigation revealed that the 2/O was found lying on *the accident site* by the Master after a loud noise was heard while one aft spring line was jumping up and down in an oscillatory movement with the other aft spring line still being entangled by the upper edge of the fender. It could be deduced that the 2/O was hit heavily in a flash by the snap-back of the aft spring line, which escaped suddenly from the upper edge of

the fender due to continuous heaving operation.

- 4.18 The 2/O positioned himself at *the accident site*, which was 4 meters only to the fairlead of aft spring lines when the AB1 was heaving the aft spring line (Figures 8 & 9 refer). The 2/O was unaware of the risk of snapping back of the aft spring lines⁶, which was entangled with the edge of the fender and might be free from the fender if under strain.

- (d) enhance safety awareness of the crew to the risk of the snap-back zone of mooring lines during the operation of shifting vessel;
 - (e) ensure the operation of shifting vessel be carried out under safe working culture, including good communication and clear leadership; and

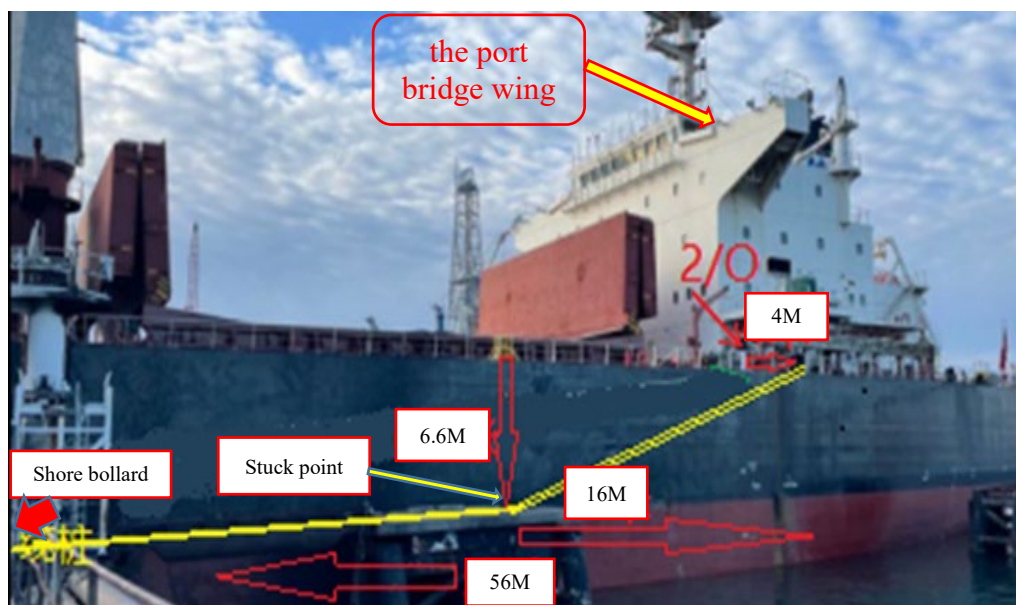
Figure 9: condition of spring lines prior to the accident

⁶ The length of the aft spring lines from the fairlead to the bollard at the terminal was about 70 meters (Figure 9 refers).

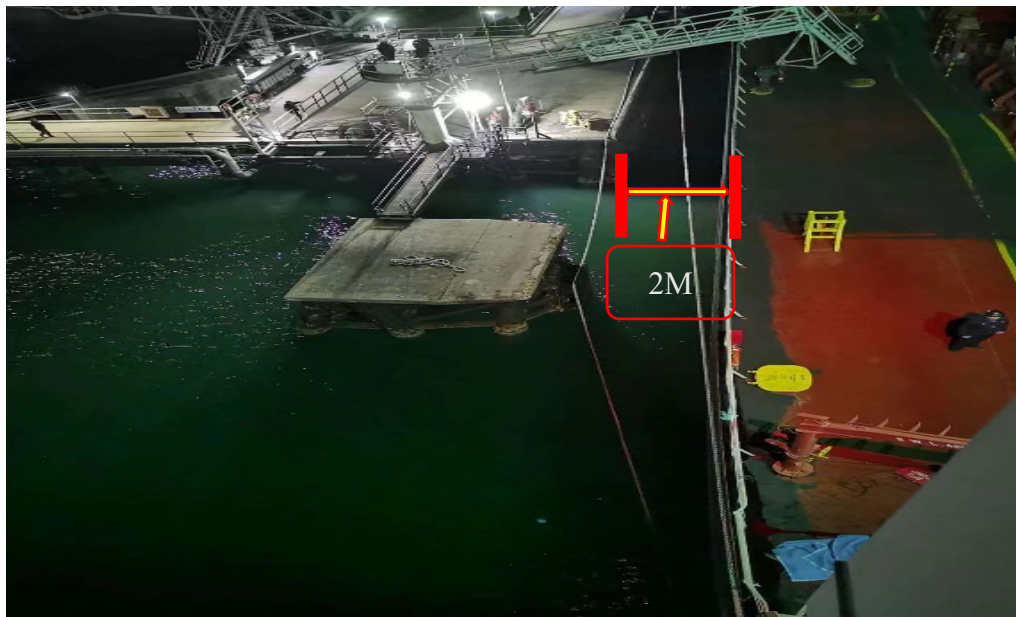
Figure 10: the condition of *the vessel* which was about 2 M apart from the terminal

- 4.27 In addition, when the Master found the aft spring lines were slack and ordered 2/O to heave the spring lines, he did not realize that the vessel was about 2 meters apart from the terminal (Figure 10). Figure 11 shows the normal mooring condition of *the vessel*. If the Master ordered C/O and 2/O to heave fore and aft breast lines first, the aft spring lines might be free from the fender before becoming strain, and the accident might have been avoided.
