**Report of investigation  
into a fatal accident on board the Hong  
Kong registered container vessel “*Wan  
Hai 172*” at sea on 1 December 2022**

The Hong Kong Special Administrative Region  
Marine Department  
Marine Accident Investigation Section

2 May 2023

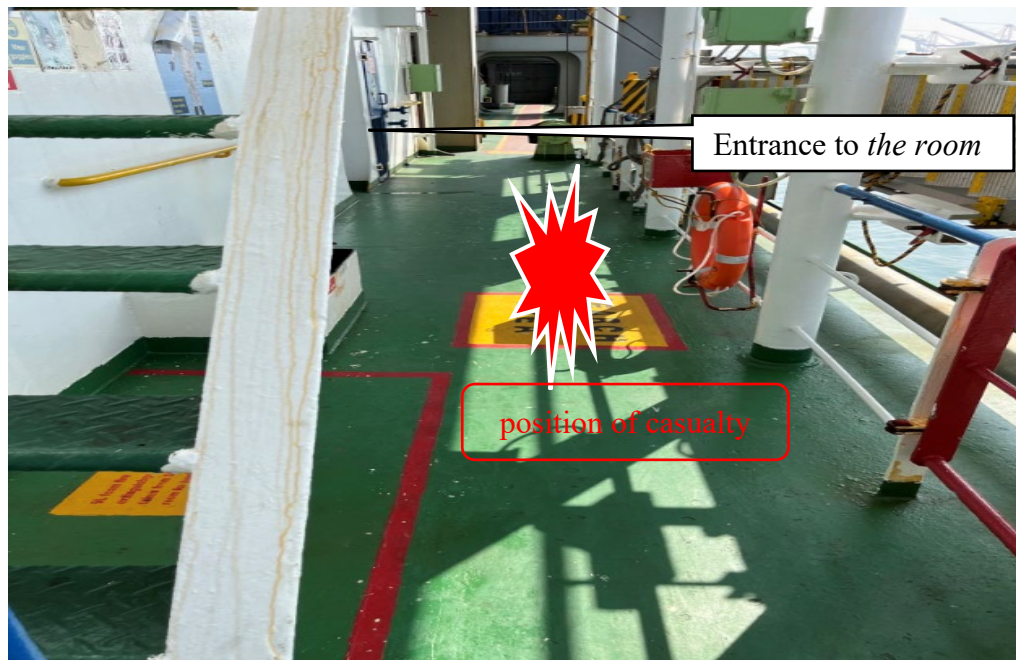
Figure 2: the port side gangway area

- 3.4 At 0833 hours, the ETO went alone to conduct routine inspection to *the room* through the access door at the port side of main deck (Figure 2 & 3). At 0835 hours, the bosun found that the life raft on port side of *A-deck* was shifted away from its bestowed position due to heavy swells, and proceeded to secure the life raft after obtaining permission from Master.

- 3.5 At 0844 hours, after securing the life raft, the bosun found the ETO, wearing a coverall, safety shoes and ear muff, lying unconsciously on the main deck near the gangway (Figure 2, 3 and 4). The bosun immediately reported the incident to the Chief Officer (C/O).

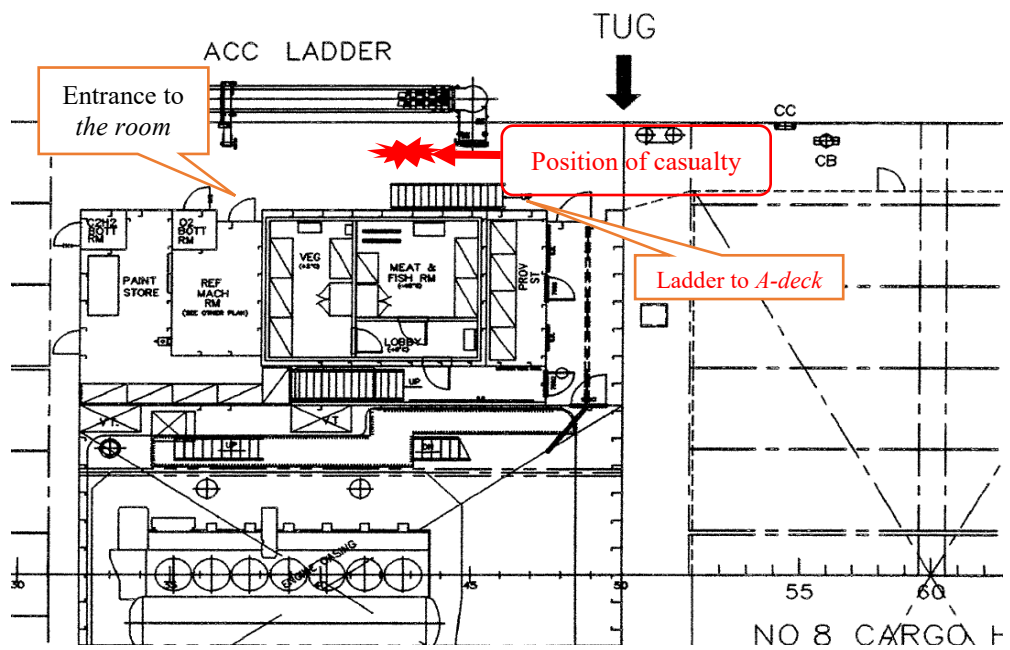
Figure 3: position of casualty

- 3.6 At 0846 hours, the first aid team of *the vessel* reached on-site and shifted the ETO to the hospital of *the vessel* for first aid treatment. The ETO was found breathing with difficulty, his right arm fractured, open wounds, bruises on his left leg, and blood in his nose, ear and head.
- 3.7 At 0914 hours, CPR was applied to the ETO as he had no breathing, followed by AED according to radio medical advice. Simultaneously, *the Company* arranged helicopter service for transferring the ETO to shore for medical treatments.
- 3.8 At 1226 hours, a helicopter arrived at *the vessel*, and the ETO was transferred to a hospital at *the destination port* at 1337 hours. Unfortunately, the ETO was declared dead by the hospital on the same day.

was intracerebral bleeding, which was led by traumatic brain injury caused by strikes by a foreign object. The cause of death was head injuries, consistent with the physical condition of the ETO described in paragraph 3.6 when he was found.

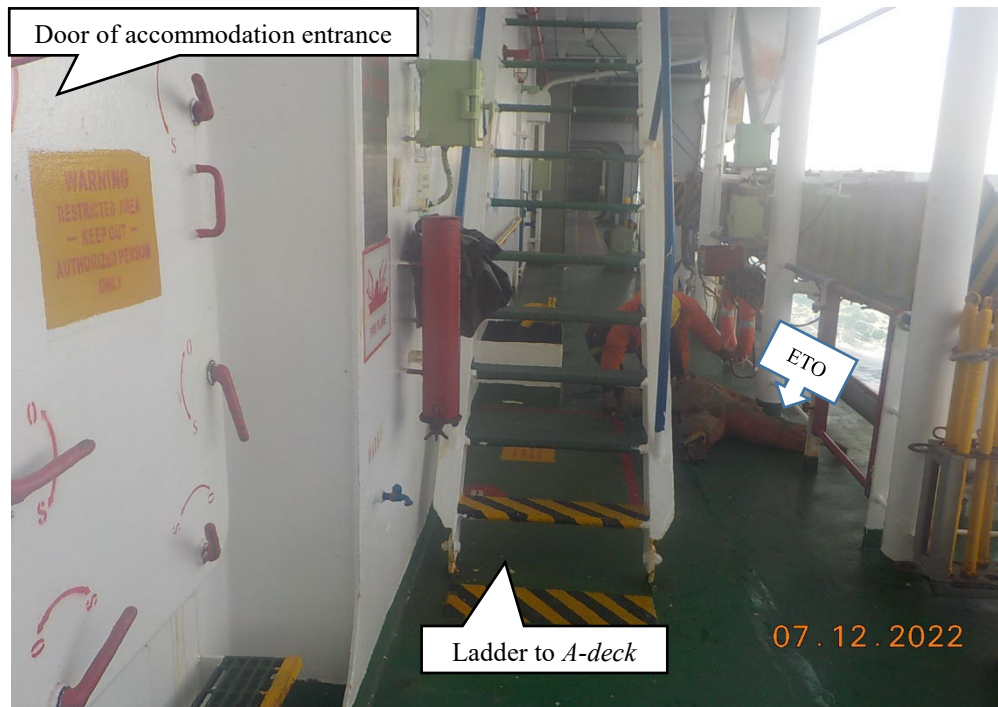
Figure 4: the accident scene simulation

- 4.15 On the day of the accident, the weather was overcast with northeasterly wind of Beaufort wind scale Force 7. The sea was rough with heavy swell, and the visibility was good. The vessel rolled and pitched heavily due to rough sea condition. The weather and the sea conditions were considered to be the contributory factors to the accident.

- 4.21 However, the investigation revealed that the ETO went to inspect *the room* alone, neither obtained the permit from Master, nor wore a lifejacket with waterproof personal protective equipment. Moreover, he did not complete the checklist “Work on Deck in Heavy Weather Permit” before working. It concluded that the ETO did not follow *the Code* and the shipboard SMM requirements when working in adverse weather.

- 6.1 The management company should issue a circular informing all masters, officers and crew members of its fleet of the investigation findings and lessons learnt from this accident to:
- (a) strictly follow the requirements of *the Code* to identify the hazards and associated risks for all involved work in toolbox meeting before commencing work;
  - (b) strictly follow the requirements of *the Code* and shipboard SMM on working outside accommodation block in adverse weather;
  - (c) ensure shipboard training on the SMM procedures be conducted effectively, especially familiarizing the procedure for working on deck in heavy weather; and
  - (d) enhance safety awareness of the crew onboard on working outside accommodation block in adverse weather.
- 6.2 A Hong Kong Merchant Shipping Information Note is to be issued to promulgate the lessons learnt from this accident.
