**Report of investigation
into a fatal accident on board the Hong
Kong registered bulk carrier “*Tiger
East*” at Sea on 23 December 2022**

The Hong Kong Special Administrative Region
Marine Department
Marine Accident Investigation Section

4 July 2023

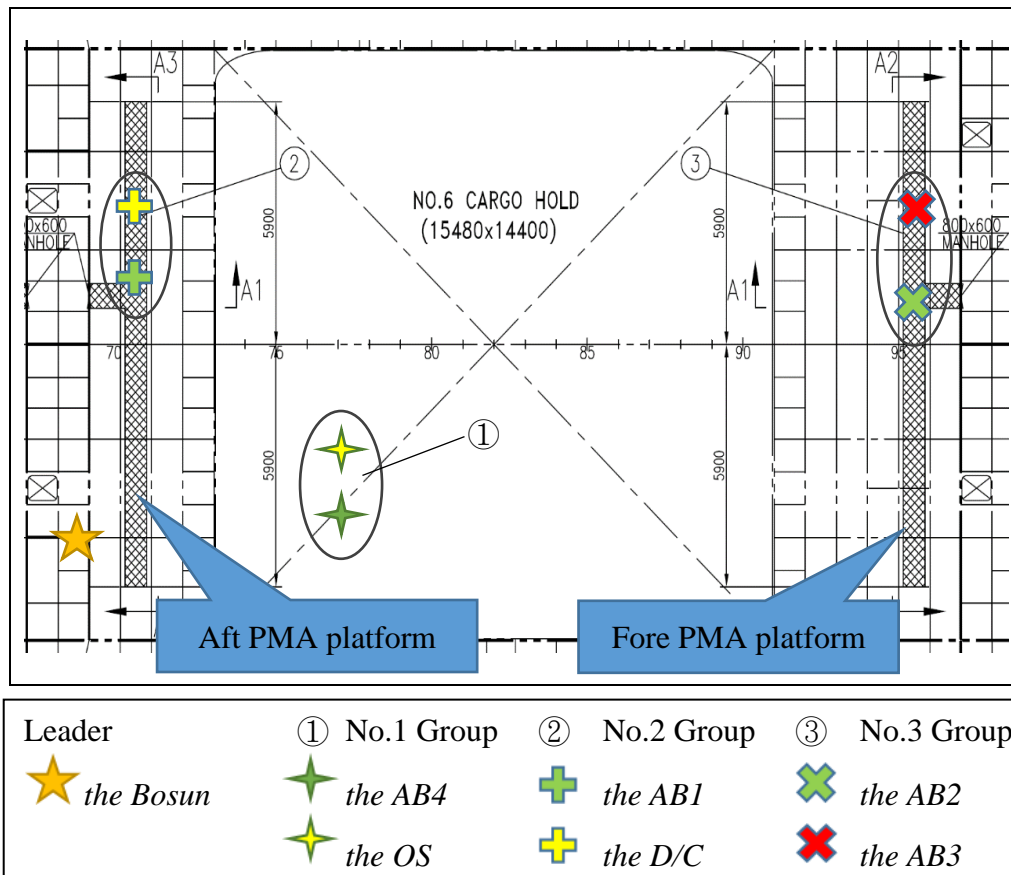
- 3.4 At about 0810 hours, *the Bosun* supervised *the hold cleaning* on the spot. Three groups of deck crew were assigned to carry out *the hold cleaning* (Figure 2). The No.1 group comprised the No.4 AB (*the AB4*) and one ordinary seaman (*the OS*). They were assigned to wash the tank top of *the hold*. The No.1 AB (*the AB1*) and one deck cadet, as members of the No.2 group, were assigned to wash the aft upper part of *the hold* on the aft PMA platform. The No.3 group comprised *the AB2* and *the AB3*, who were assigned to wash the fore upper part of *the hold* on *the fore platform*.

Figure 2: location of the team members for *the hold cleaning*

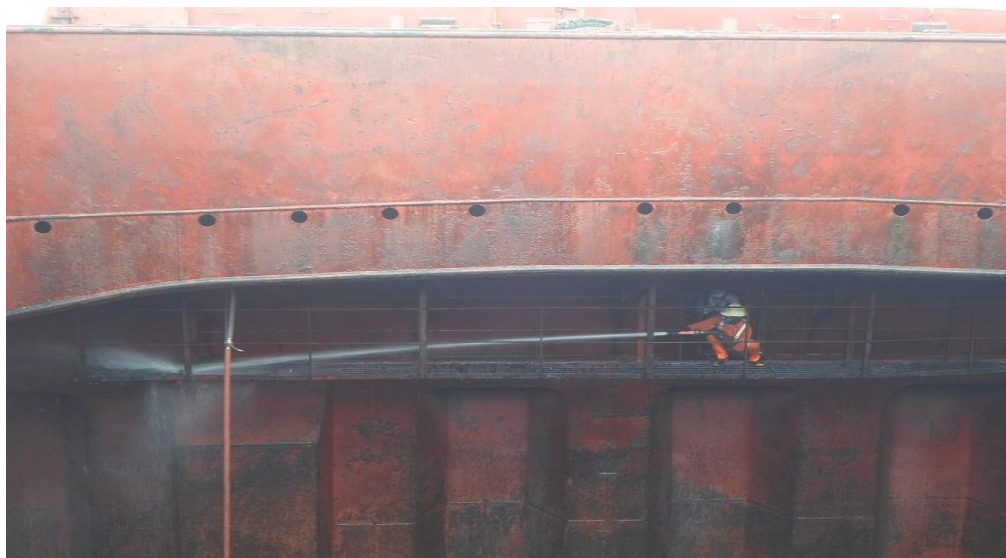
- 3.5 During *the hold cleaning*, *the hold* was swept first and then washed using a fire hose with high-pressure seawater by each group at their designated locations (Figure 3). The hatch cover of *the hold* was fully opened with natural ventilation and daylight.

Figure 3: *the hold cleaning* operation onboard

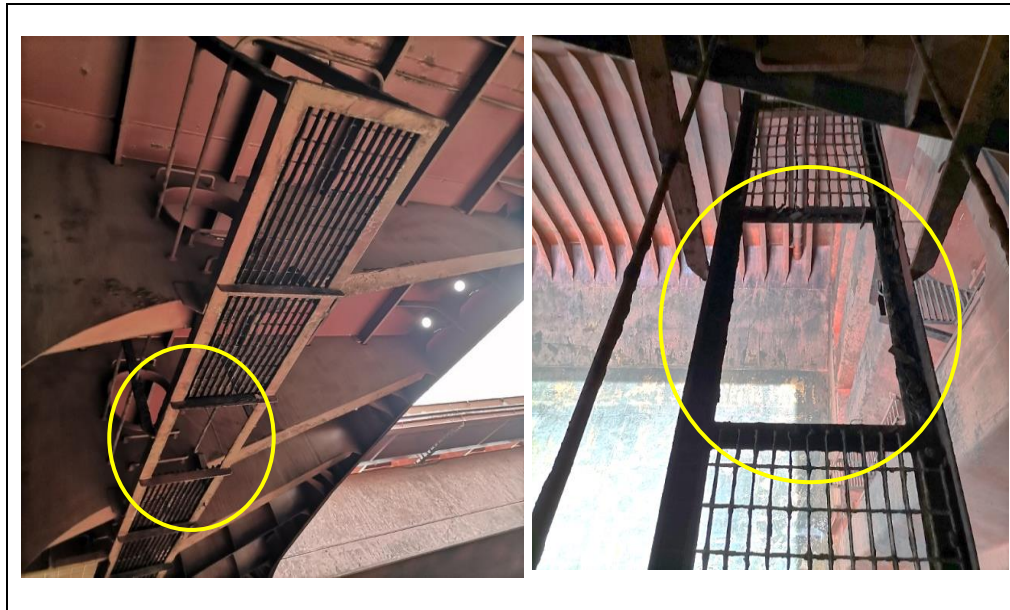
- 3.6 *The AB2 and the AB3 entered the hold through the forward manhole on the main deck to the fore platform to clean the hold. At 0848 hours, the AB3 brought a pressurized fire hose and walked on the fore platform to the port side without wearing a safety belt. When he stepped on the third grating counted from the port side (Figure 4), the grating detached from its support frame. The AB3 lost his balance and fell on the tank top from a height of about 15.8 meters, together with the detached grating.*

Figure 4: the detached grating of *the fore platform*

- 5.3 At about 0848 hours, *the AB2* and *the AB3*, as members of the No.3 group, were on *the fore platform* to wash the forward upper part of *the hold*. When *the AB3* walked to the port side of *the hold* on *the fore platform* with a pressurized fire hose, the grating detached from its support frame where *the AB3* was standing. As a result, *the AB3* lost his balance and together with the detached grating fell onto the tank top from a height of about 15.8 meters. *The Bosun* immediately reported the accident to *the C/O* and *the Master*. *The Master* then assembled the rescue team to provide first aid to *the AB3* and altered the ship's course heading to Kota Manado to seek shore emergency medical assistance. Afterwards, *the AB3* was transferred to a local hospital by a patrol boat of the Indonesian Coast Guard for further medical treatment. Unfortunately, he was certified dead on the same day.

- (d) ensure PMA platforms and their gratings are properly maintained and inspected;
 - (e) ensure the conditions of PMA platforms and their gratings to be checked before entering into the cargo holds for cleaning and maintenance; and

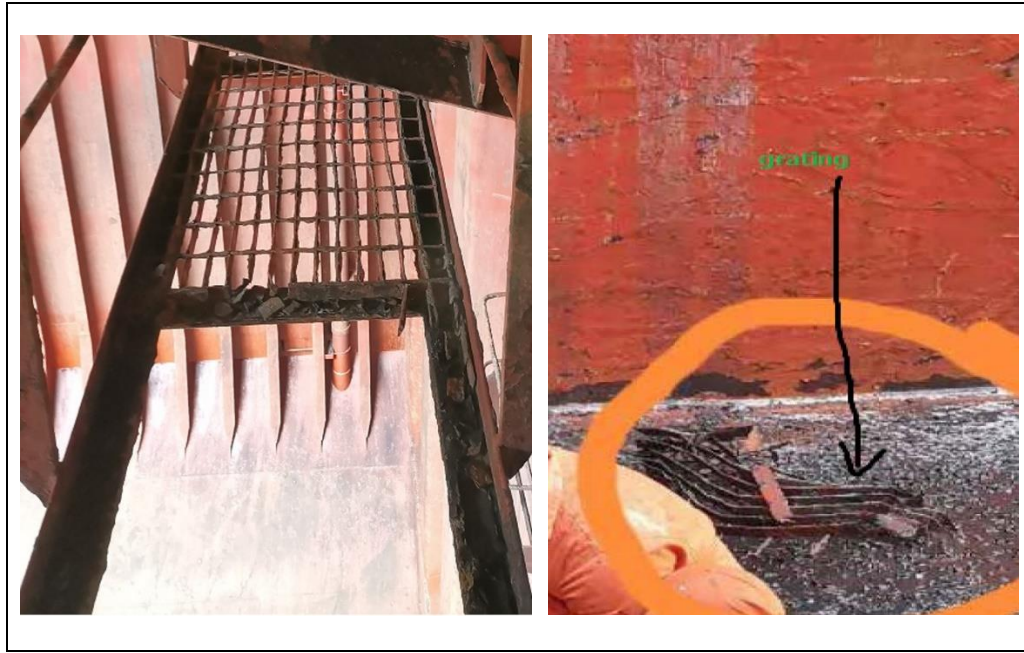
- 4.25 The “Instructions for cargo holds / tanks structure and coating inspection” (the MAINT-07) of the shipboard SMS stated that a detailed inspection of the cargo holds, including PMA platforms and their structures, should be carried out by the chief officer every 6 months and recorded properly.
- 4.26 The last detailed inspection of cargo holds was carried out on 17 June 2022. No defective PMA platforms, passageways, or gratings were identified and recorded during the inspection. However, according to the condition of the detached grating and its support frame of *the fore platform* (Figure 5), their metallic structures were heavily corroded and thinned. It revealed that the crew did not properly maintain *the fore platform* of *the hold* and failed to follow the ship SMS to conduct the detailed inspection of the cargo holds effectively every 6 months.

Figure 5: The condition of the detached grating and its support frame
