**Report of investigation  
into a fatal accident on board the Hong  
Kong registered container carrier “*Lexa  
Maersk*” at Guayaquil, Ecuador on 15  
January 2023**

The Hong Kong Special Administrative Region  
Marine Department  
Marine Accident Investigation Section

19 Jul 2023

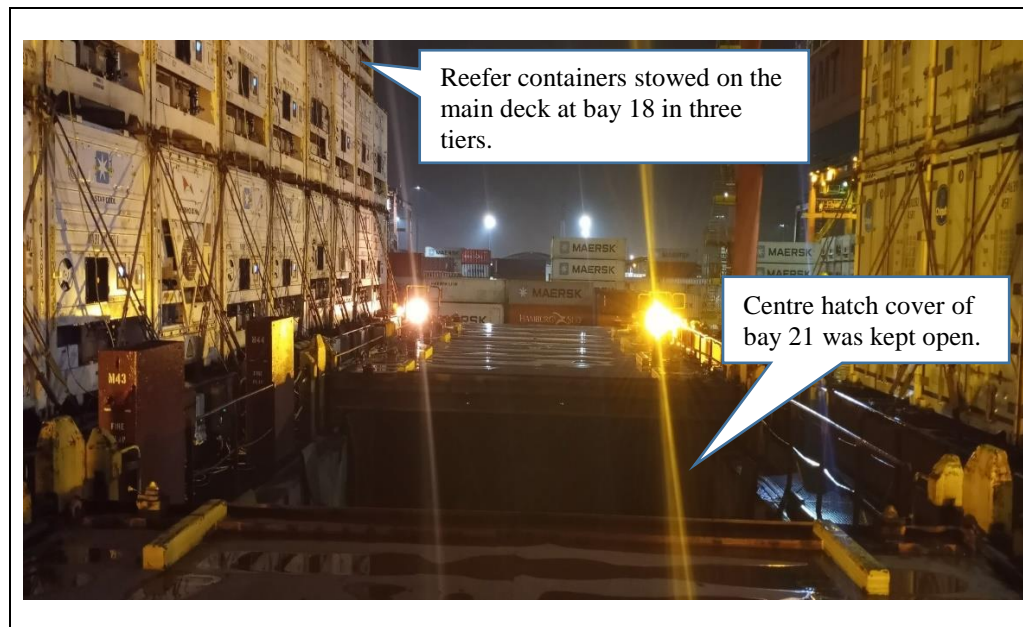
Figure 2: Photo of bays 18 & 21 taken after the accident

- 3.1 At 1615 hours on 13 January 2023, *the vessel* berthed at the port of Guayaquil, Ecuador and commenced discharging containers at 1646 hours on the same day.
- 3.2 At 0755 hours on 14 January 2023, *the vessel* commenced loading containers on board, including reefer containers.
- 3.3 At 2055 hours, eight shore technicians of *the service company* boarded *the vessel* to connect *the vessel's* power supply to the reefer containers stowed in each of the bays on board.
- 3.4 At 0010 hours on 15 January 2023, *the hatch cover* was opened. *The vessel* commenced loading containers under the deck for *the hold*.
- 3.5 At 0331 hours, the loading operation for the cargo hold of bay 18 was completed, and a total of 94 forty-foot reefer containers were loaded. There were three tiers of reefer containers stowed on the main deck at bay 18 (Figure 2).

- 4.34 Four floodlights on fore and aft catwalks between bays 18 to 21 and bays 21 to 24 (Figure 2 refers) were in operation with sufficient illumination at the time of the accident. The light condition was not considered to be the contributory factor to the accident.

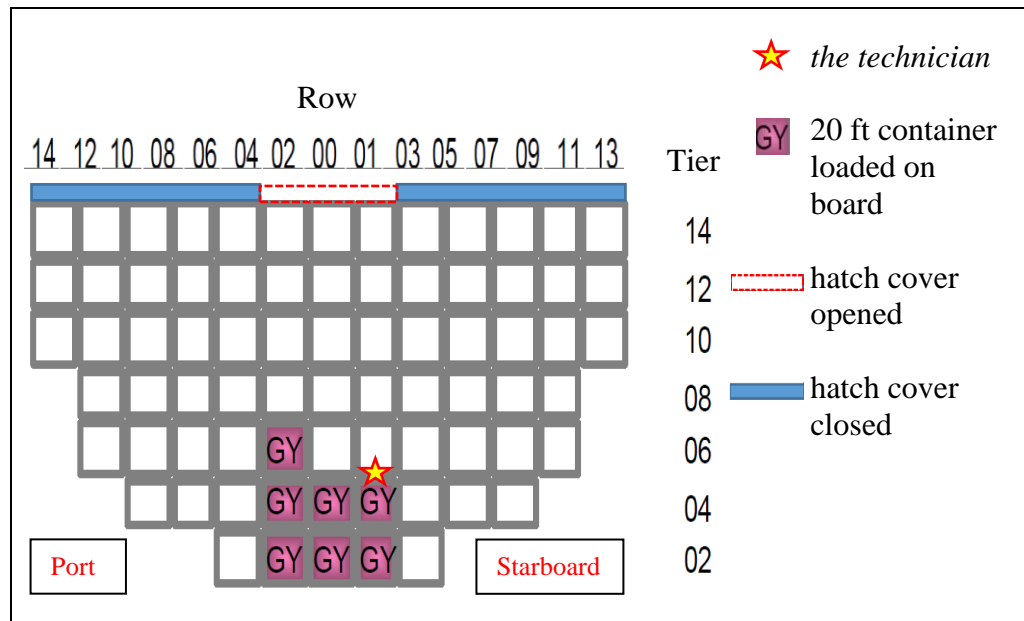
Figure 3: Position of *the technician* at bay 21

3.6 At 0335 hours, *the D/C* found that stevedores on board were suddenly rushing to bay 21 when he assisted in a cargo watch on the deck at bay 10. He followed them and saw *the technician* lying unconsciously on the top of *the container* at row 01 tier 04 stowed under the deck in *the hold* close to the starboard side (Figure 3). He immediately reported the accident to *the 2/O* and *the C/O*.

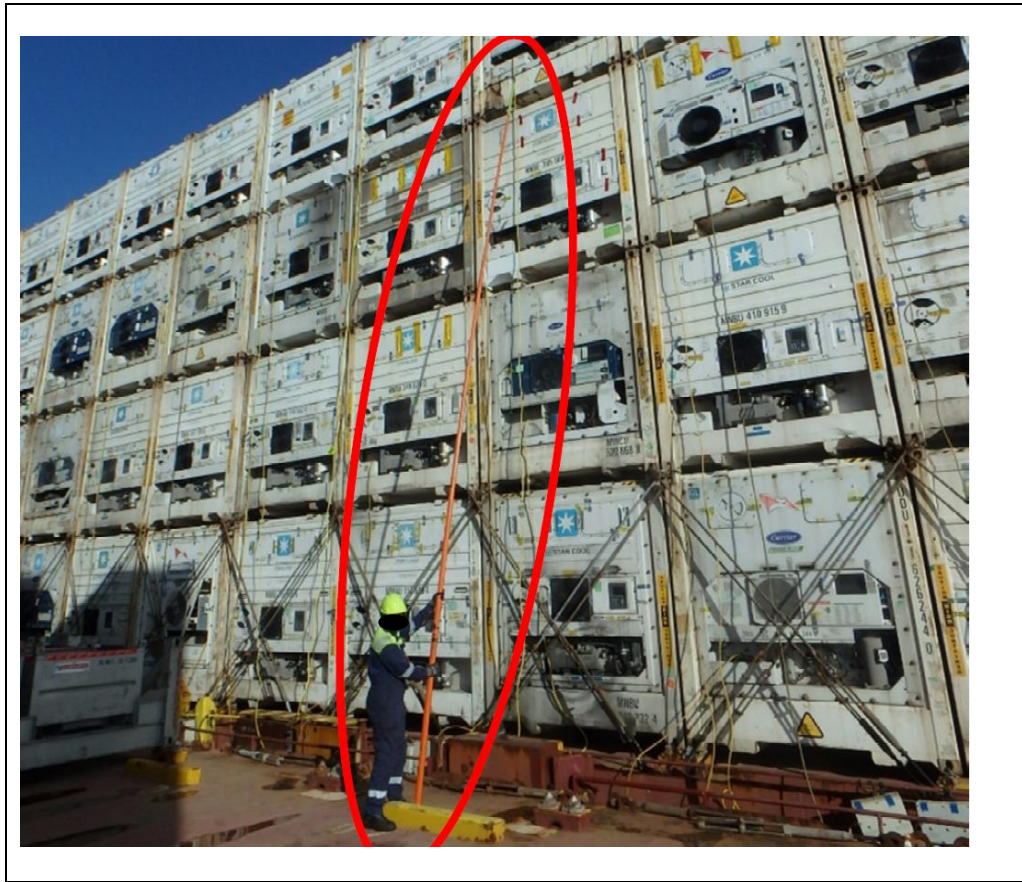
Figure 4: Photo of a fully extended cable picker reaching the fourth (4<sup>th</sup>) tier of reefer containers

above on the deck, lowered it onto the deck by a cable picker<sup>2</sup> (Figure 4), and connected it to the power supply of *the vessel* because *the vessel* was not fitted with a lashing bridge.

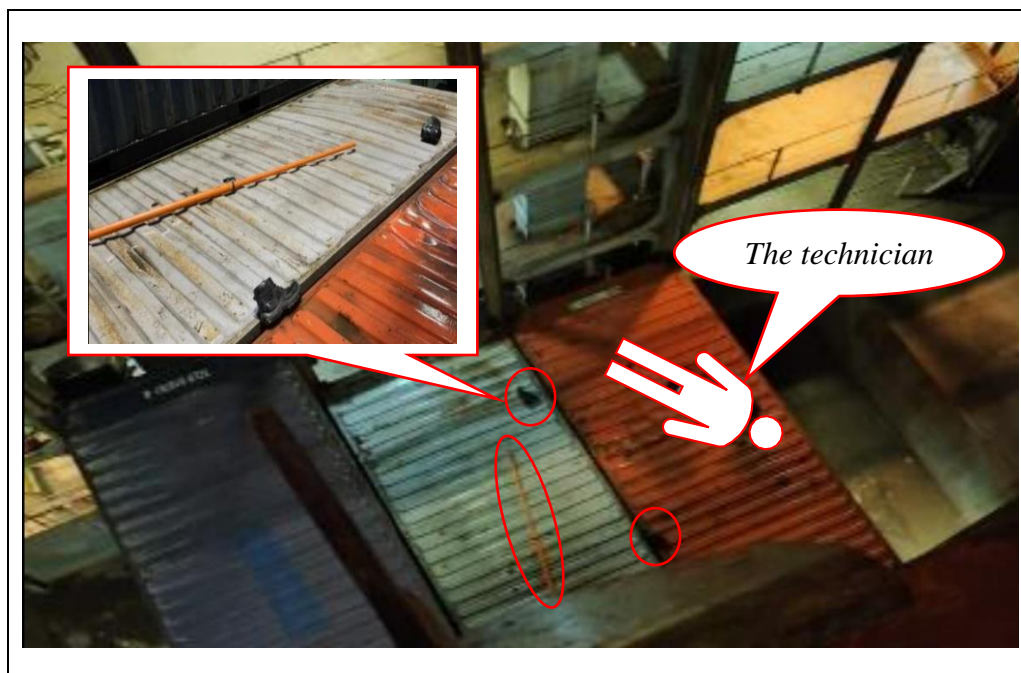
- 4.21 There was no eye witness in this accident, and the autopsy report of *the technician* was unavailable. Therefore, the probable cause of the accident was based on available information provided by *the Company*.
- 4.22 In the accident, *the technician* was found with face down lying on the top of *the container* in *the hold* close to the starboard side (Figure 5). The top of *the container* and the hatch coaming of bay 21 was about 13 metres.

Figure 5: A pair of safety shoes and a partly extended cable picker were found nearby the body of *the technician* adjacent to *the container*

- 4.30 *The technician's* safety shoes were found lying on the right-hand side of his body at a distance of about 1.5 metres (Figure 5 refers), and he did not wear a safety helmet and safety harness. According to the information provided by *the Company*, despite the duty crew checked all shore technicians were wearing proper PPE at the gangway during embarkation, the unsafe act of *the technician*, i.e. without wearing of safety harness or other arresting device when working aloft, was not properly monitored by the duty officer through random checks.

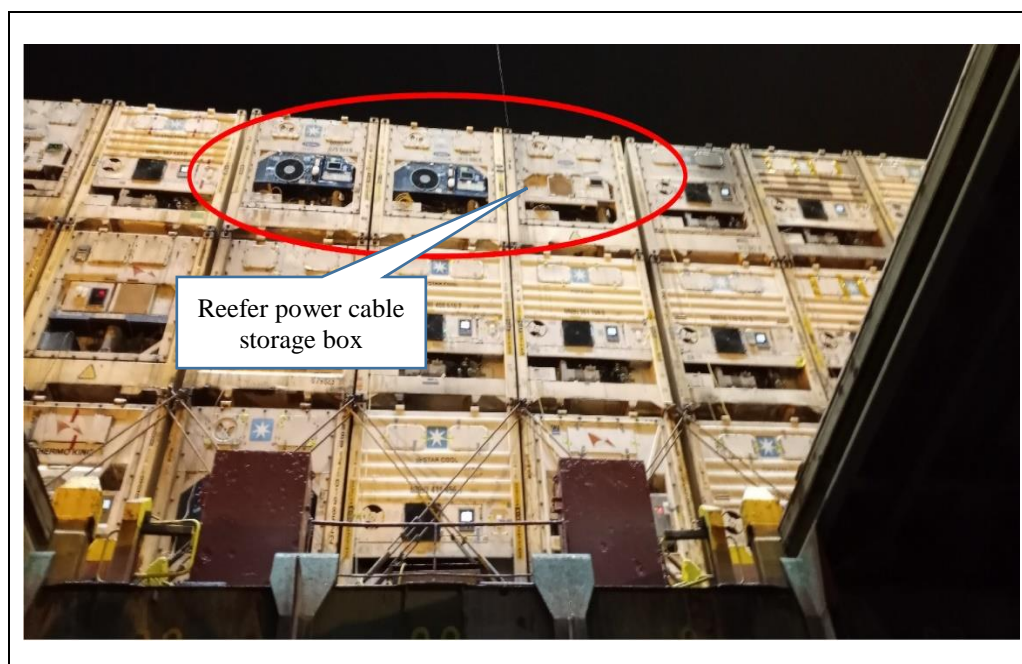
4.23 The investigation found that all reefer containers loaded in bay 18 were connected to *the vessel's* power supply at the time of the accident, except three reefer containers loaded on deck at the centre of tier 86 rows 02, 00 and 01 (*the unplugged reefer containers*), which were located in front of the opening of *the hatch cover* (Figure 6 & 7).

Figure 7: View from inside cargo hold of bay 21 to bay 18 of *the unplugged reefer containers*

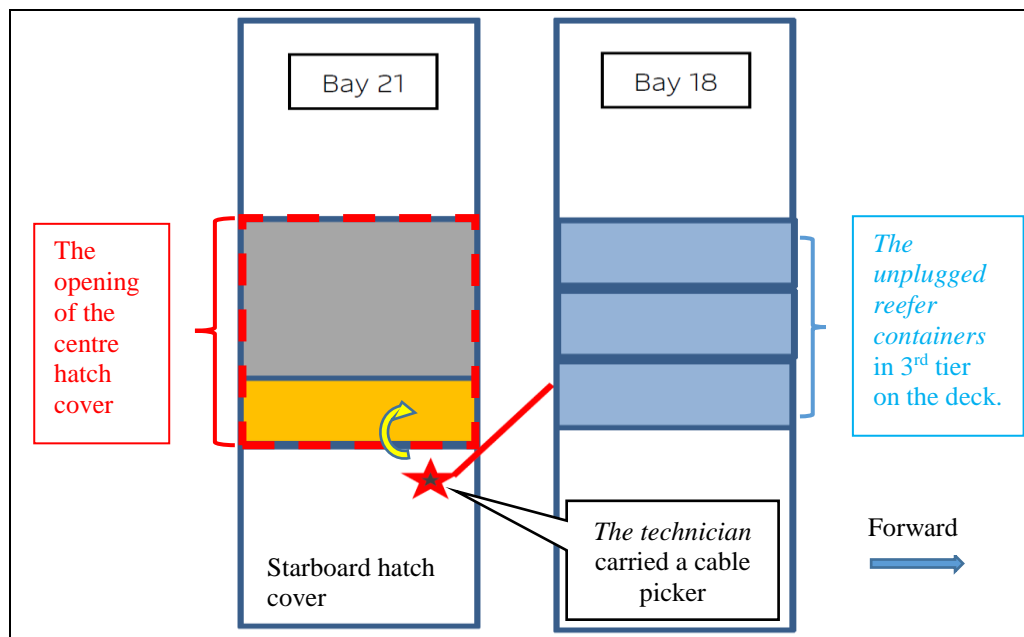
- 4.24 The investigation deduced that *the technician* was working alone on the catwalk between bays 18 and 21 to connect the power cable of *the unplugged reefer containers*. At the time of the accident, he probably walked through an unsafe route to the starboard side hatch cover in bay 21 in order to get a better angle to pick the power cables out of *the unplugged reefer containers* by a partly extended cable picker (Figure 8).
- 4.25 As *the unplugged reefer containers* were located at the centre positions on the deck at the 3<sup>rd</sup> tier of bay 18, *the technician* might require to stretch his body close to the opening of *the hatch cover* to pick the cable out of its storage box. As a result, he might lose his balance and fall into *the hold*, causing his death.

Figure 8: Probable position of *the technician* before falling into *the hold*

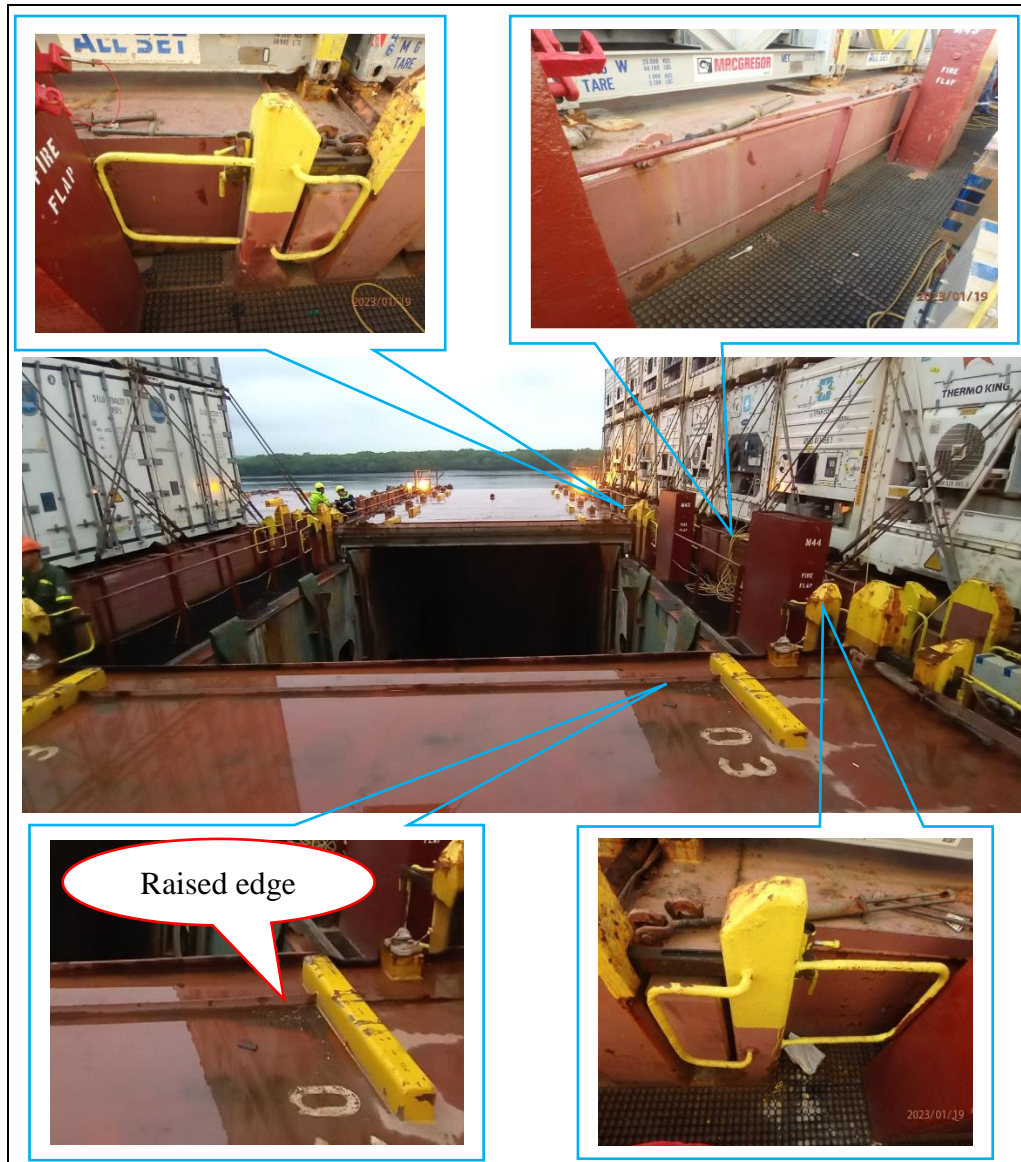
- 4.35 The catwalk and railings between bays 18 and 21 were in sound condition and properly maintained. The catwalk was placed with a layer of anti-slip mat. The railings were found intact, and it could avoid personnel working on the catwalk from accidentally falling into *the hold* when *the hatch cover* was removed.

- 4.36 The hatch covers of *the hold* are of steel structure and were in sound condition at the time of the accident. Their surfaces had no anti-slip coating or materials added. However, *the technician* might have a chance to trip over by the raised edge of the hatch covers and fall into *the hold* when he was walking near the opening of *the hatch cover*.

- 4.38 However, the investigation revealed that *the hatch cover* was not closed immediately when the cargo operation in bay 21 was temporarily stopped. If *the vessel* and the shore personnel had established good communication to follow the requirements of *the Code* to close *the hatch cover* as soon as cargo operation stops or take suitable control measures against the risk of falling into *the hold*, the accident might have been avoided.

Figure 9: Conditions of catwalk, railings and hatch cover between bays 18 and 21

- ii) strictly follow the requirements of *the Code* to close hatch cover immediately as soon as cargo operation stops.
- 6.2 A Hong Kong Merchant Shipping Information Note is to be issued to promulgate the lessons learnt from this accident.
