**Report of investigation
into a fatal accident on board the Hong
Kong registered bulk carrier “*Zhen Zhu
Hai*” at sea on 17 January 2023**

The Hong Kong Special Administrative Region
Marine Department
Marine Accident Investigation Section

21 June 2023

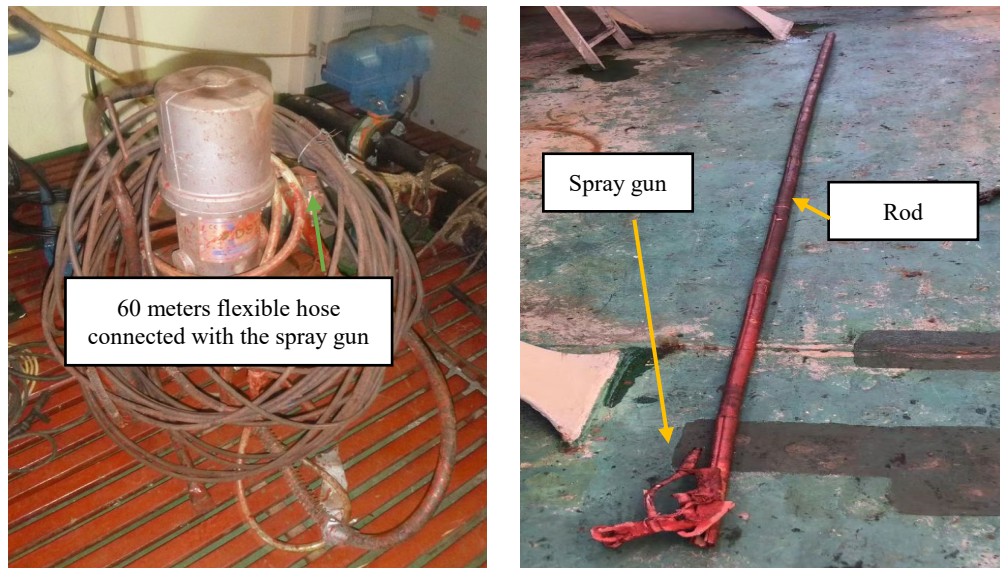
- 3.5 The bosun was the supervisor of *the deck team*. The carpenter conducted *the paintwork* using a pneumatic paint sprayer machine (Figure 2) with the assistance of the purser and the steward, including moving the sprayer machine and tidying up the flexible hose.

Figure 2: pneumatic sprayer machine and spray gun tied up with the rod

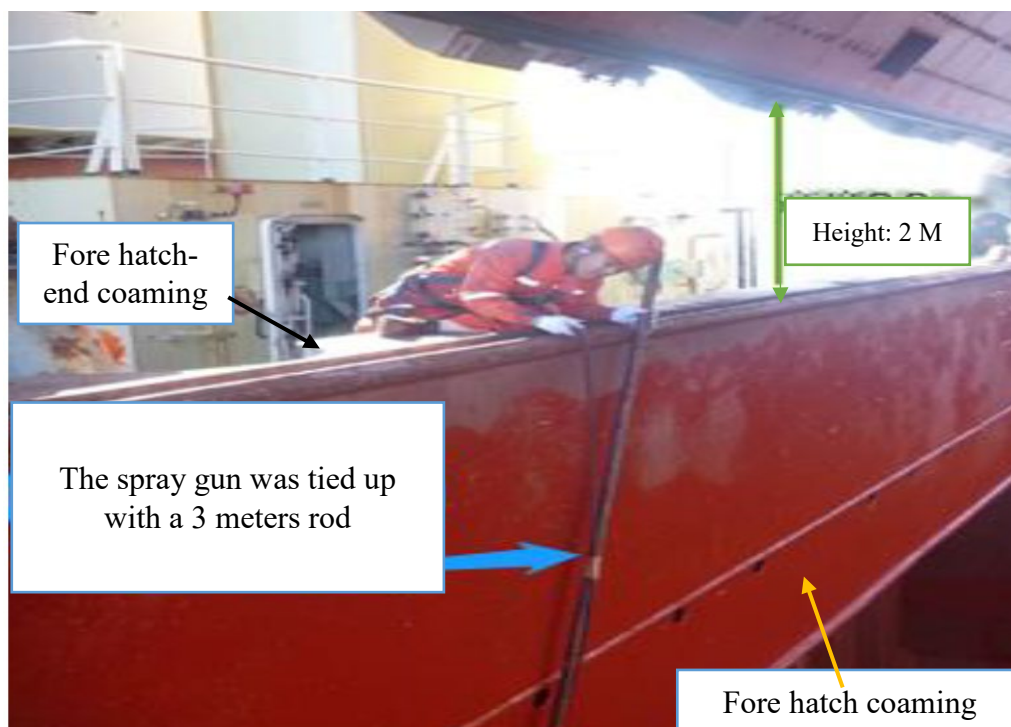
Figure 3: the simulated painting

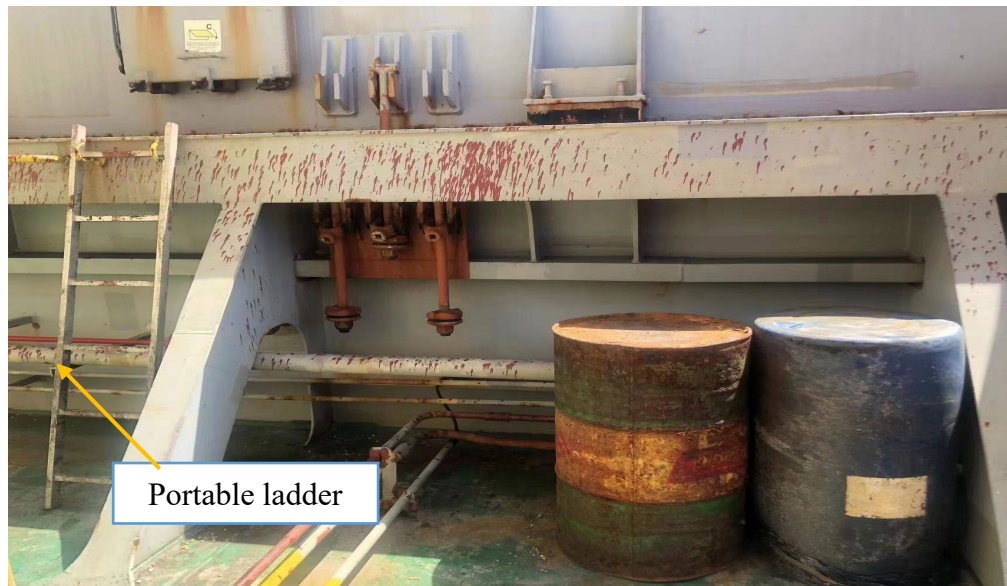
Figure 4: Portable ladder used on the painting site

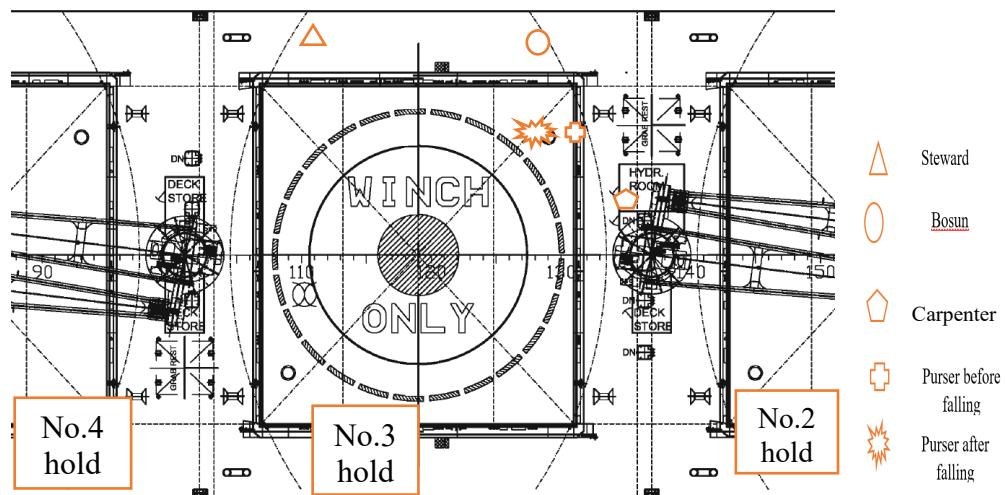
- 3.7 At 0940 hours, *the paintwork* of the fore hatch coaming of *the hold* was completed, and the bosun turned off the paint machine. After tidying up the working site with the steward, the bosun moved to the starboard side of *the hold* to continue *the paintwork*. The carpenter handed over the painting rod to the purser, stepped down from the ladder, and then entered the pump room to start the hydraulic pump to open the No.4 hatch cover as informed by the Master, who was checking cargo holds condition and took photos on the main deck.
- 3.8 At 0942 hours, when the bosun was about 6 to 7 meters away from the fore hatch coaming of *the hold*, he suddenly heard someone screaming and the sound of a falling object hitting against *the tank top* (Figure 5 & 6). The bosun immediately ran to check *the hold* and found the purser lying *on the tank top*.

Figure 5: positions of *the deck team of the paintwork* at time of accident

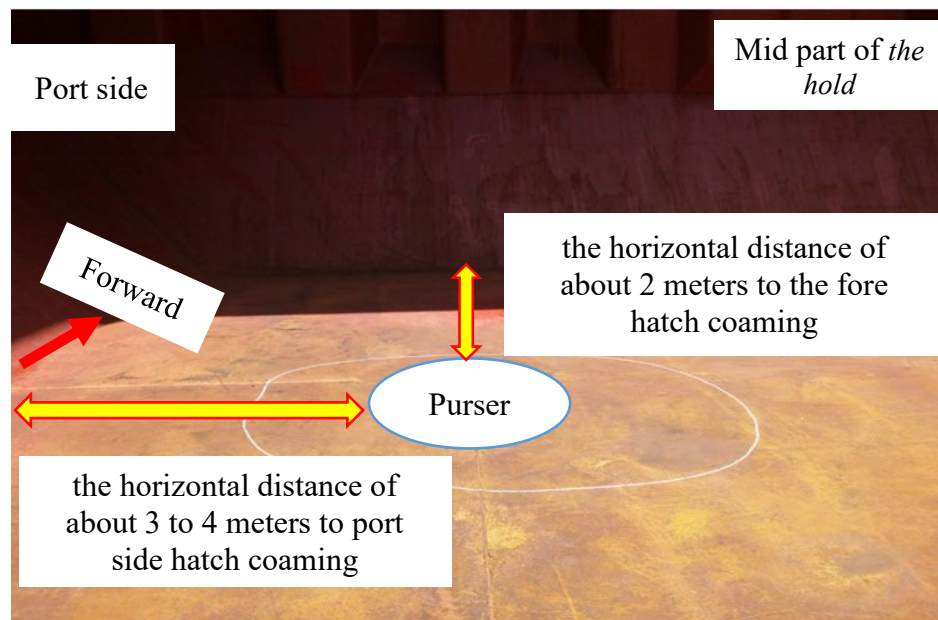
Figure 6: position of the purser on *the tank top*.

- 4.12 According to the investigation report of *the Company*, with the position of the purser lying on *the tank top* (Figure 6), and the painting rod being hung vertically inside the hatch coaming of *the hold* (Figure 7 & 8), it was deduced that the purser fell onto *the tank top* from the hatch coaming when he might carry out patch-painting using the painting rod with spray gun, resulted in losing his balance and falling into *the hold*.

- 4.17 According to paragraph 3.9, when the purser was found lying on *the tank top*, he did not wear a safety harness or arresting device, and no safety net was rigged under the hatch coaming. As such, the purser failed to follow *the Code* and shipboard SMS requirements to take necessary preventive measures when working aloft.

- (a) follow strictly the requirements of *the Code* to carry out a shipboard risk assessment for painting work;
 - (b) follow strictly the requirements of *the Code* and shipboard SMS to take preventive measures when working aloft;

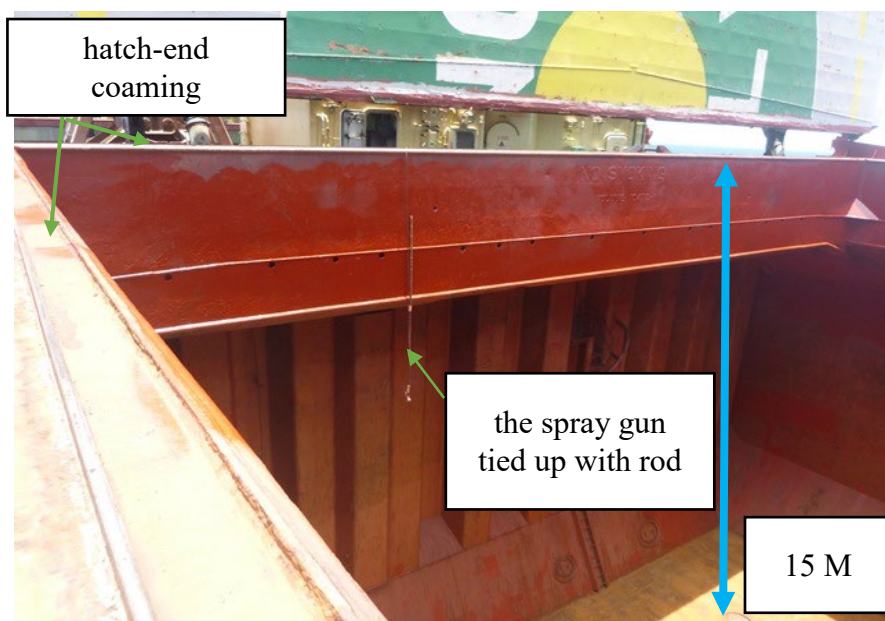
Figure 7: the accident scene

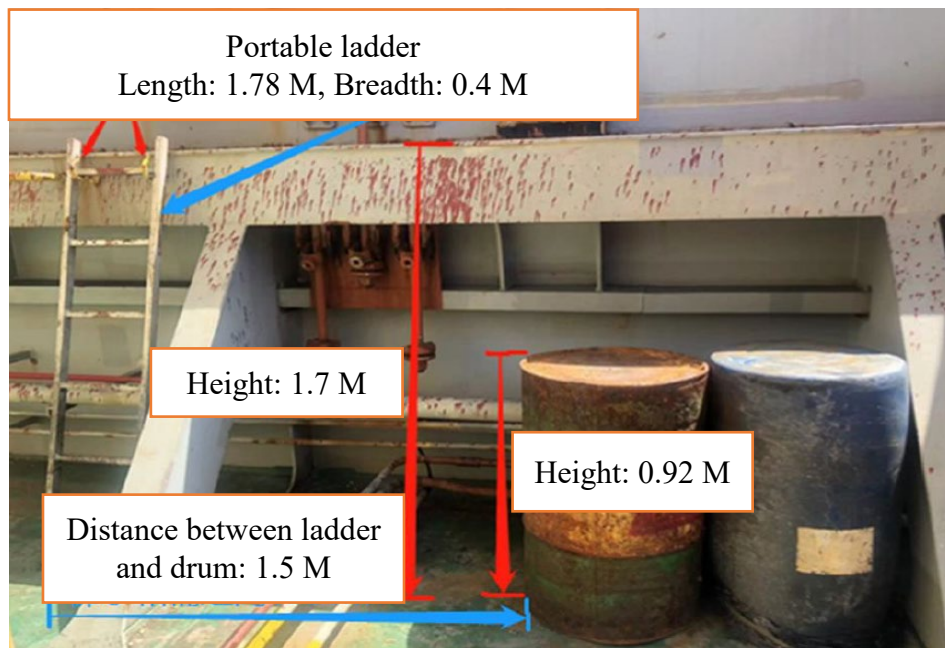
Figure 8: portable ladder and two empty oil drums nearby the corner of the hatch coaming
