Report of Investigation  
into the Collision between  
High-speed Passenger Crafts  
*New Ferry LXXXV* (新輪捌拾伍)  
And  
*Dong Qu Yi Hao* (東區一號)  
in Position about  
22° 10.3'N, 113° 38.6'E  
on 19 June 2006

# Preliminary Inquiry No. 1 of 2006

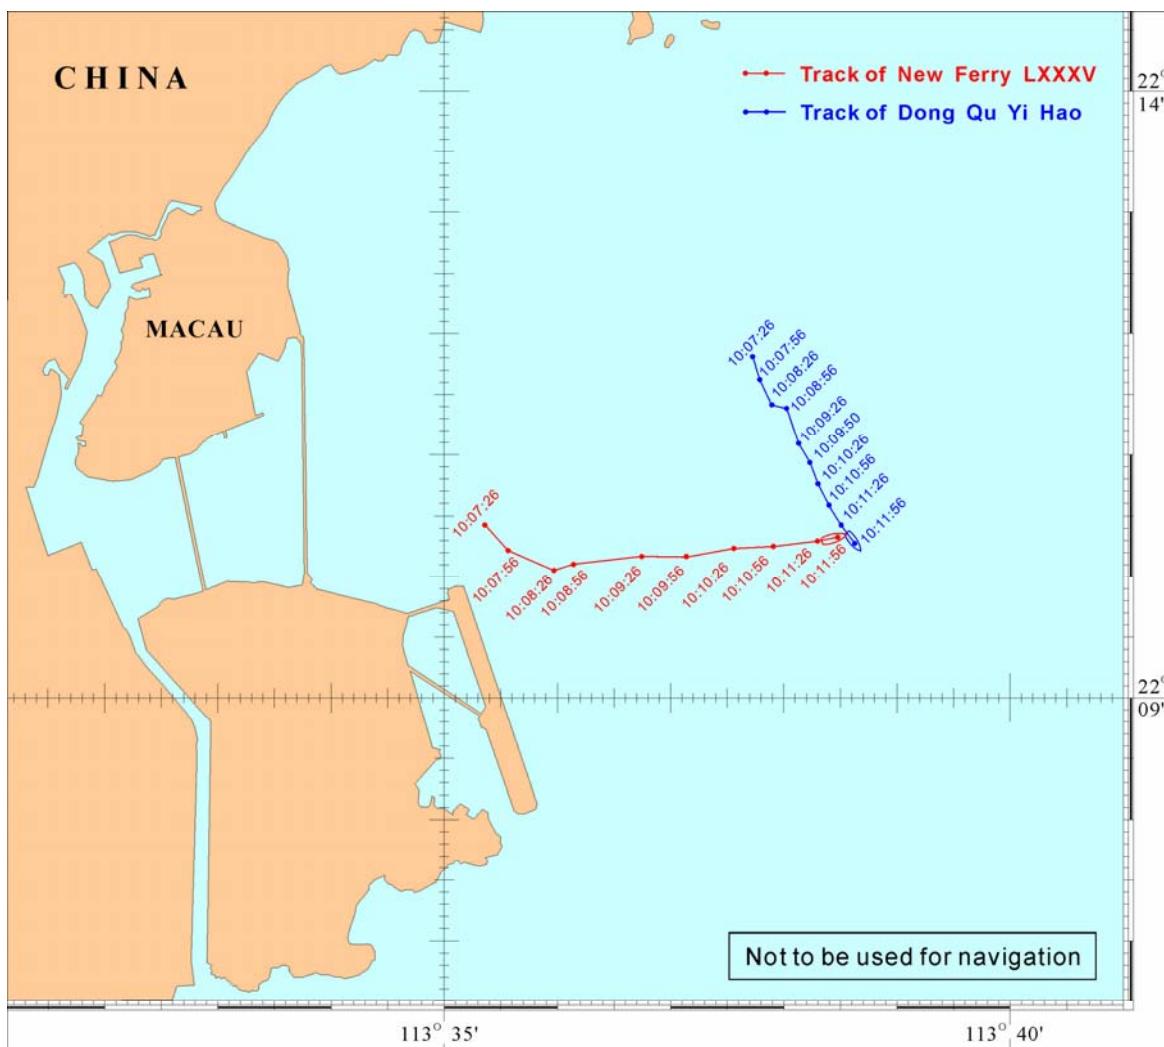
Figure 3- Radar Plot showing the collision tracks of *New Ferry LXXXV* and *Dong Qu Yi Hao*

- 5.4.1 According to the record of the VTS system of Macau Maritime Administration, after departing Macau Ferry Terminal in Macau at 1000 and at about 1007, *New Ferry LXXXV* was steaming along the Macau Channel on a course of 125°T with a speed of about 43 knots (Figure 3).
- 5.4.2 At 1008, *New Ferry LXXXV* altered course to port to 082°T to head towards Hong Kong. After steadyng on the new course at 1009, the vessel was making a speed of about 43 knots. The VTS system recorded that *New Ferry LXXXV* maintained almost the same course and speed until she collided with *Dong Qu Yi Hao* at 1012.

5.5.1 According to the record of the VTS system of Macau Maritime Administration, from 1007 to 1012 i.e. time of collision, *Dong Qu Yi Hao* maintained a course of about 153°T with a speed of about 23 knots (Figure 3).
